# BUILDING CONDITION REPORT

**JEFFERSON HIGH  
SCHOOL DISTRICT #1**  
July 21, 2020

SMA|ARCHITECTS

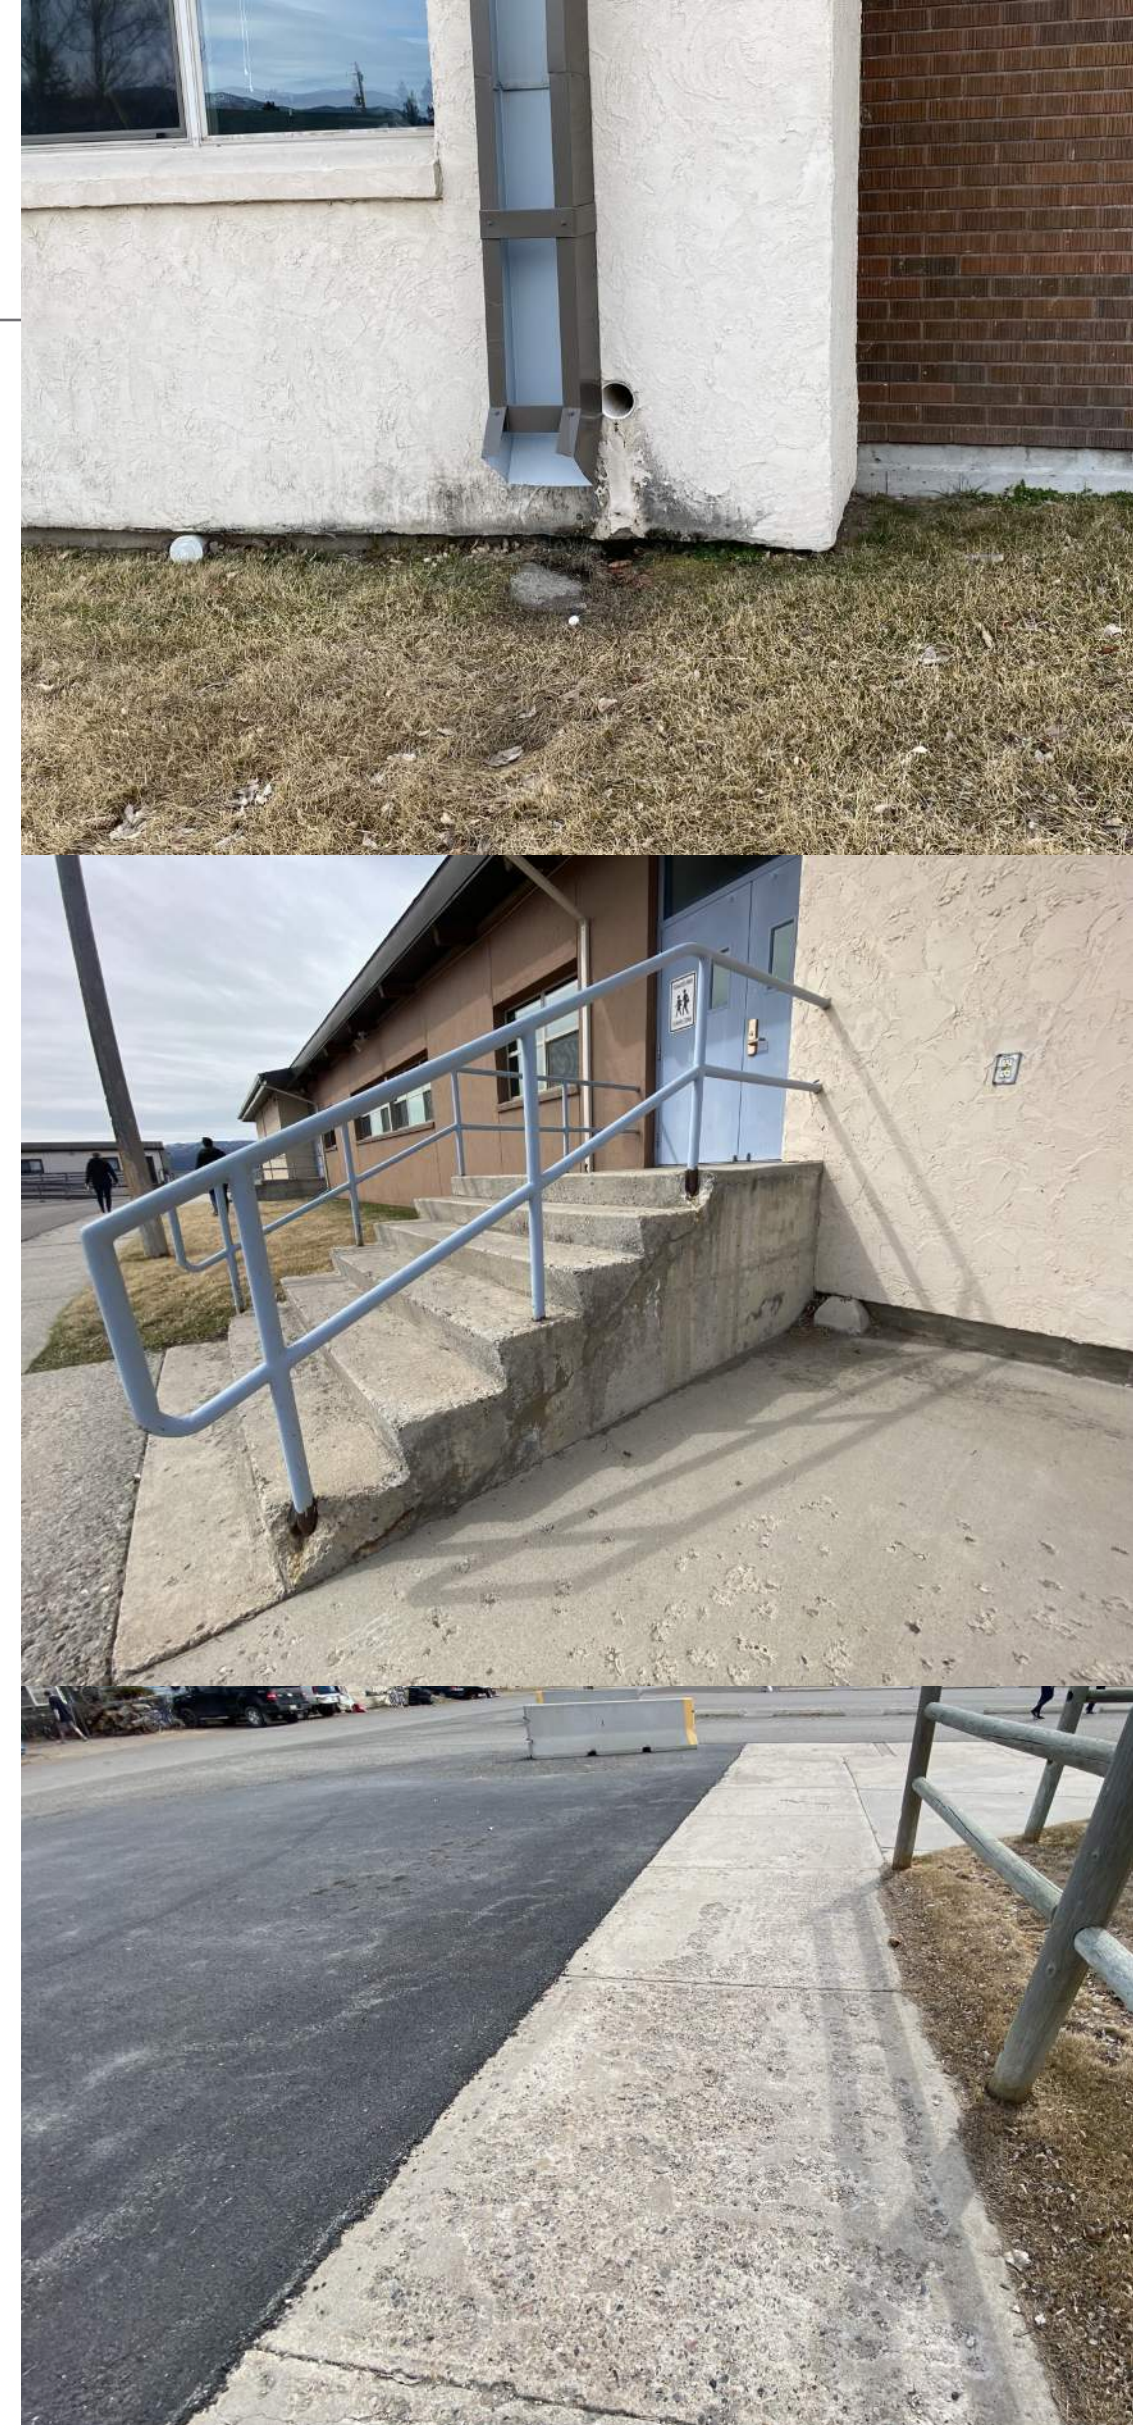
- Foundation in good condition
- Some Roof drains do not direct water away from foundation. Add splash blocks or other to direct water away from building.
- Exterior concrete stairs and exterior concrete flatwork is spalling and cracking.
- Entrance accessibility is good.
- Some damage or discoloration of exterior finishes, but otherwise in good condition.
- Exterior doors and windows in good condition.
- Security:
  - Not able to see visitors as they approach building

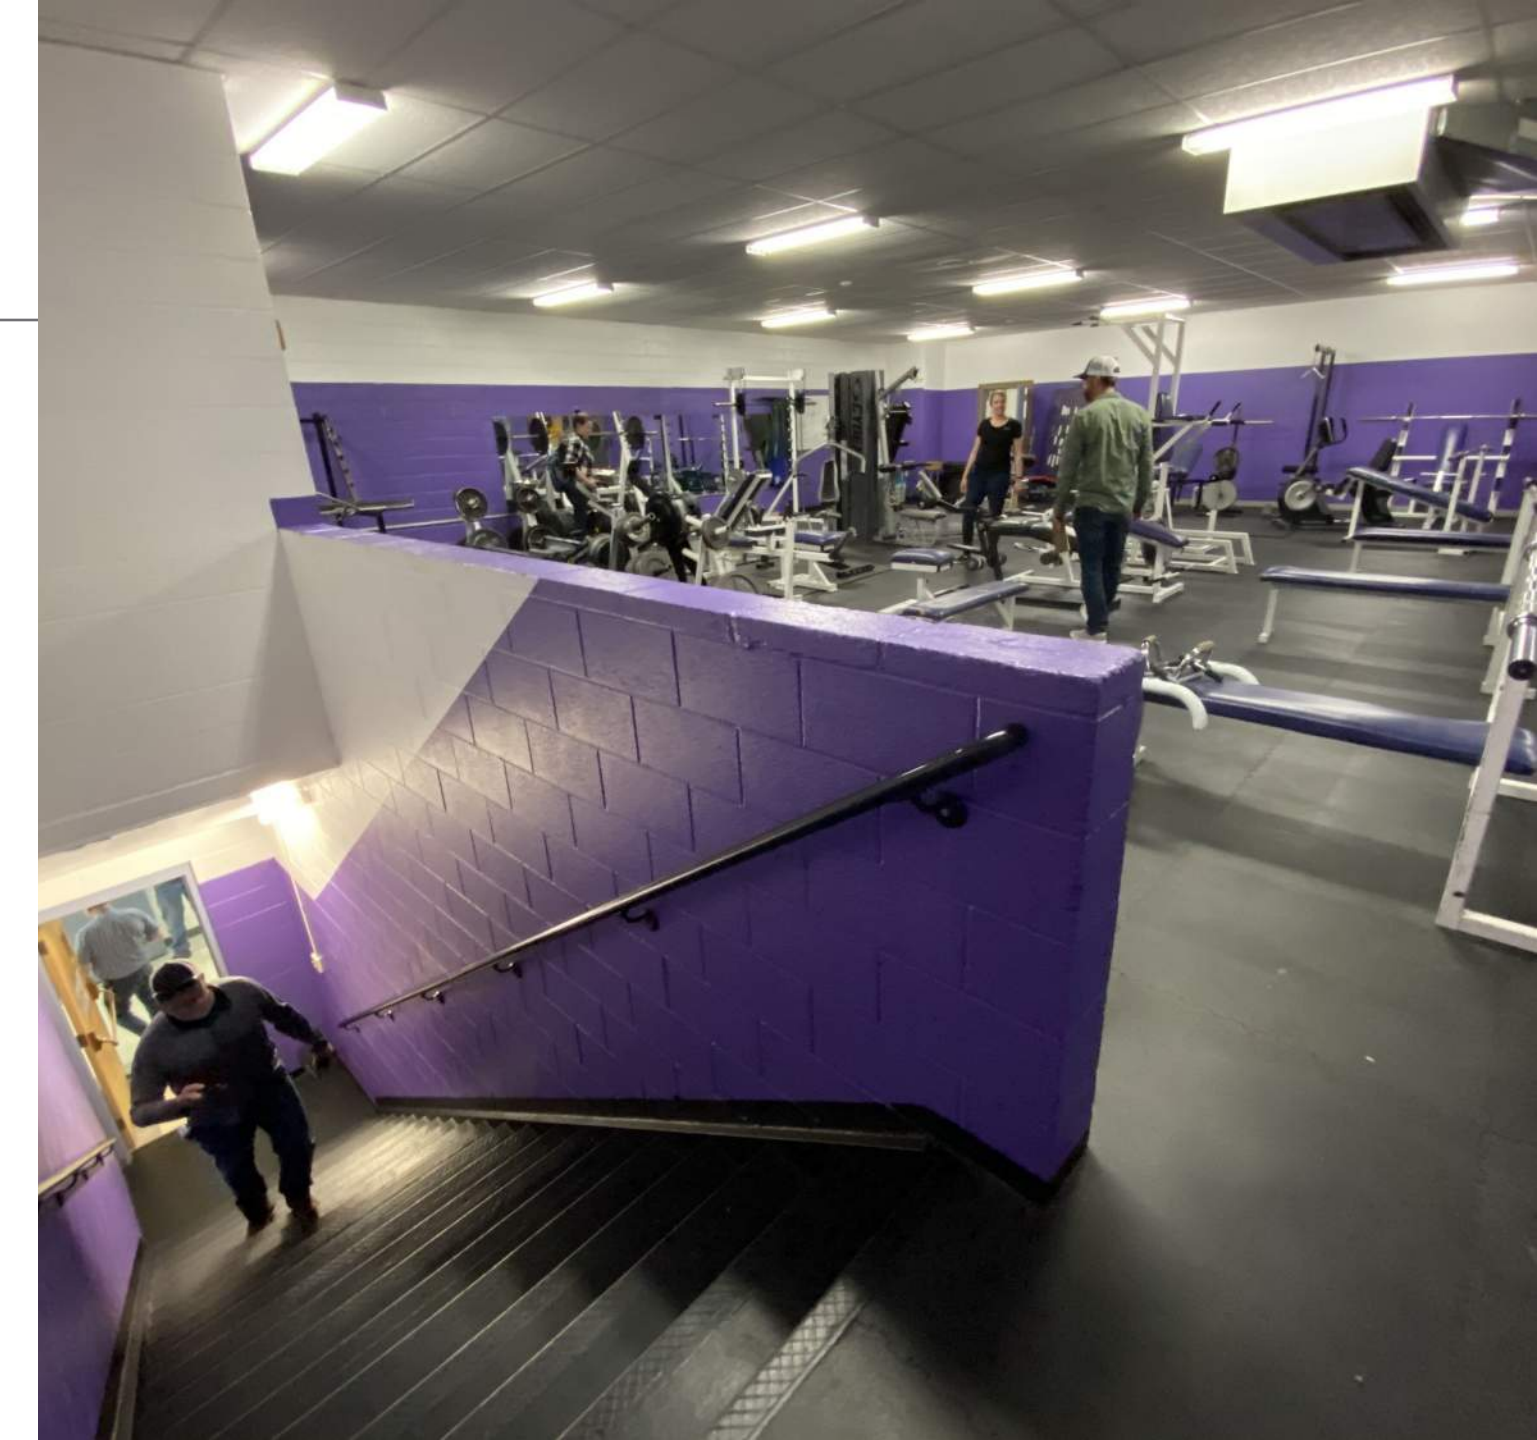
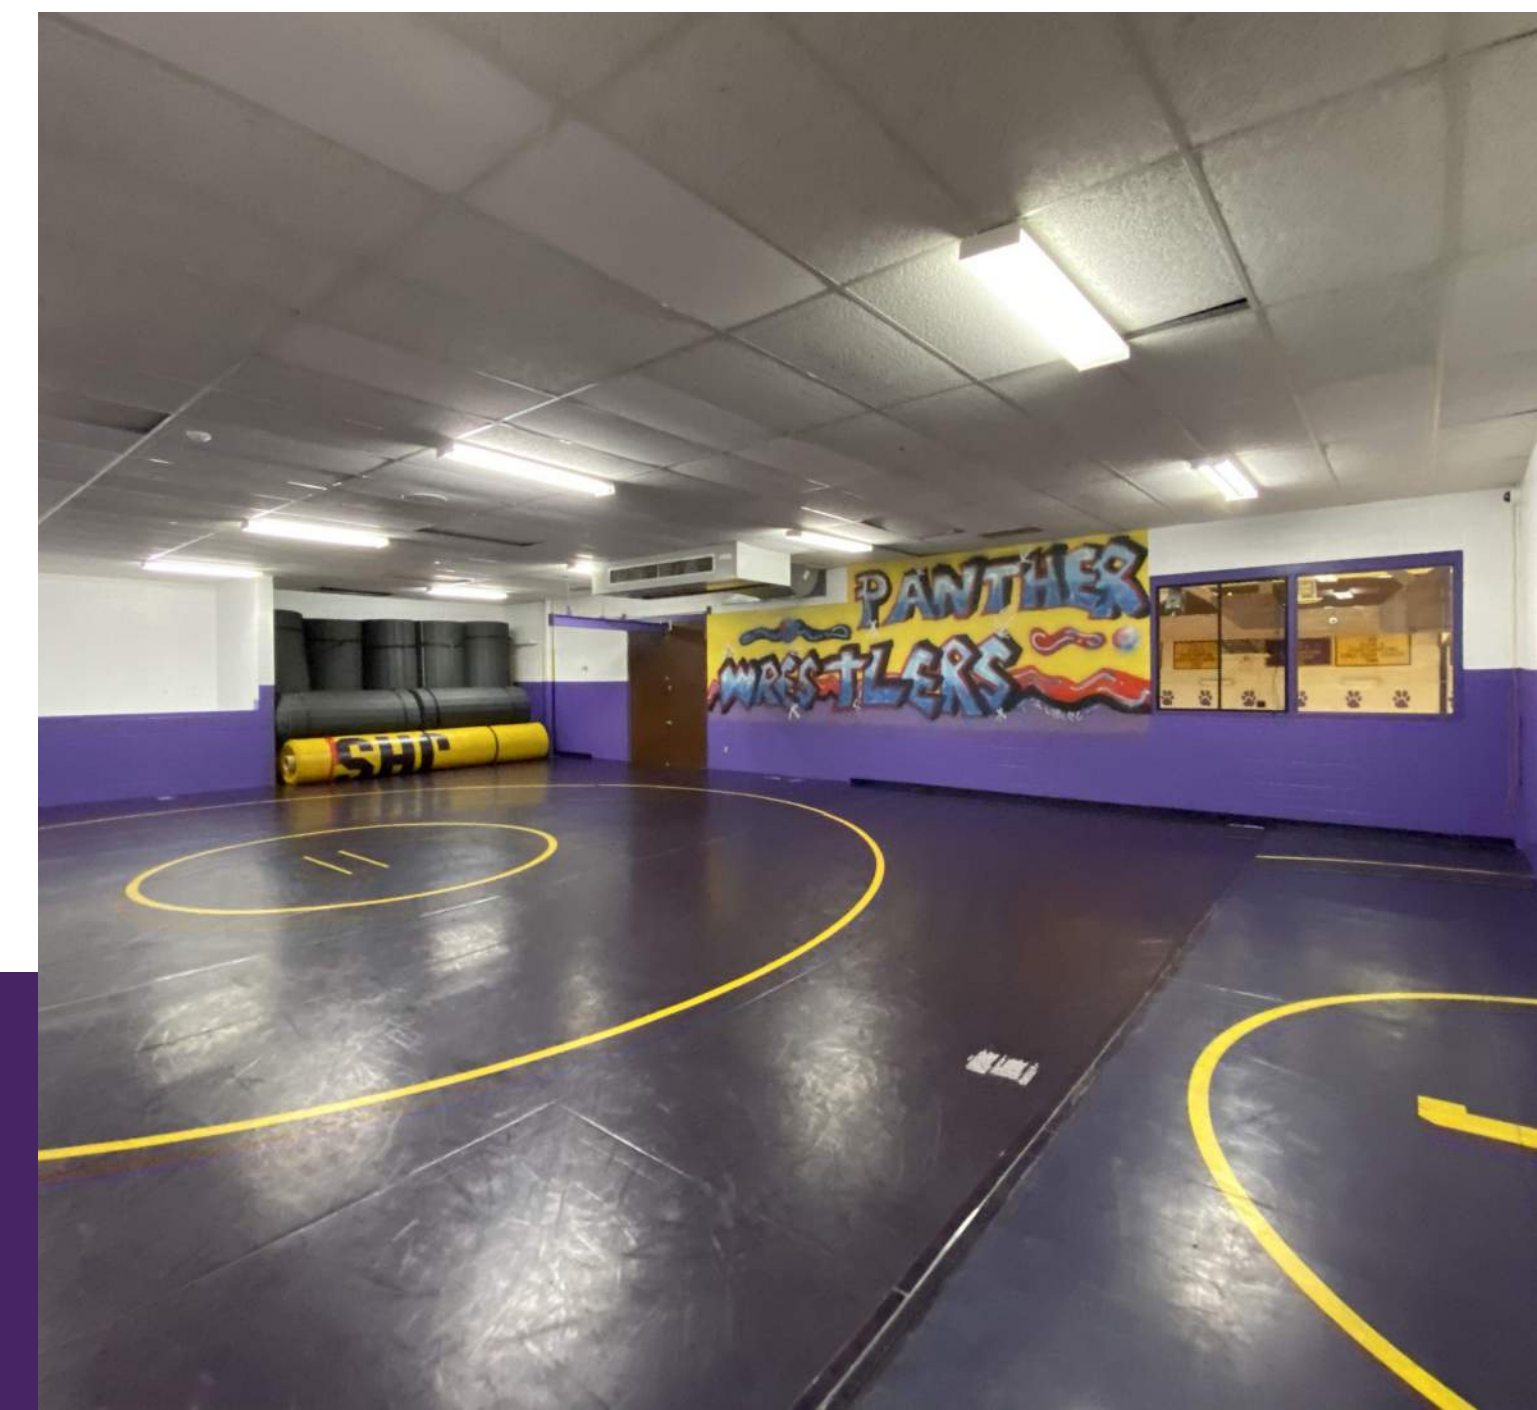
- Accessed via stairs to the mezzanine
- Finishes well maintained, but ceiling tiles showing damage, warping and stains
- Not ADA accessible
- Stair riser height taller than allowed code (measured at 7.5", code is 7")
- Mezzanine not designed as weight or wrestling room—drawings say designed as “Multi-Purpose Room”
- Weight of equipment and heavy plates striking composite slab is likely causing damage faster than intended
- Overall weight room undersized for students and equipment, more equipment and space needed to accommodate current class sizes
- Wrestling space cannot accommodate women’s and men’s wrestling
- Communication between weight and wrestling is only through telephone to the gym (difficult for setting up mats, etc.)

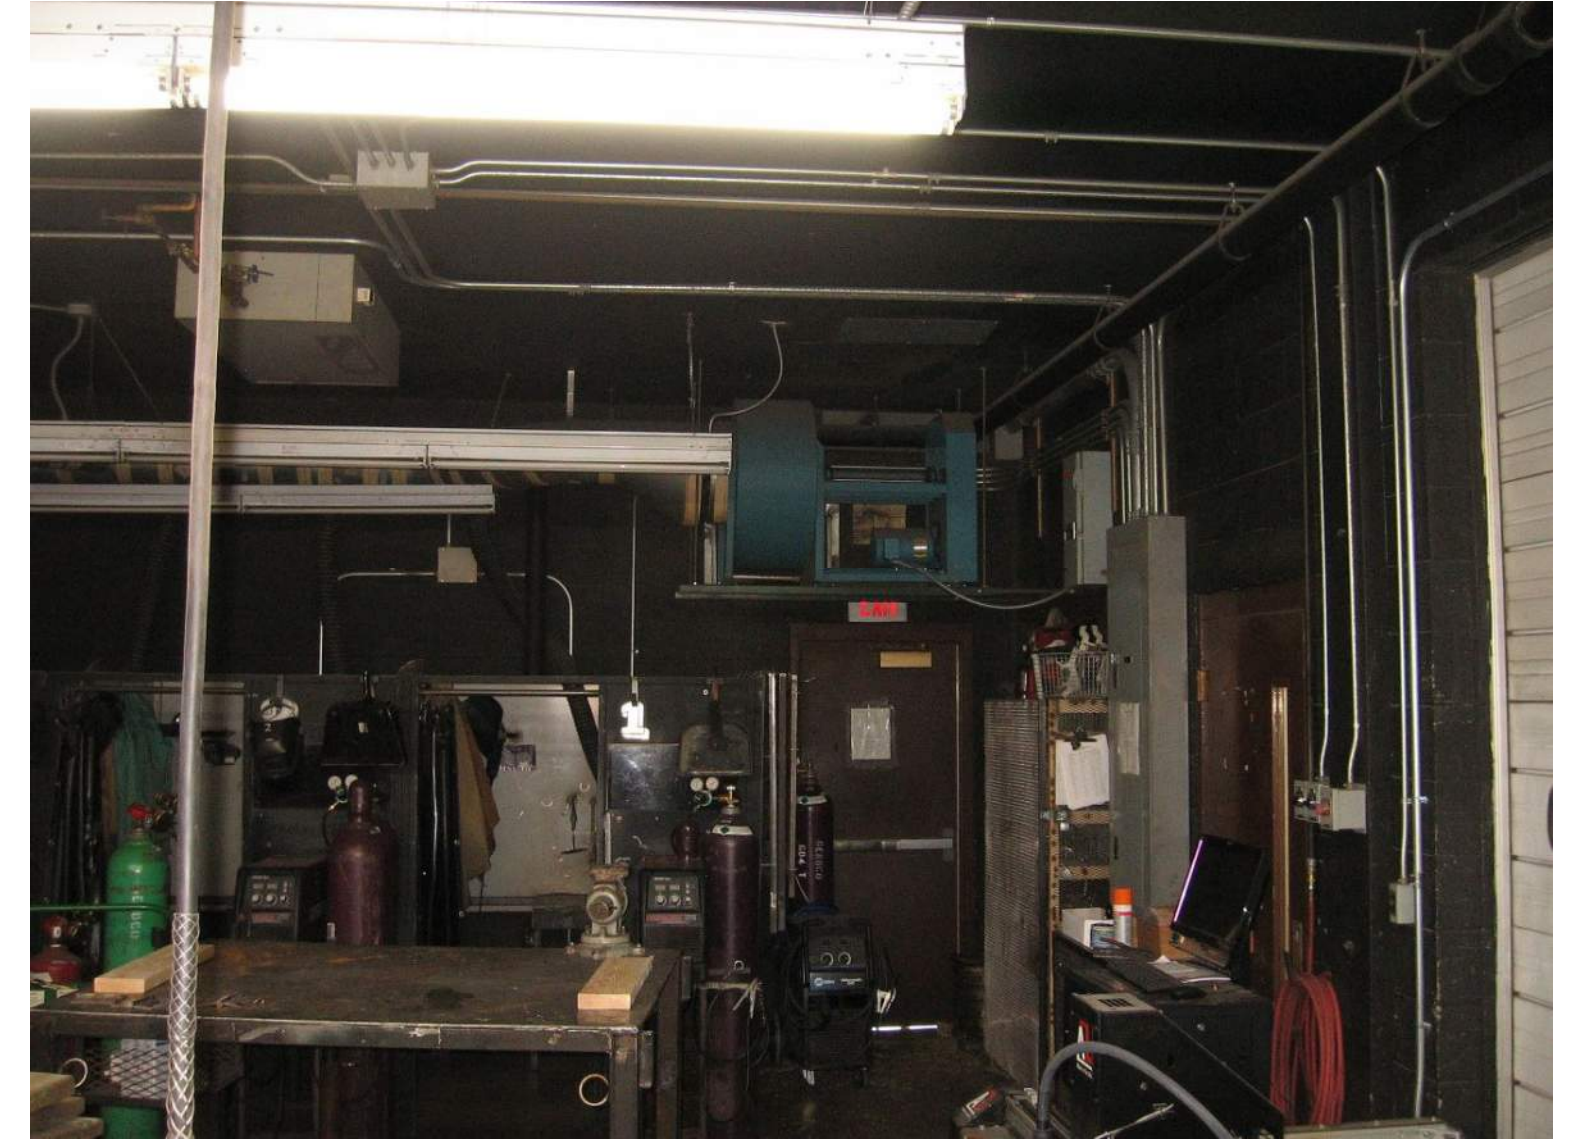
M21: Welding Shop Exhaust Fan

- Kitchen
  - Indirect drain lines revised to provide air gap
  - Prep sink piped as an indirect drain with air gap
  - Grease interceptor replaced
- Install mixing valves in bathroom lavatories
- Domestic water entrance lines leak
- Welding exhaust fan repaired/replaced

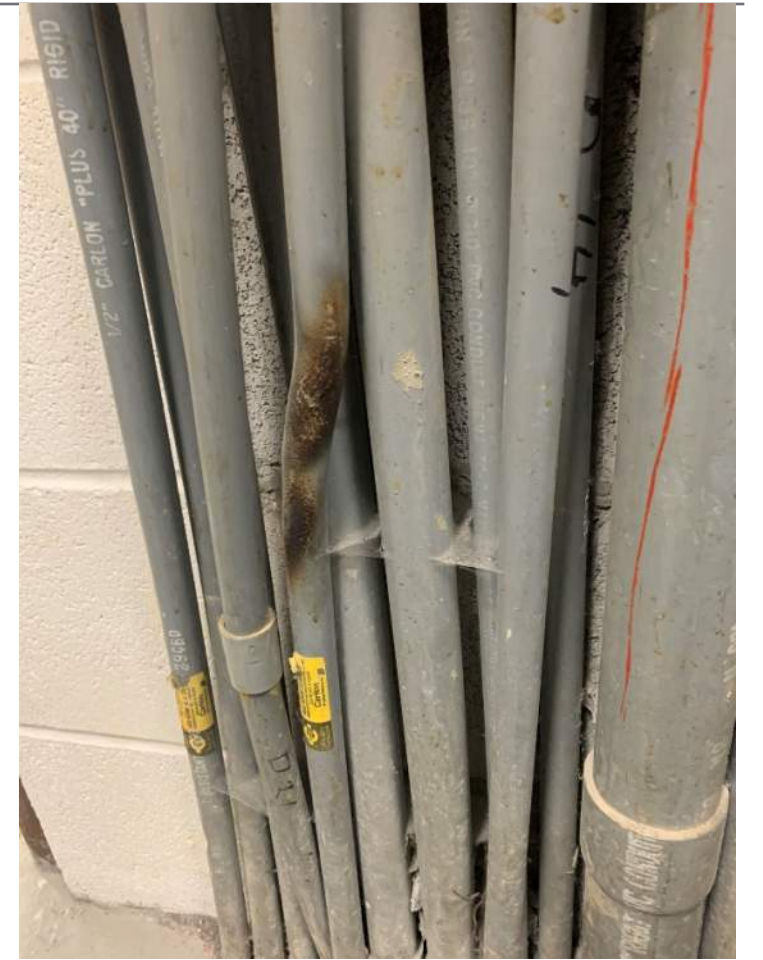
- Emergency & Egress Lighting Upgrades
- Motor Control center cover plates missing
- Conduit showing signs of electrical fire at panel D1

E5: Conduit shows signs of electrical fire and should be replaced.

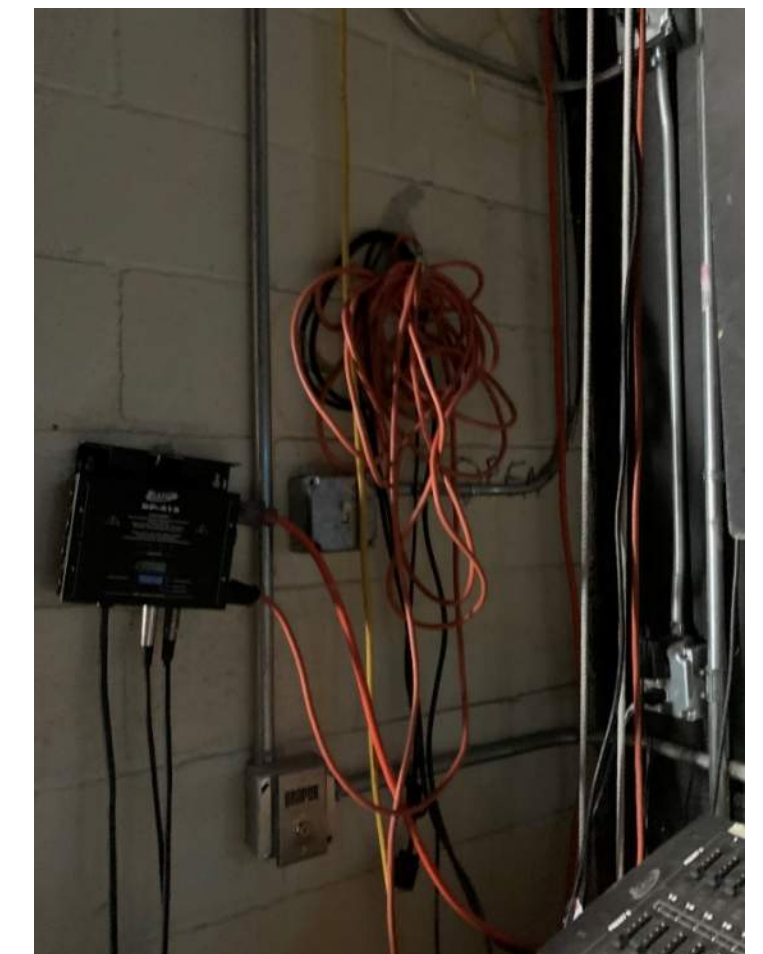
- Extension cords in South Gym Stage
- Extension cords & power strips in Library
- Communication cables routed along floor

E7: Extension cords at stage area.

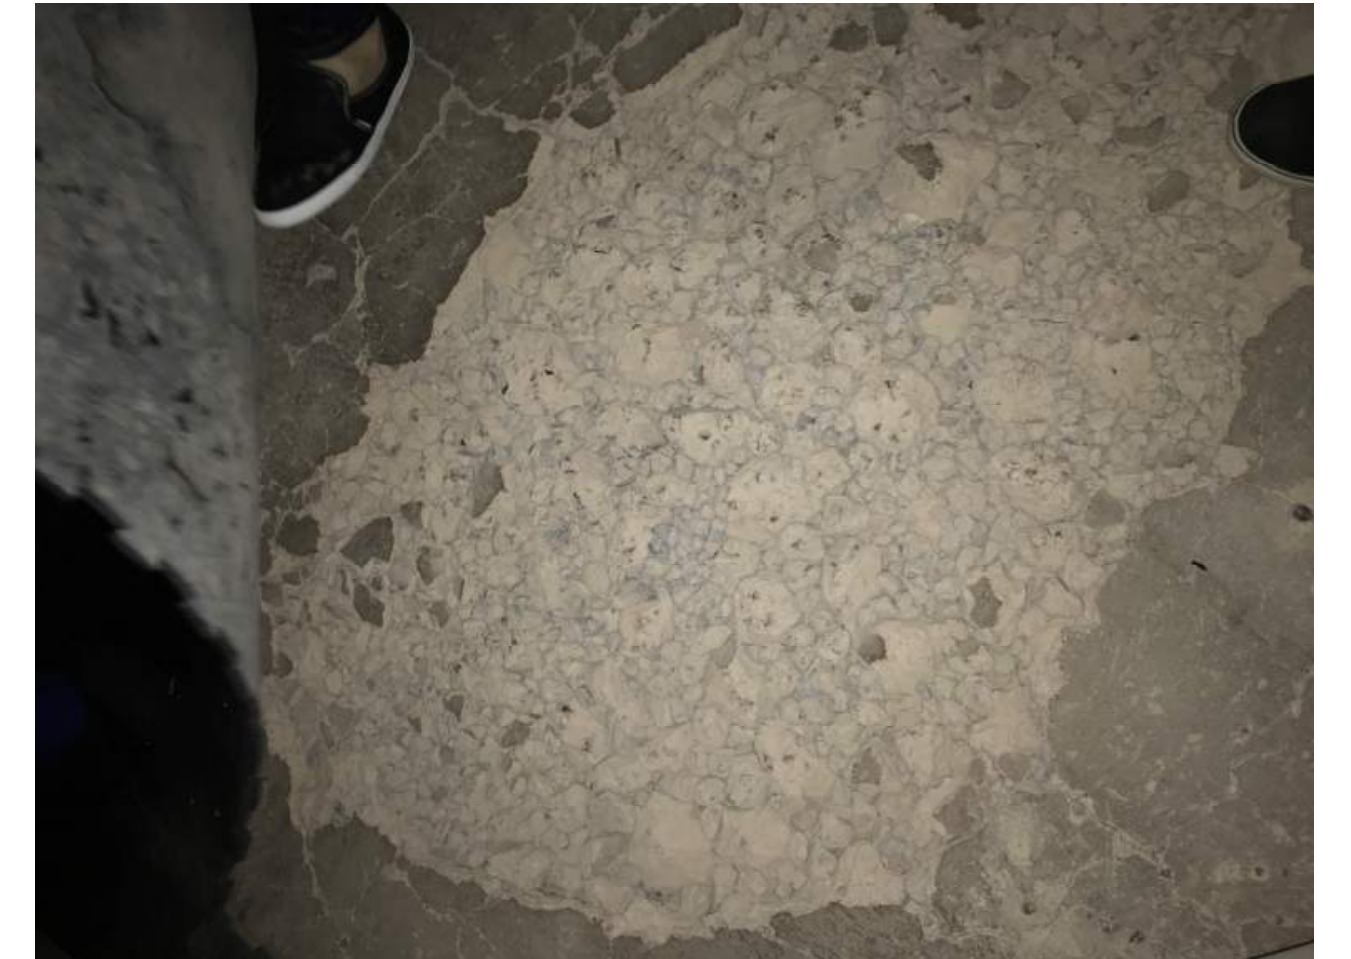
Figure 5. Deteriorated Concrete Floor Slab in Weight Room (1985 Addition)

- Overall in good condition, considering its age
- Very few signs of deterioration, damage or over stressing
- Recommend replacement of weight room floor in damaged areas of concrete slab.
- General roof to wall connections
- Treat exposed wood roof framing ends on exterior

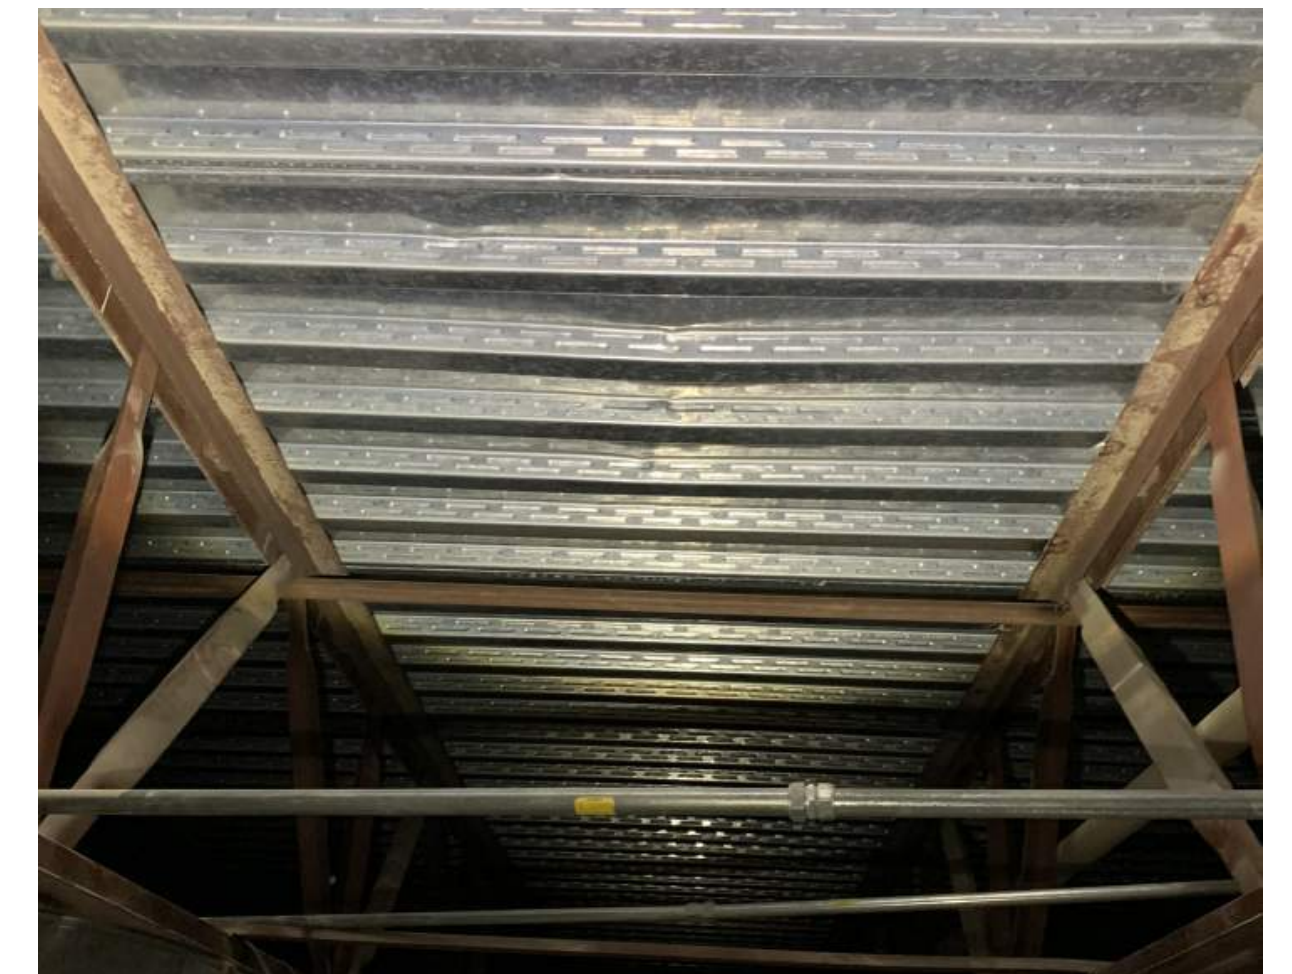
Figure 6. Deformed Metal Deck Below Weight Room (1985 Addition)
