Jefferson High School Building Condition Report

312 S Main Street, Boulder, Montana 59632

July 30, 2020

SMAARCHITECTS

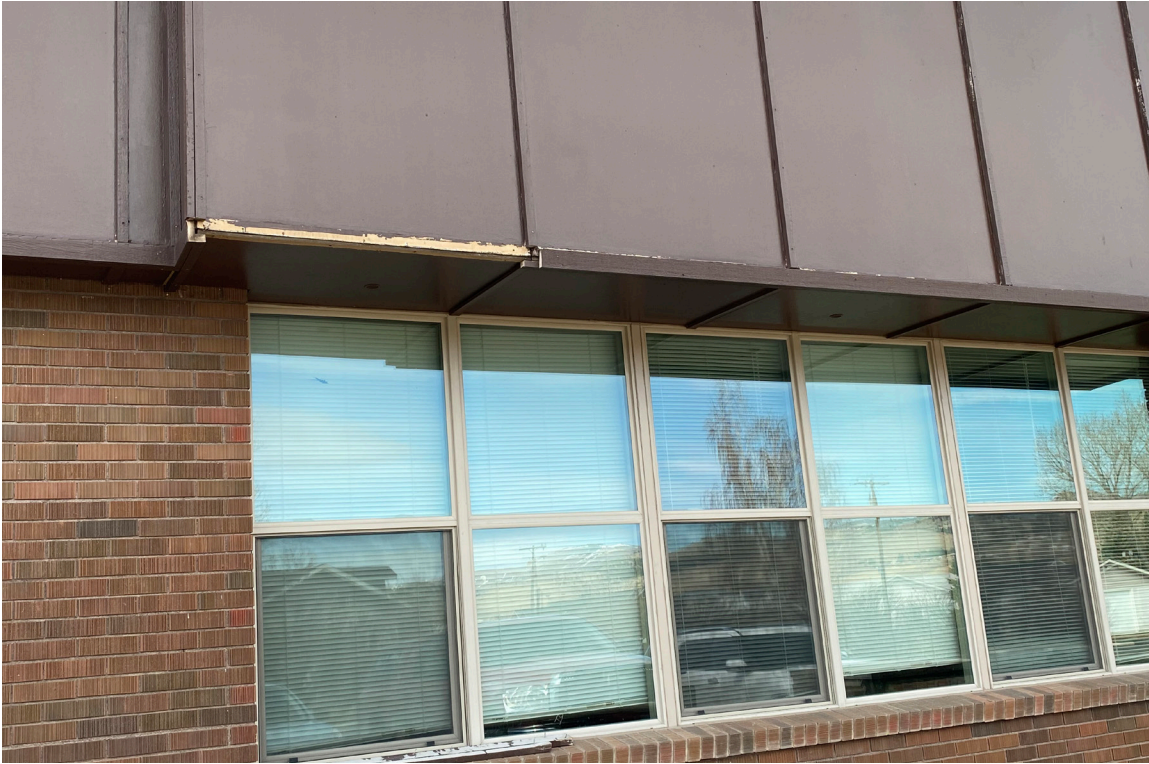
Wood fascia that is worn and coming apart.

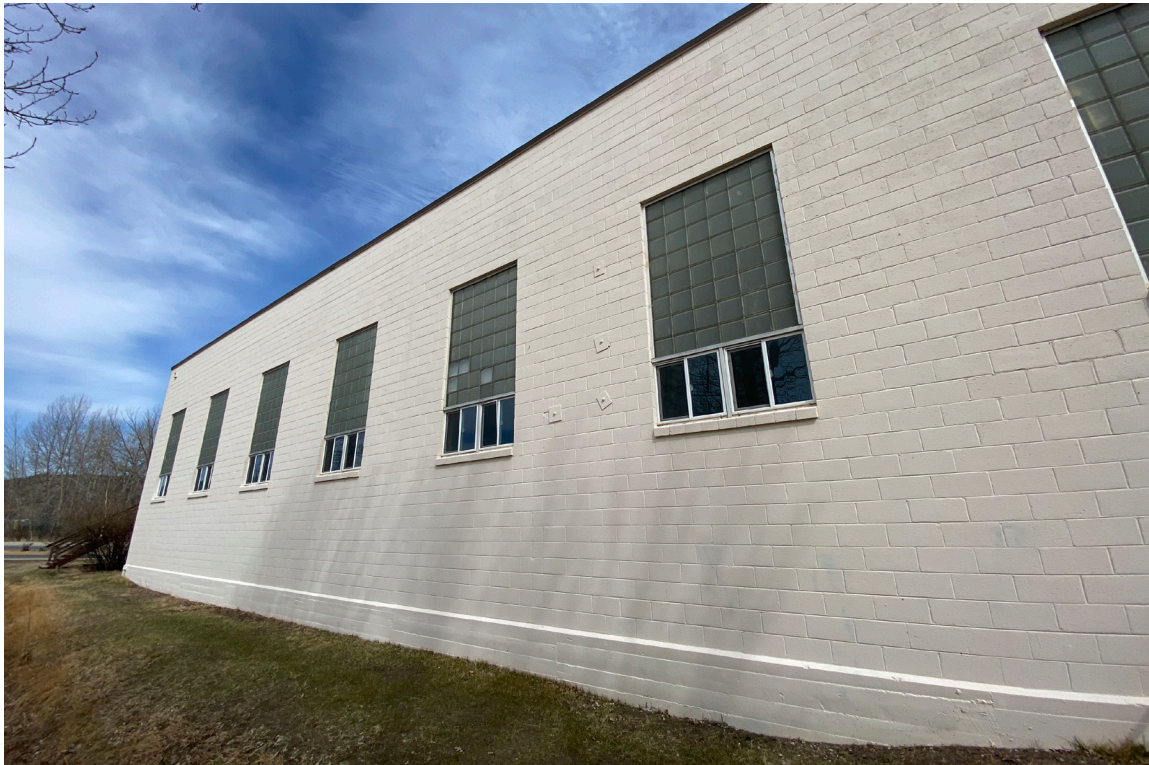
South side of Existing Gym, next to irrigation canal from the Boulder River. Masonry block is holding up well, and paint appears new.

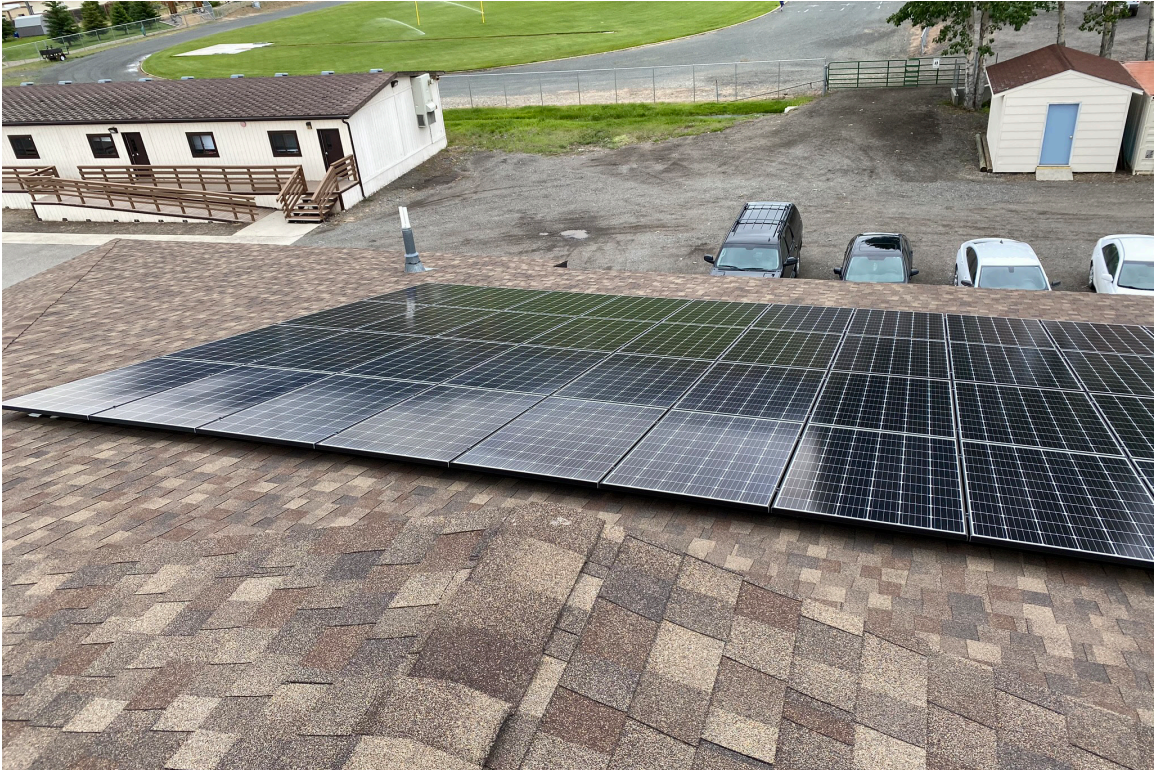
South Library roof, looking towards modulators and storage sheds. Shingles on the Library roof appeared in good condition. Modular roofs had shingles damaged and torn off, mostly from high winds over the previous weekend. Solar panels did not appear damaged.

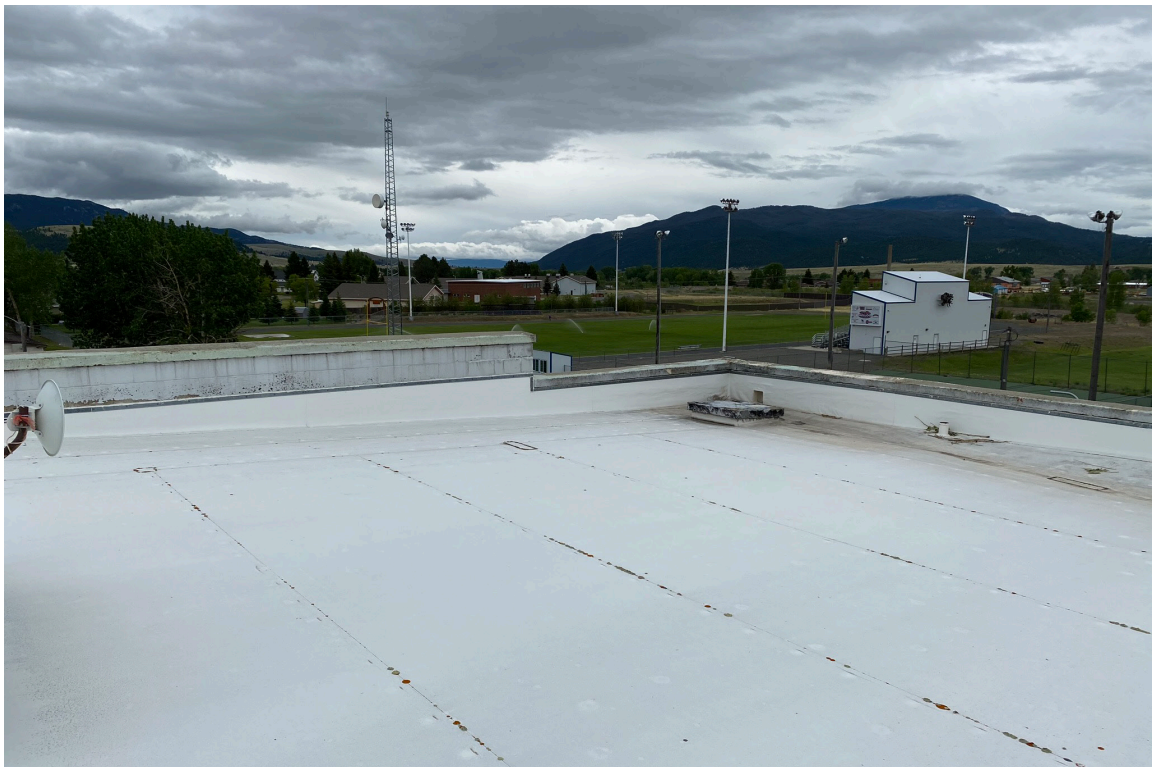
The majority of the existing roofs appeared to be in good condition. This roof, over the Existing (South) Gym, had very little damage and transitions and termination bars were in good working order.

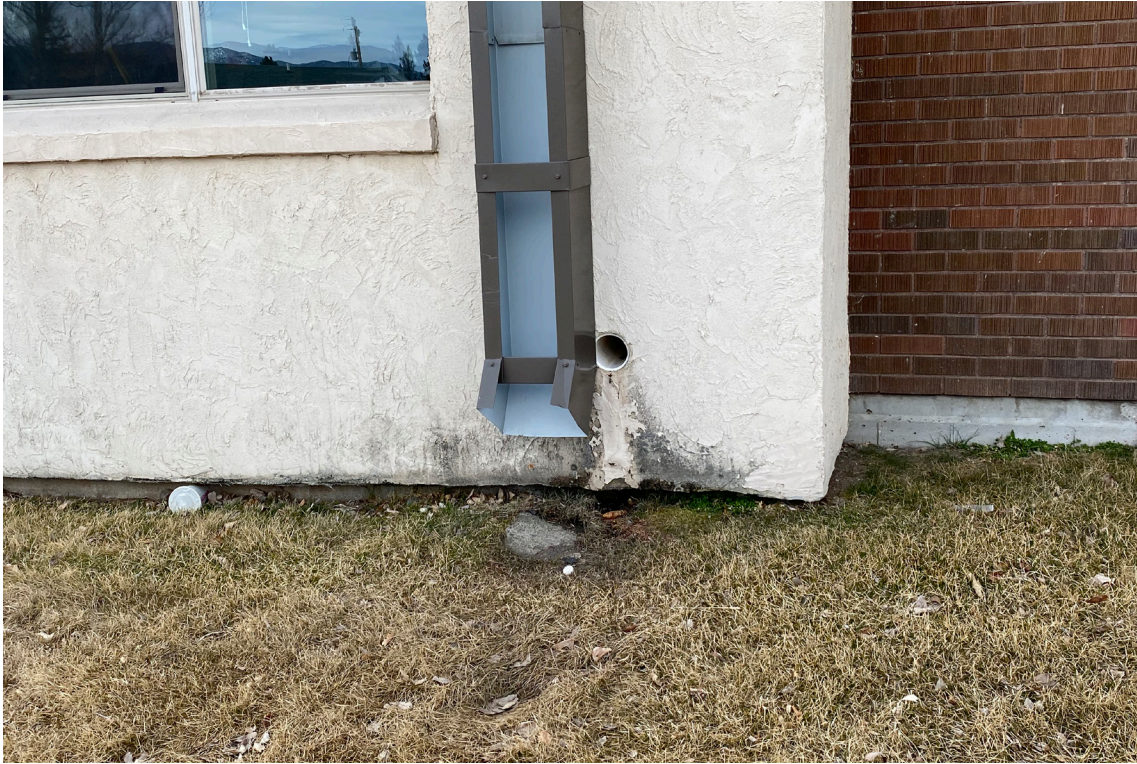
A large roof downspout and overflow on the north side of the building. Most of these large downspouts did not have a splash block or other method of diverting large quantities of water away from the foundation, and most runoff soaks into the grass area.

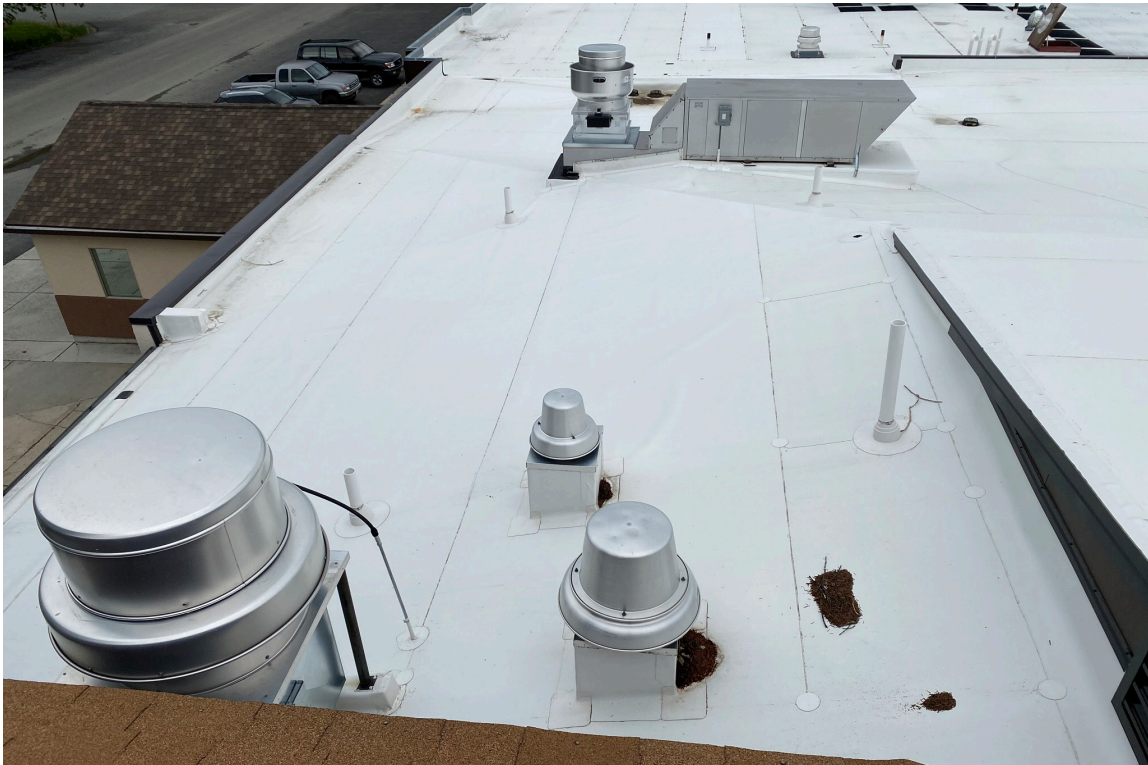
The roof looks relatively new. This area over the Kitchen space had welds and wrapping of membrane applied correctly.

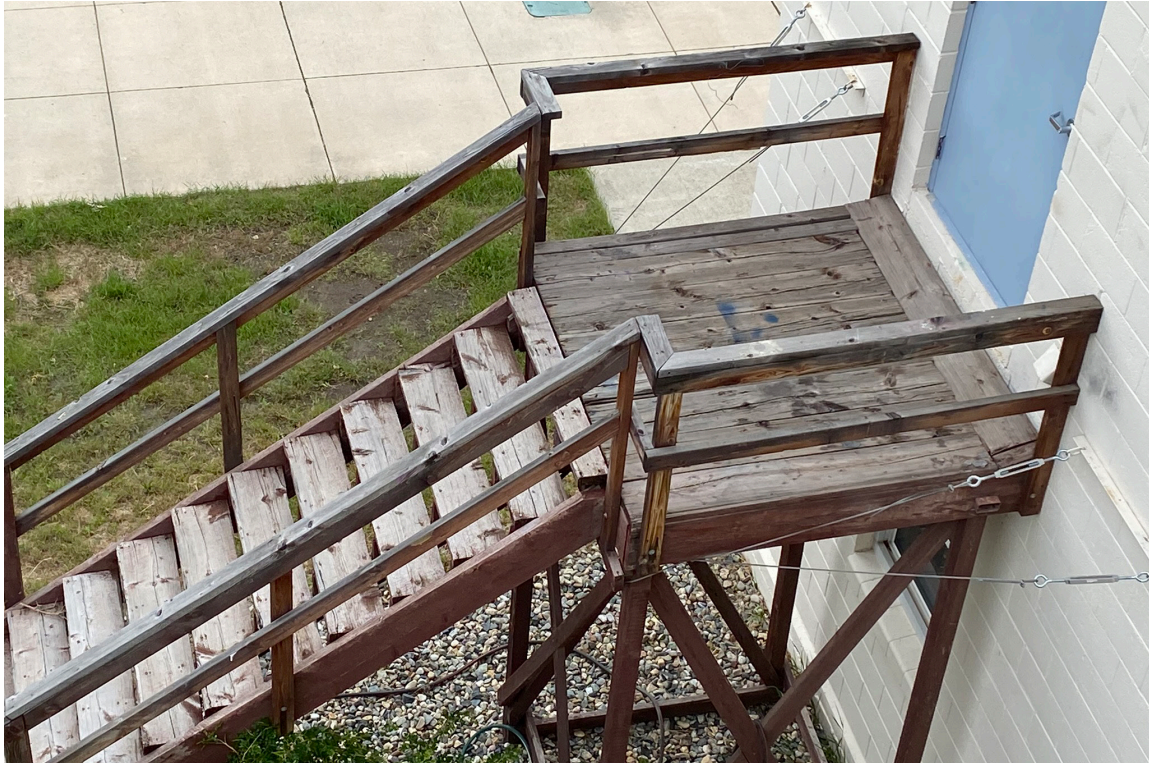
The egress stairs from the Art Room, as seen from the South Gym roof. The wood appears deteriorated and is secured to the building with cables. This stair does not comply with current accessibility codes and needs to be replaced with a more permanent stair.

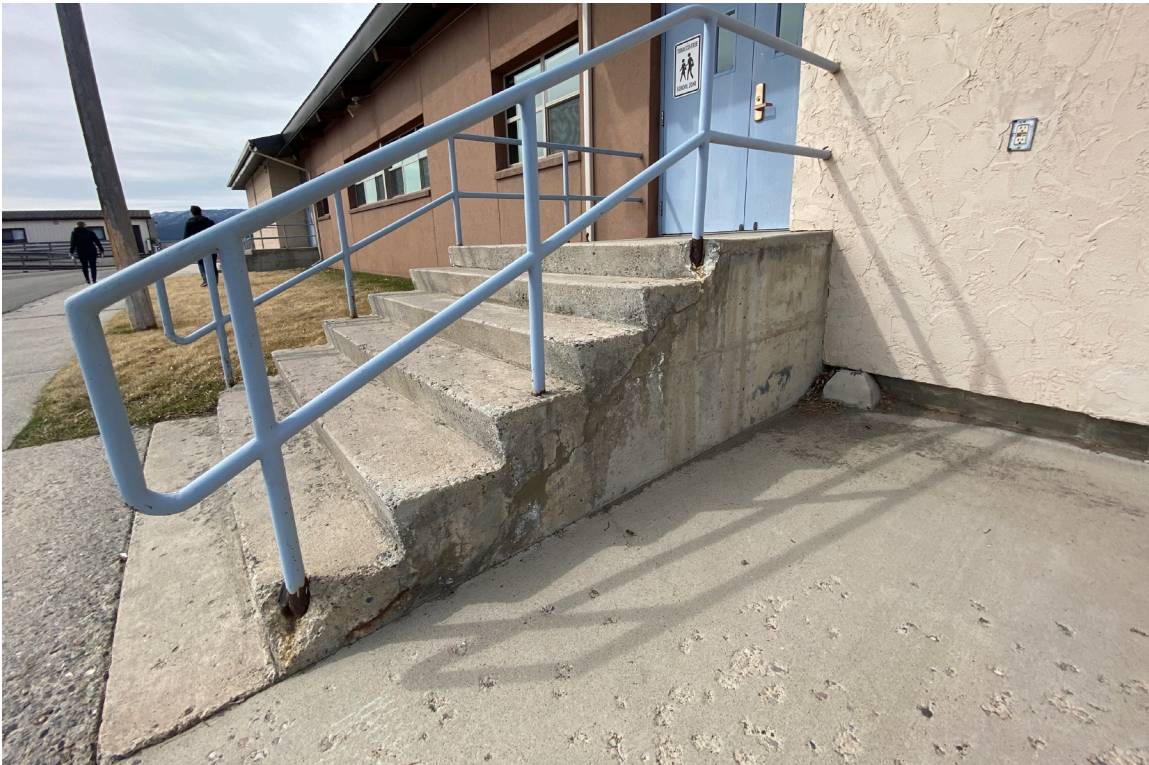
An area of spalling concrete around handrail posts. While not dangerous or against accessibility codes, continued wear will eventually lead to the handrail dislodging from the concrete. This could give way under lateral load when in use and cause injury.

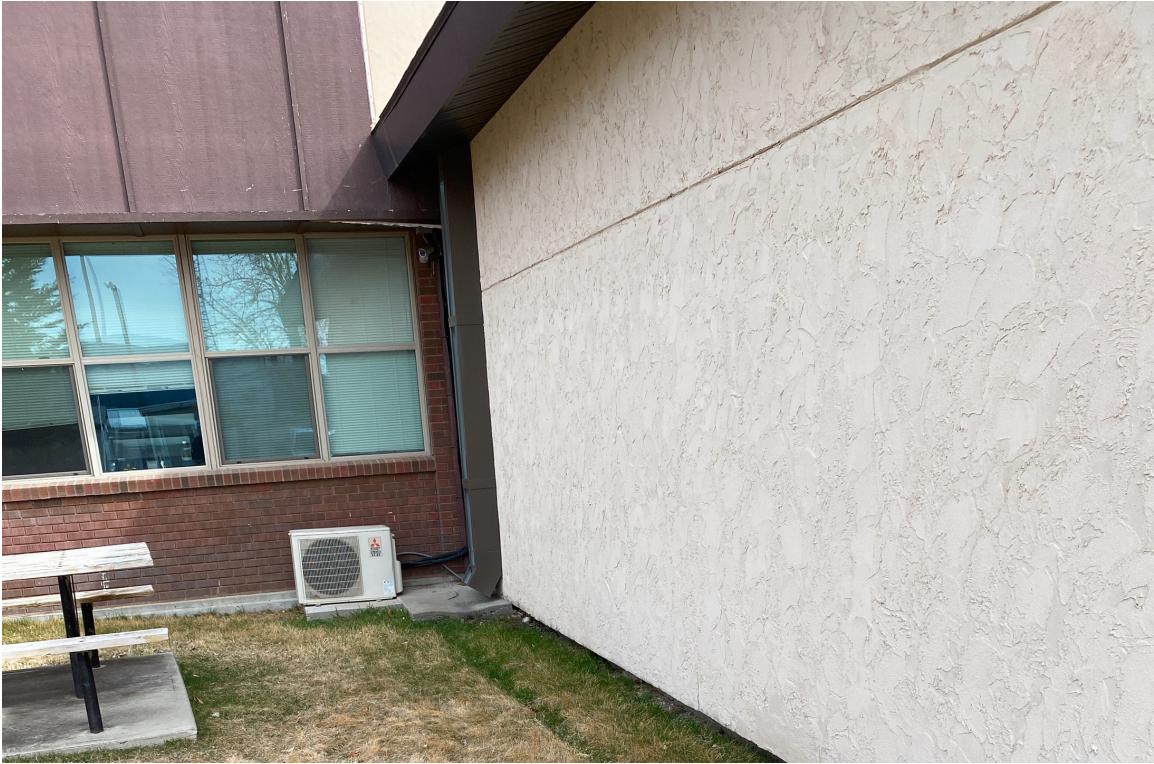
Another large downspout that drains to a splash block in the back of the building. This spout is partially shaded by the wall adjacent to it. During heavy rains, water could flood around the condenser unit here. The drainage swale is visible in the grass leading out to the parking lot. ■

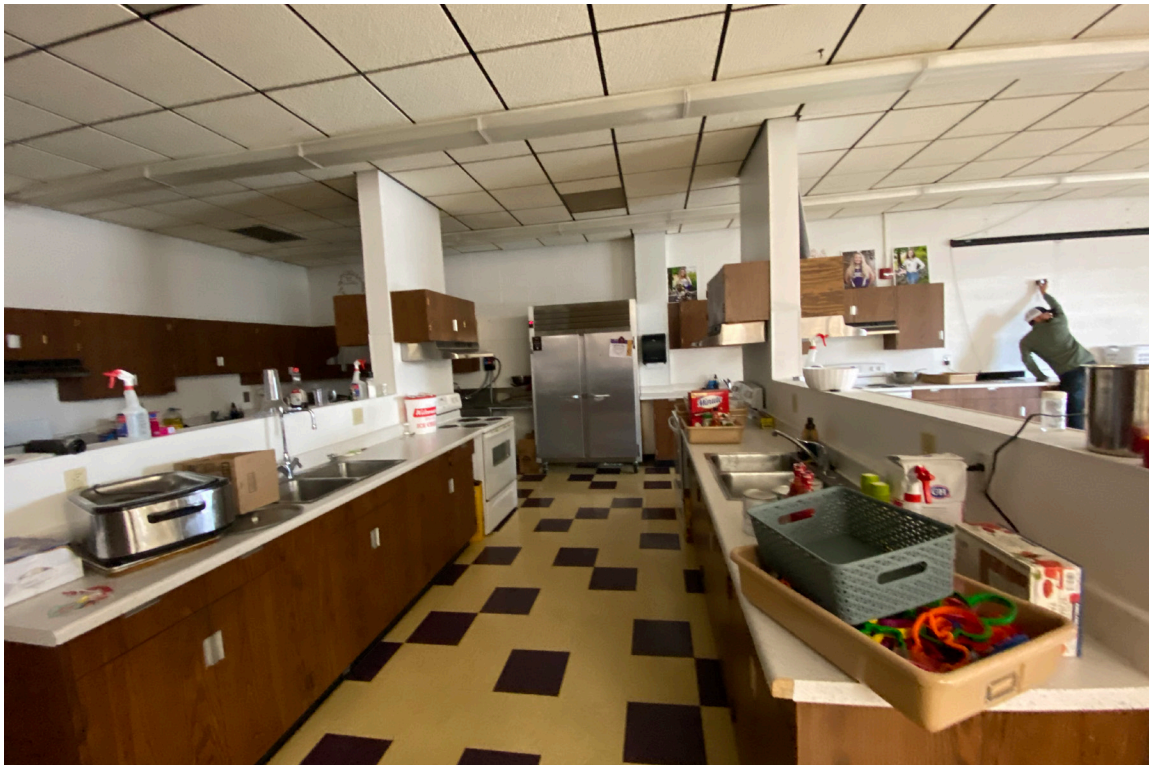
The FCS room. This space was noted to have ventilation problems and the finishes were slightly dated. However, the room had ample space for students and functions.

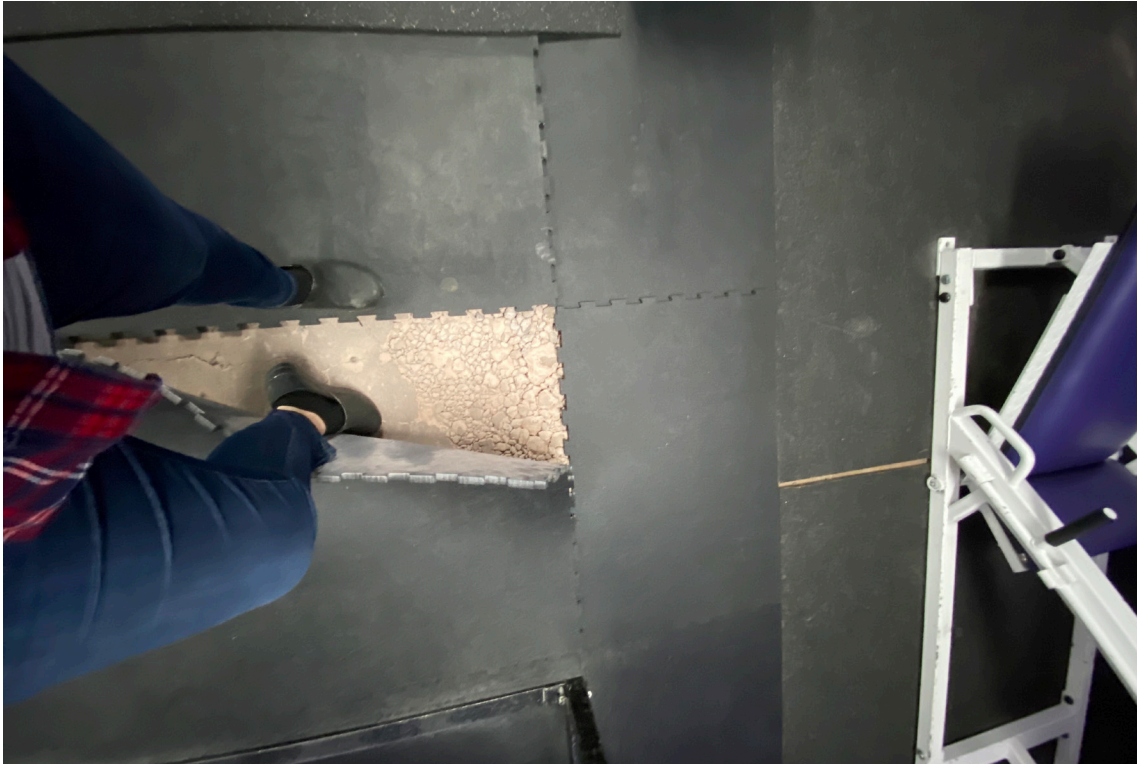
Crumbling composite concrete deck of weight room. Heavy plates and dropping of weights has resulted in severe deterioration of the deck. While this is not a structural problem, it is recommended that the weight room be moved to a floor with a thicker concrete slab.

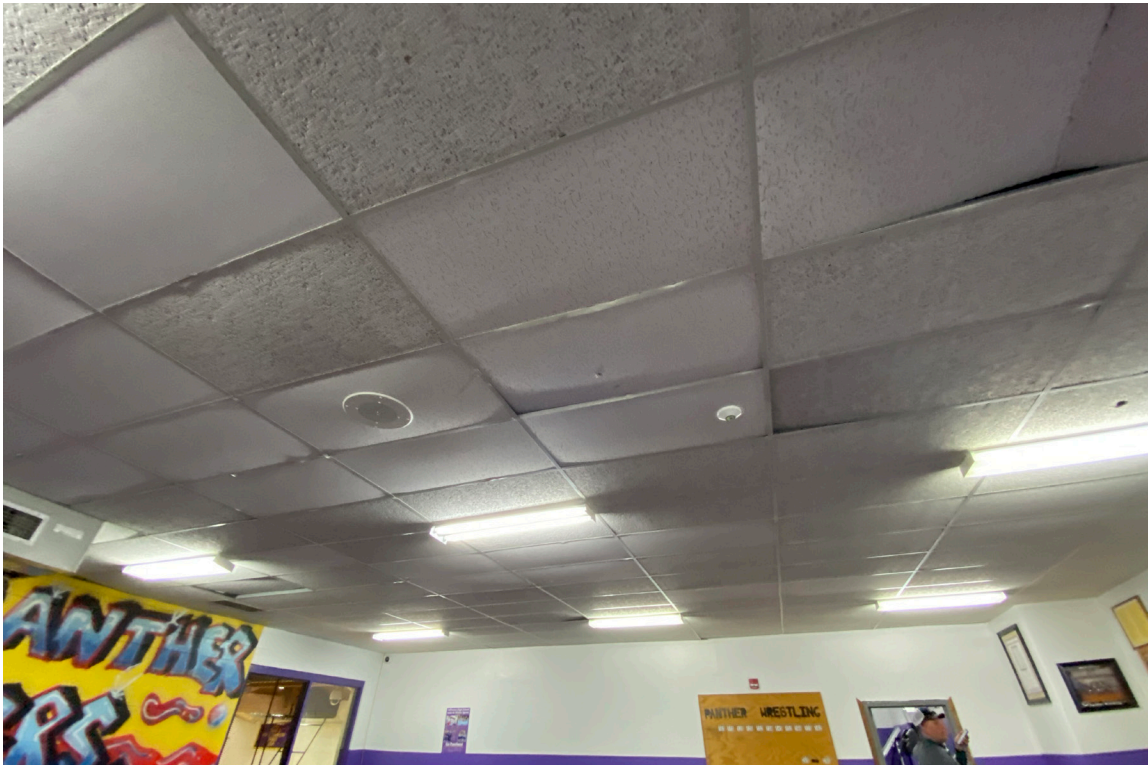
Ceiling tiles in the wrestling room are severely warped and discolored, from previous roof leaks and excessive moisture. Many areas in the school have the same issue and need to have the tiles replaced.

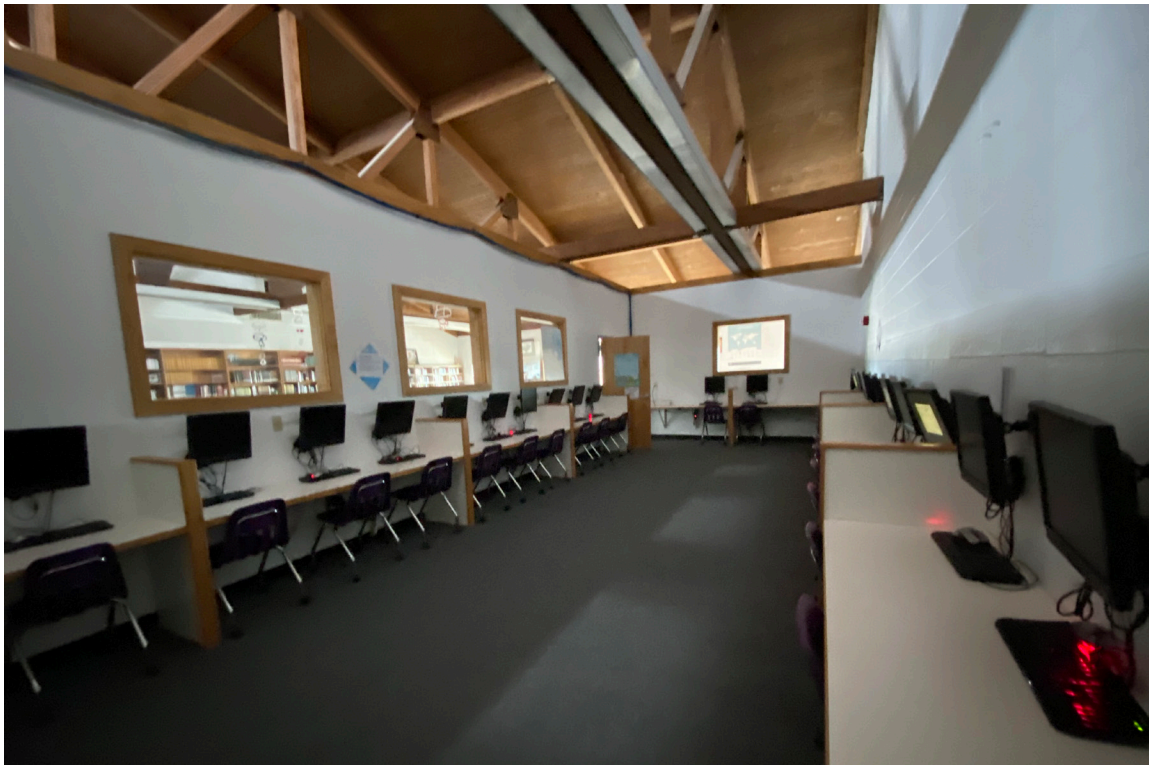
View of computer lab within library space. The large gap above the walls allows sound to travel between spaces.

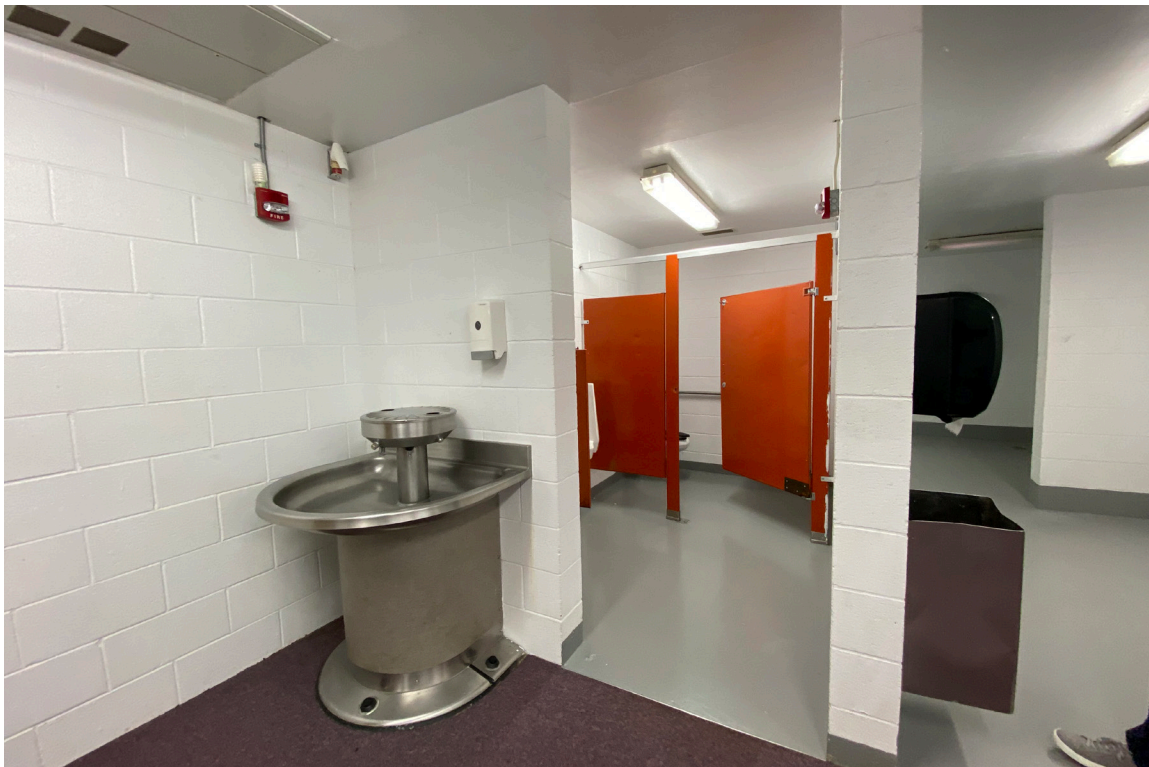
The main floor locker rooms with hand wash station. These stations are designed to serve students around its perimeter, but placement next to the CMU block wall limits access. This reduces the number of required lavatories per the International Building Code (IBC) and amendments per the Administrative Rules of Montana.

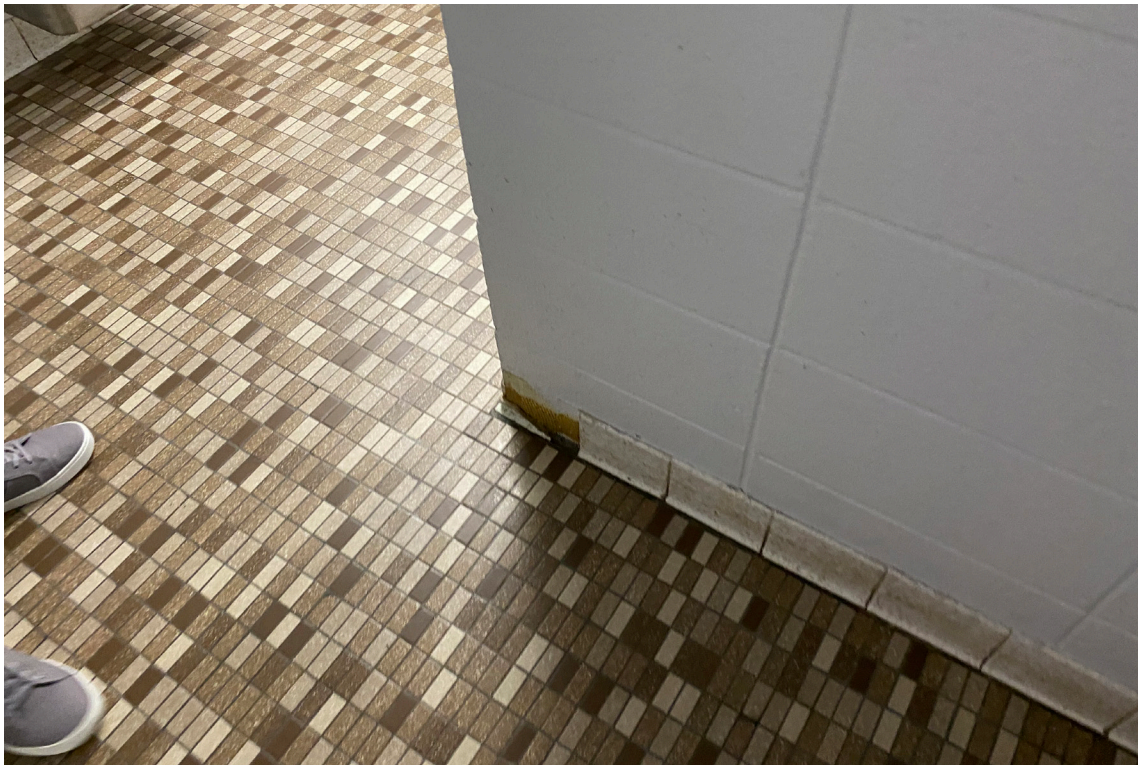
Most restrooms were in good condition, with minor areas of repair needed. However, this CMU block wall makes accessibility difficult for wheelchair users.

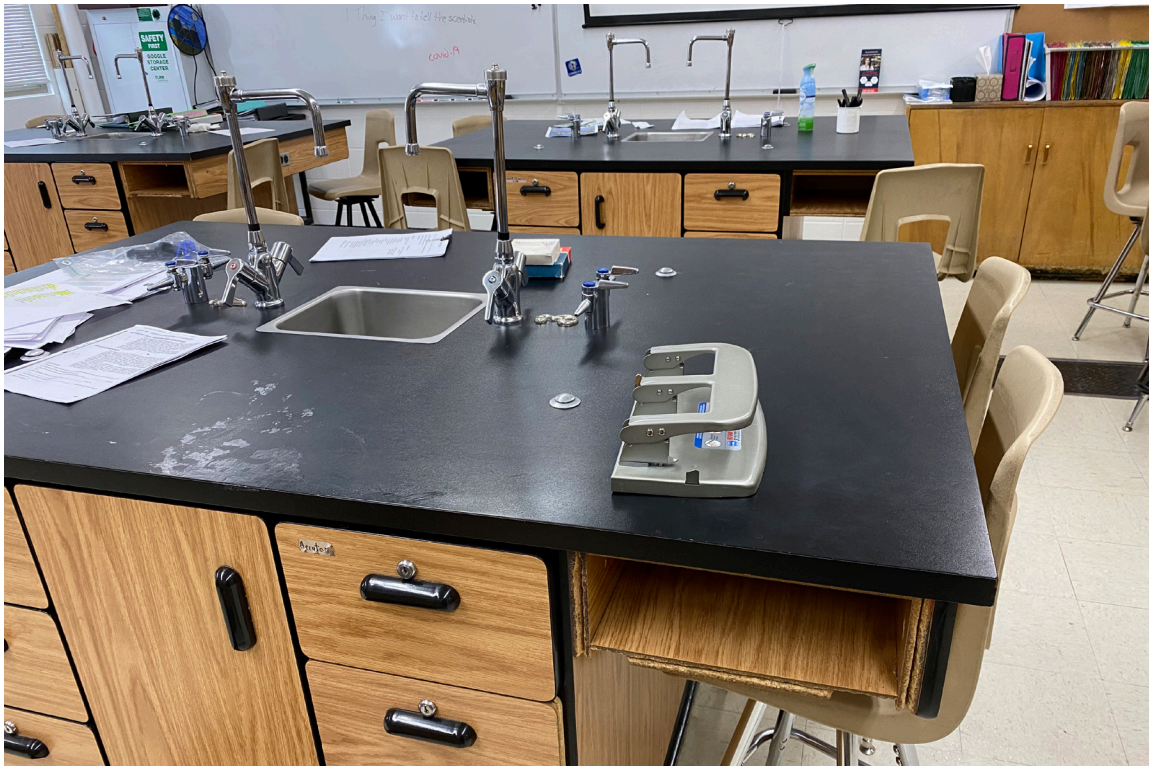
Casework and countertops in the Life Sciences room. While most of these are in good condition, there are areas of wear. This room is too small for a typical science room.

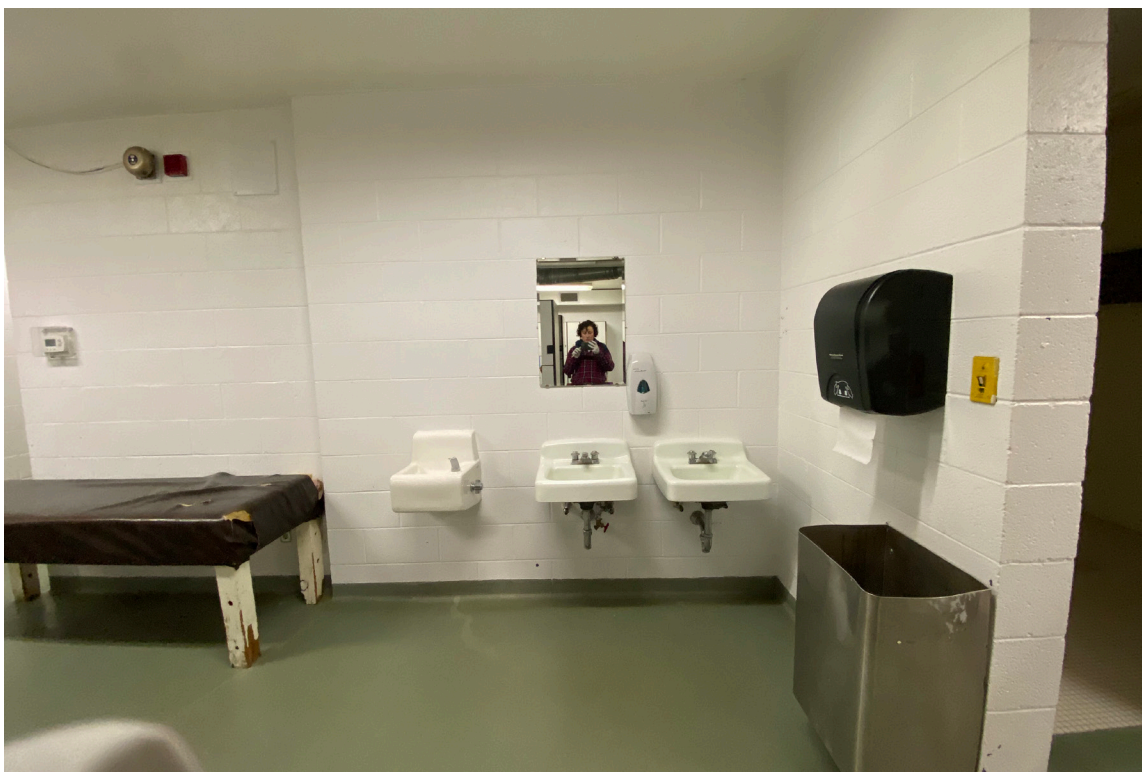
Women's lower level locker room. Floor and walls are in good condition but the training bench is very worn.

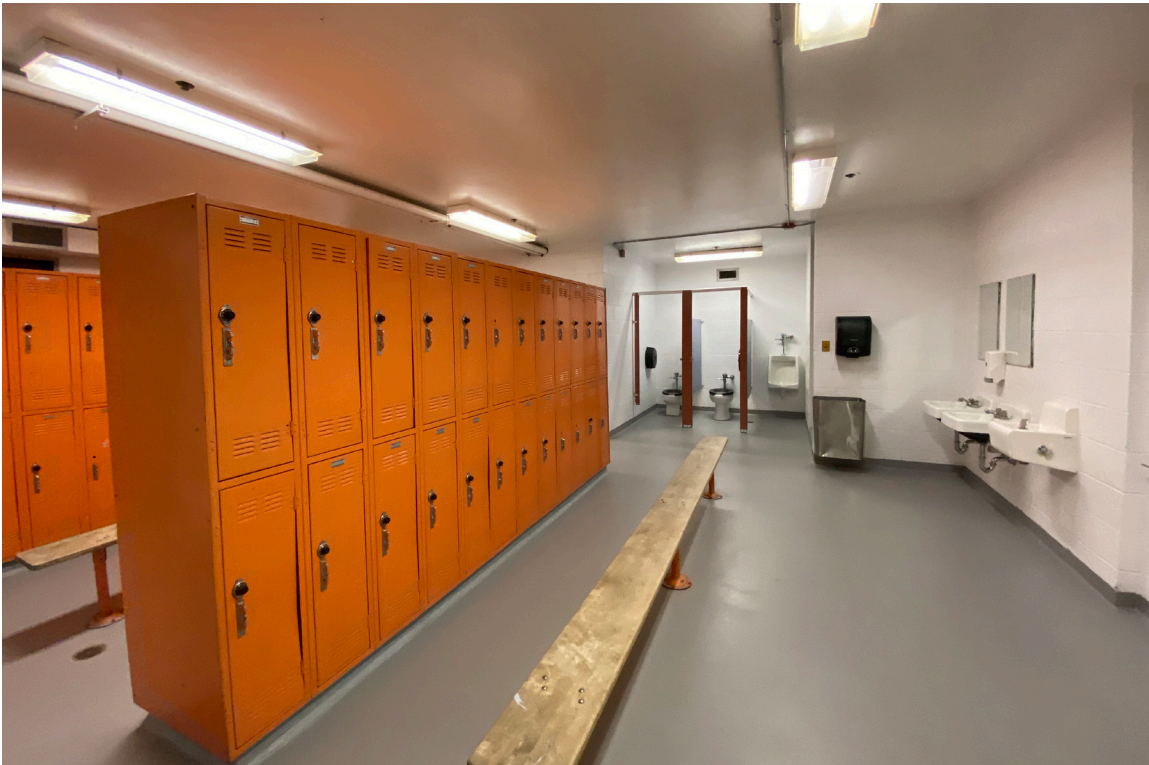
Men's locker room in the lower level of the gym. There are multiple issues in this space, such as accessibility, ventilation problems and doors missing from the stalls. Equipment storage outside this room poses potential Title IX problems.

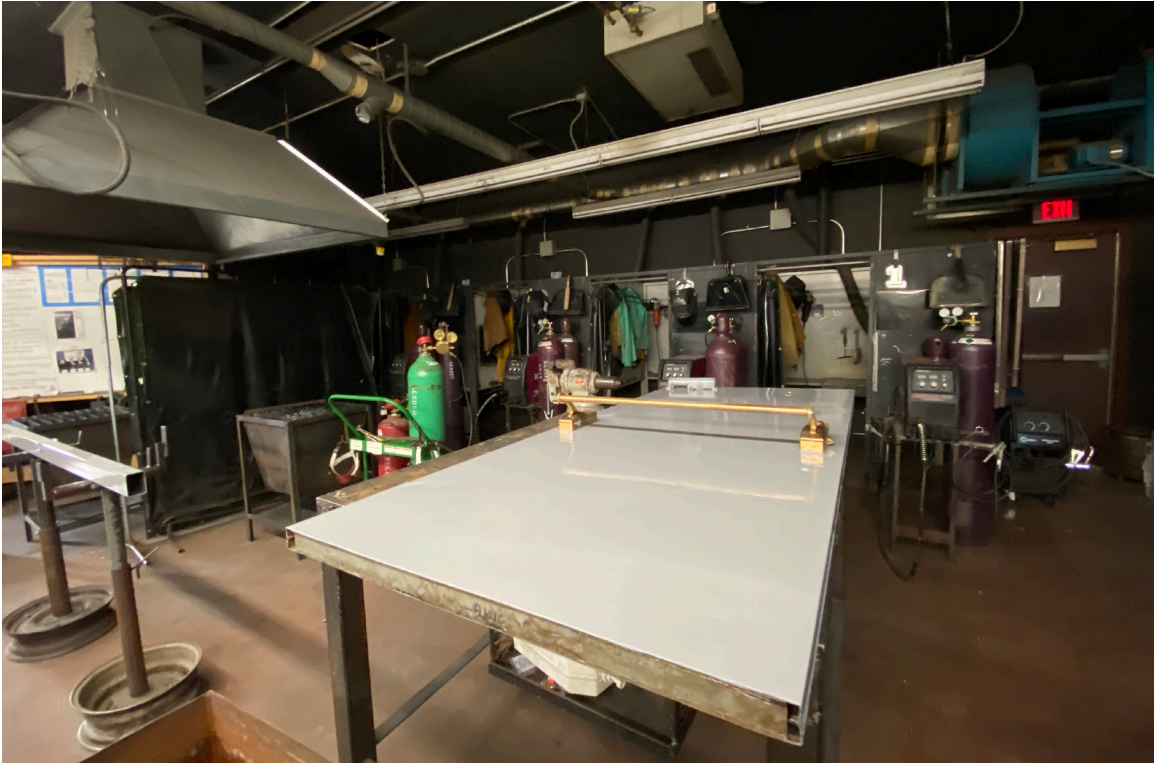
The welding space has a close proximity to the small engines space. Gas fumes are smelled in this room and there are questions of flammability.

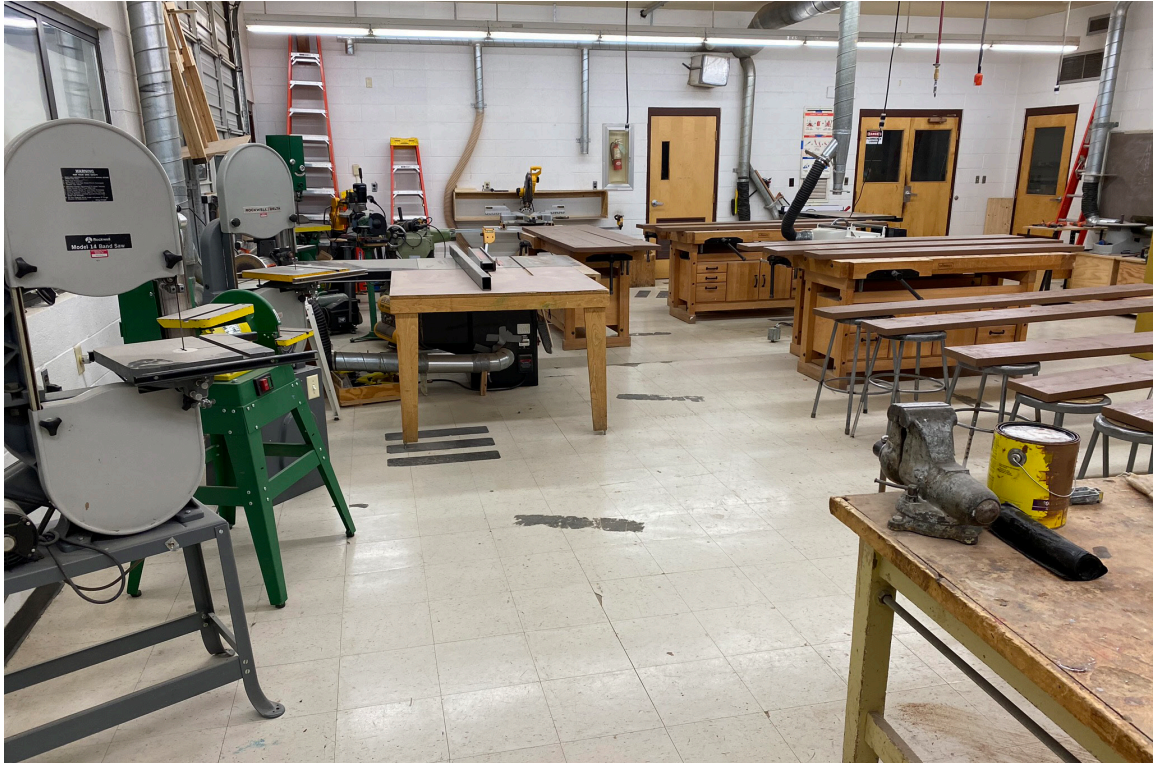
Another view of the shop space. Flooring and tables are worn as expected. The users of this space report slick floor surfaces when covered in sawdust.

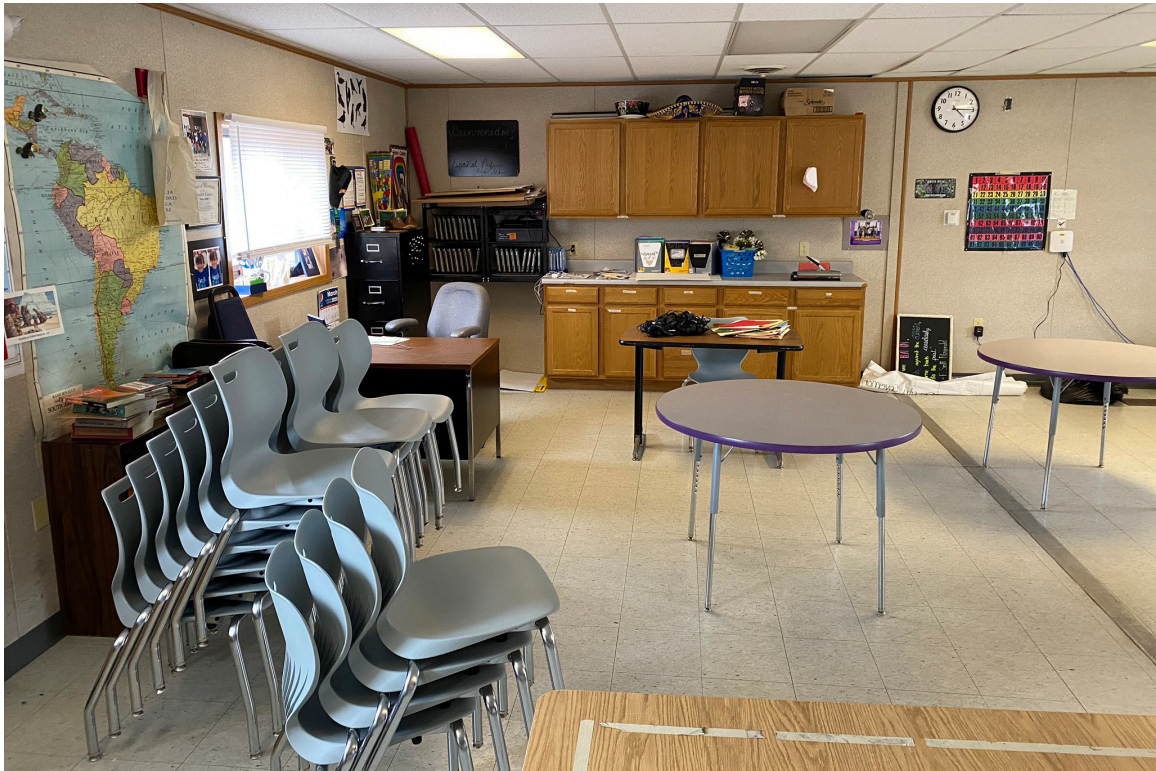
View of one of the modular classrooms. These classrooms are detached from the school building, which poses major security issues.

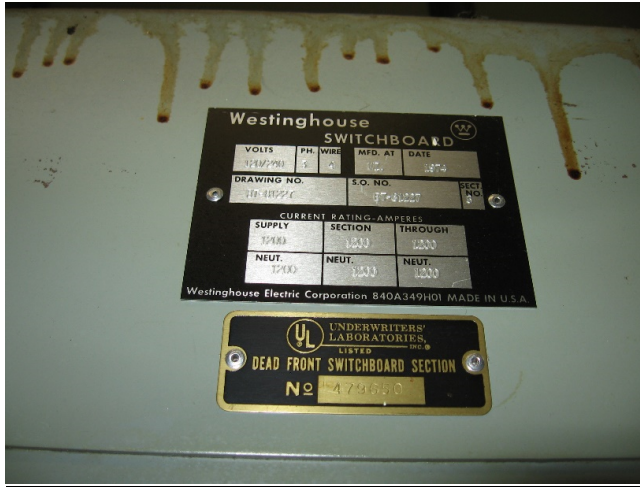
E1: Main Distribution Board showing liquid substance leaking from/onto equipment.

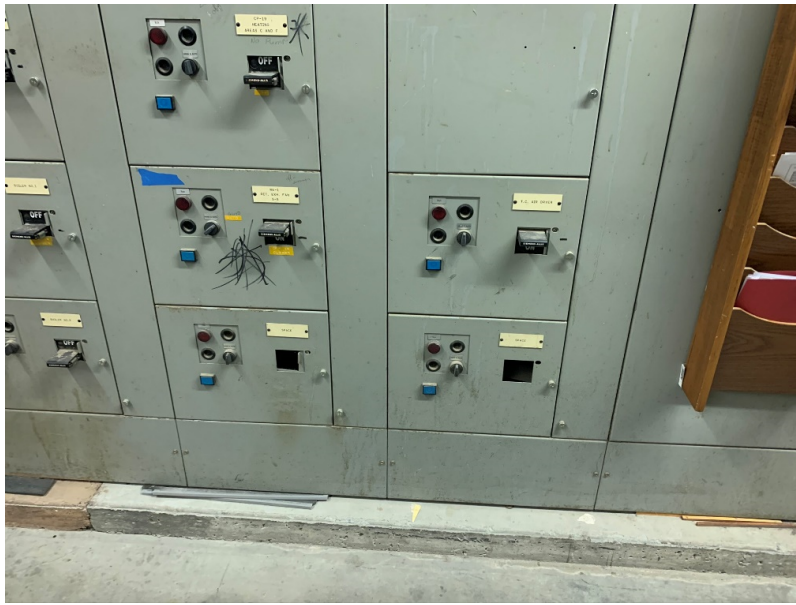
E2: Missing cover plates on MCC buckets need to be repaced.

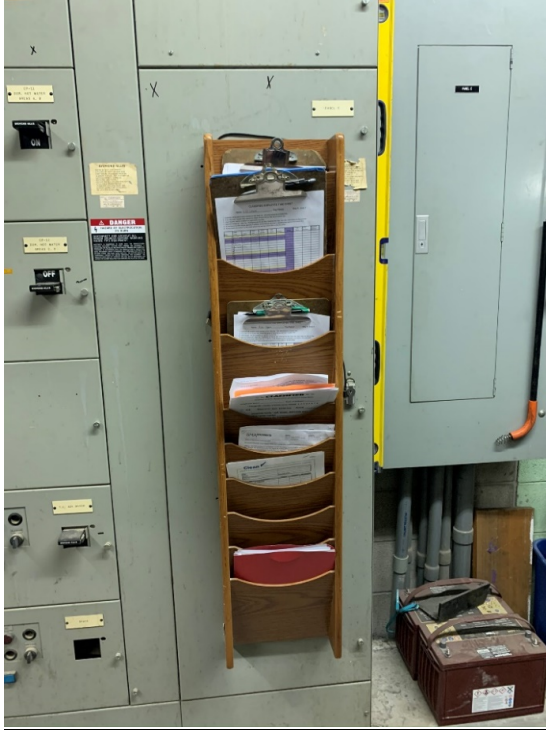
E3: File cabinet mounted to front of Motor Control Center

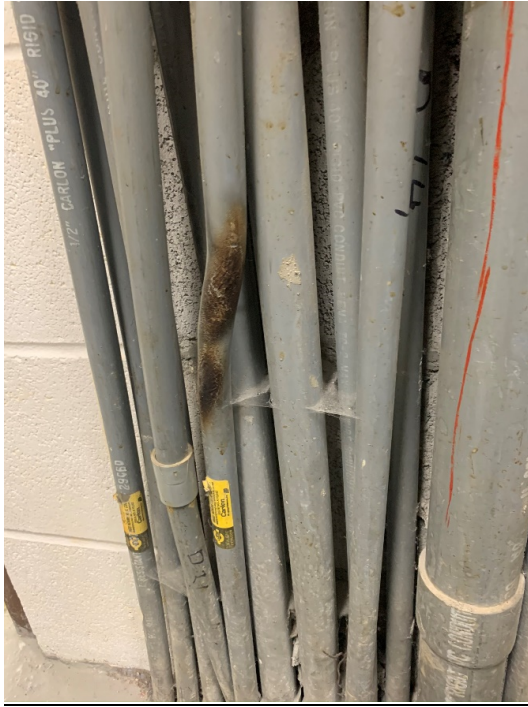
E5: Conduit shows signs of electrical fire and should be investigated by Electrician and replaced.

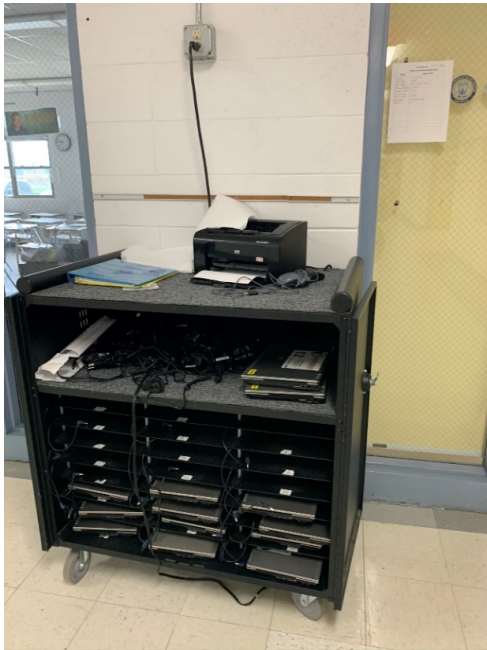
E6: Laptop charging station out in the hallway.

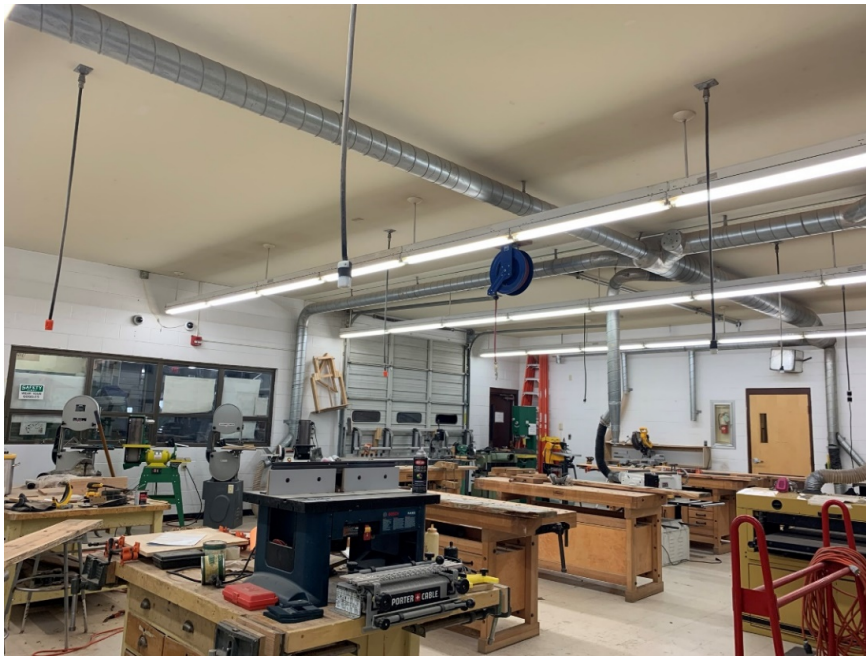
E8: Image of lighting in wood shop. Wire Guards are recommended.

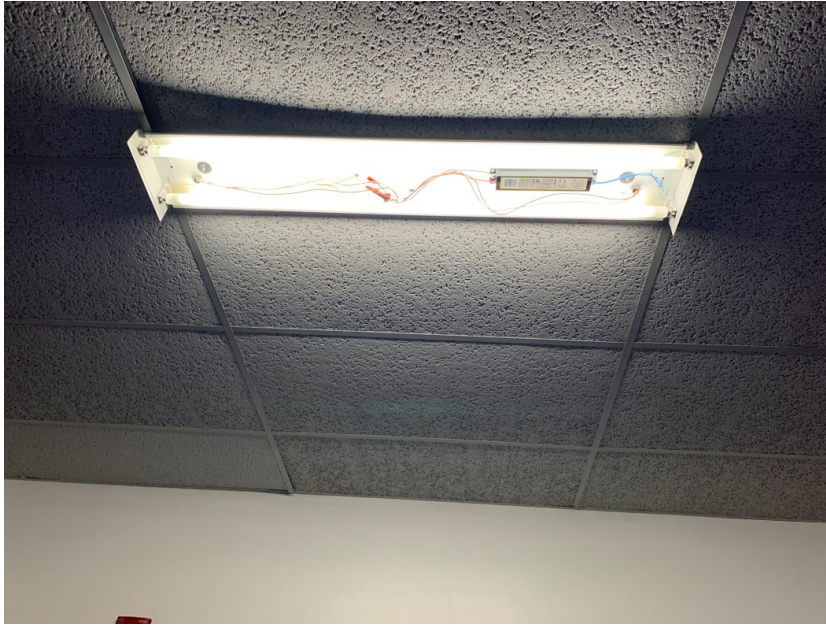
E12: Light in Locker room missing lens

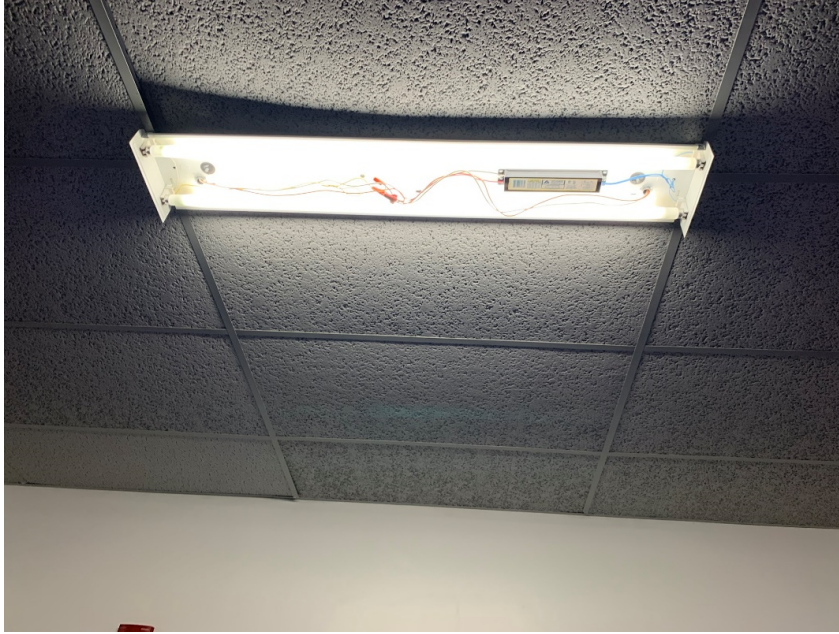
E15: Damaged fixture in weight room.
