Jefferson High School Building Condition Report

312 S Main Street, Boulder, Montana 59632

July 30, 2020

SMAARCHITECTS

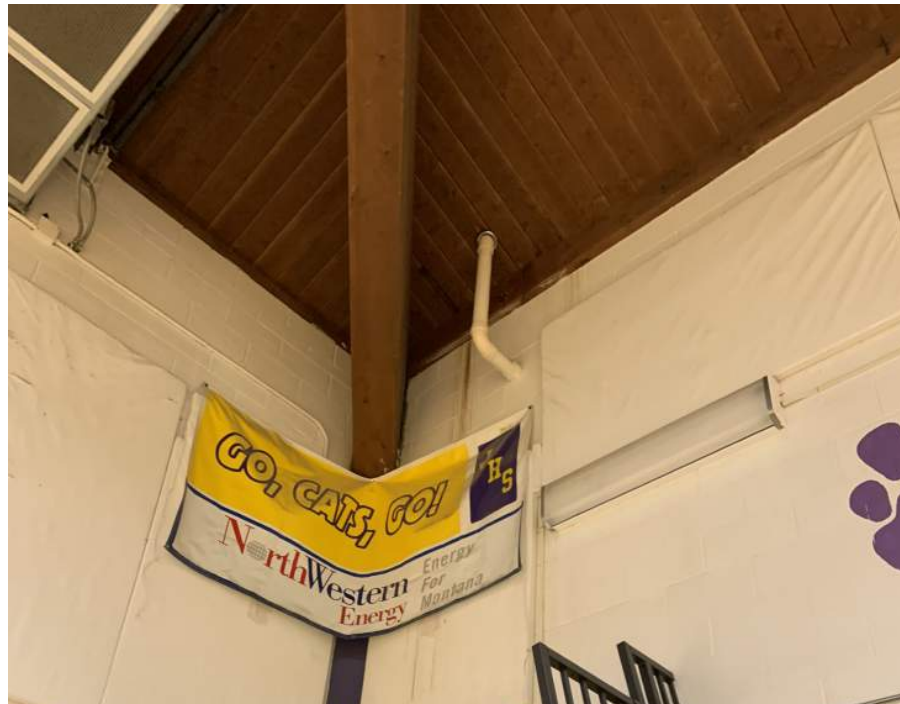
Figure 4. Water Stains on south CMU wall of 1985 Gym

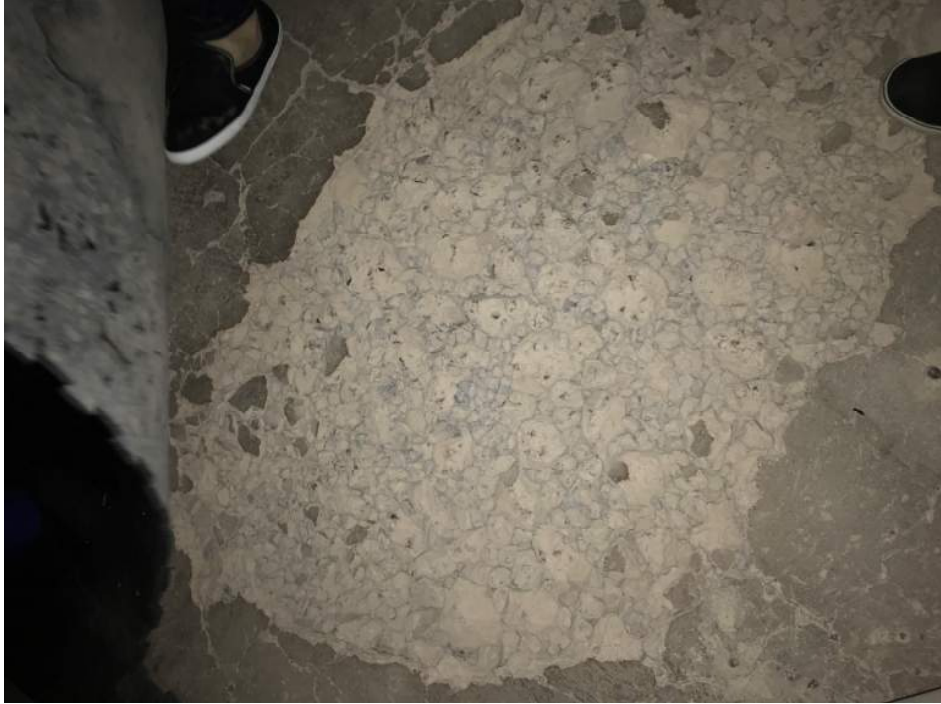
Figure 5. Deteriorated Concrete Floor Slab in Weight Room (1985 Addition)

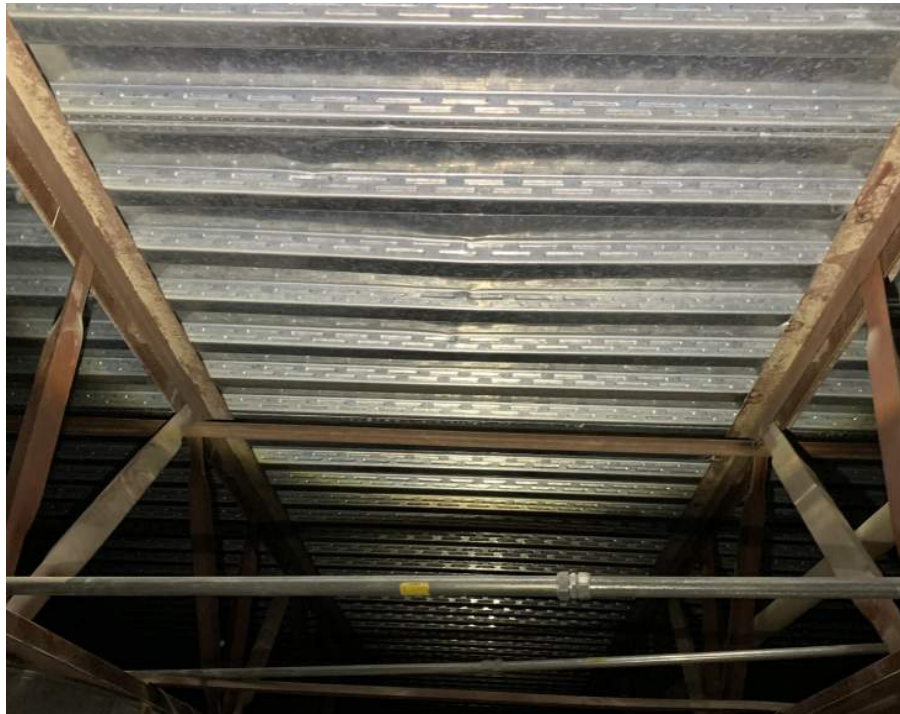
Figure 6. Deformed Metal Deck Below Weight Room (1985 Addition)

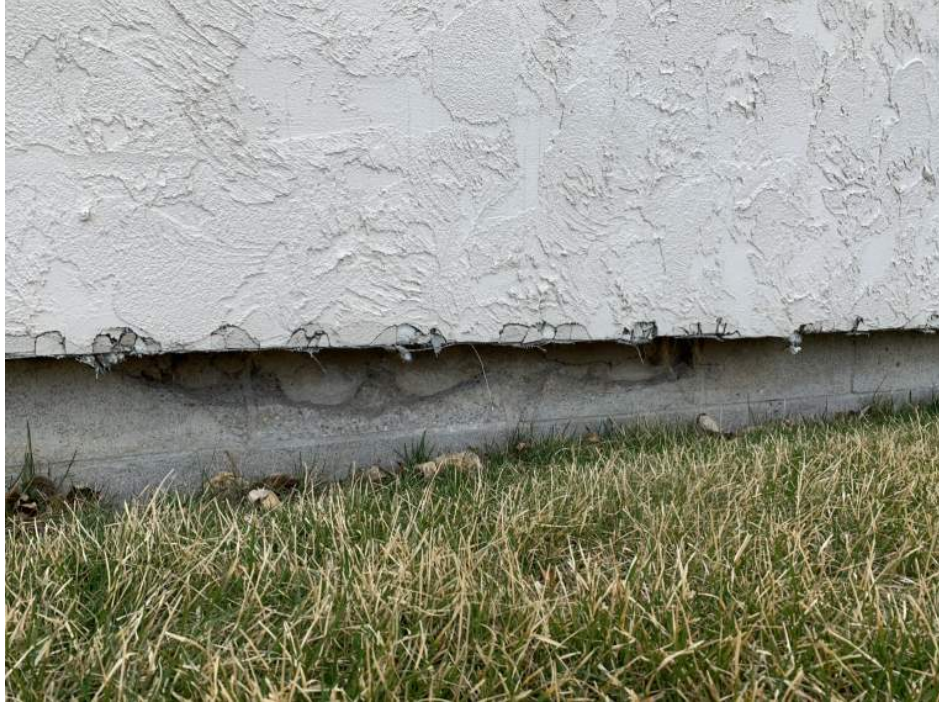
Figure 7. Exterior Foundation Wall Damage at 1985 Gym

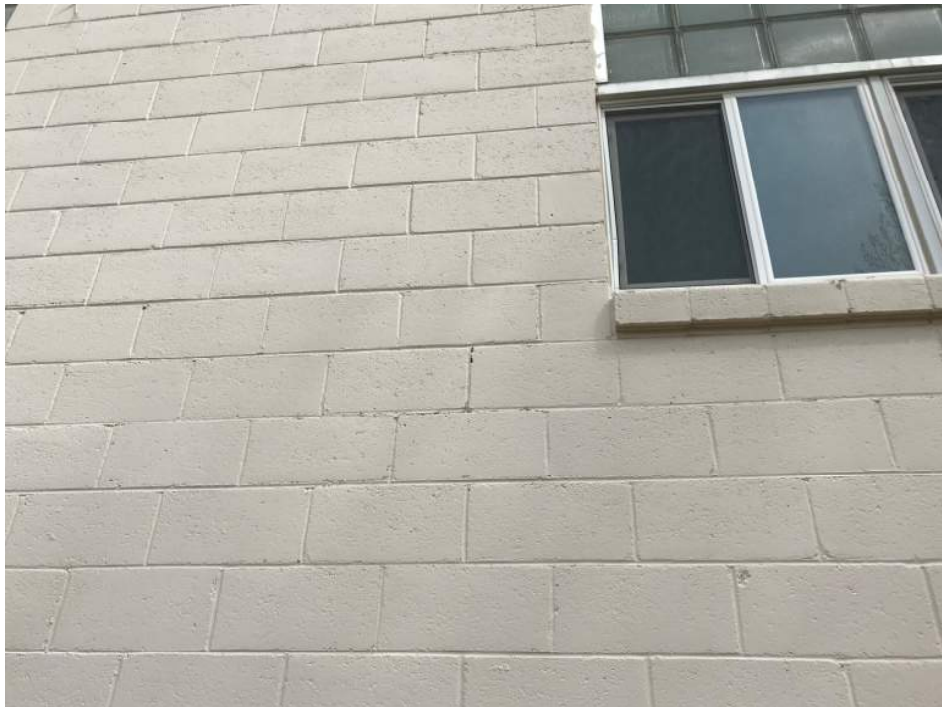
Figure 18. Cracking in Exterior Wall Along Mortar Joints (1956 Addition)

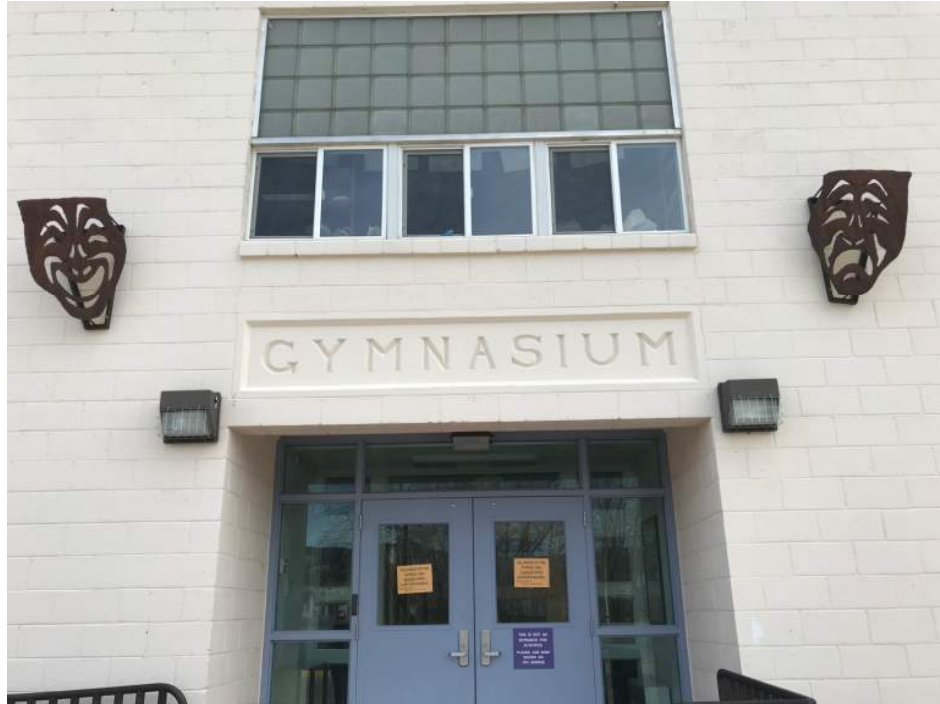
Figure 19. Cracking in Exterior Wall Around Plaque (1956 Addition)
