# BUILDING CONDITION REPORT

**JEFFERSON HIGH  
SCHOOL DISTRICT #1**  
July 21, 2020

SMA|ARCHITECTS

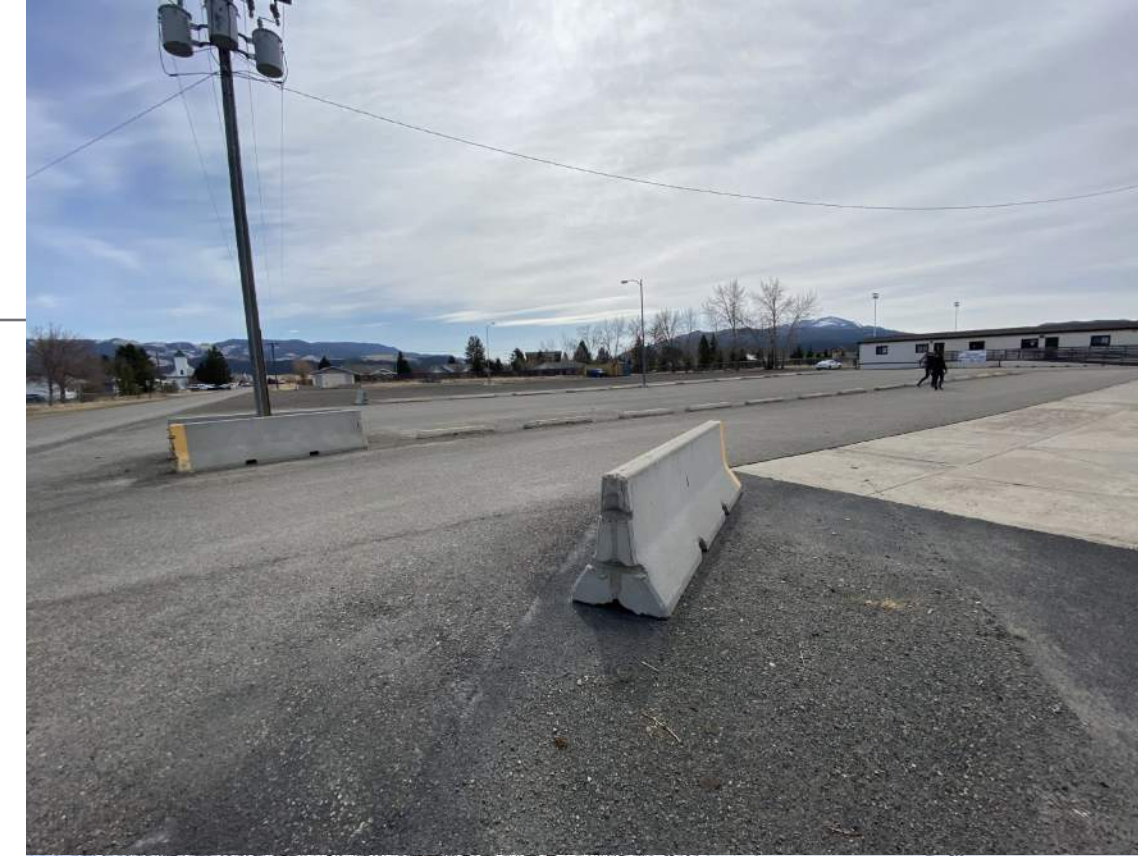
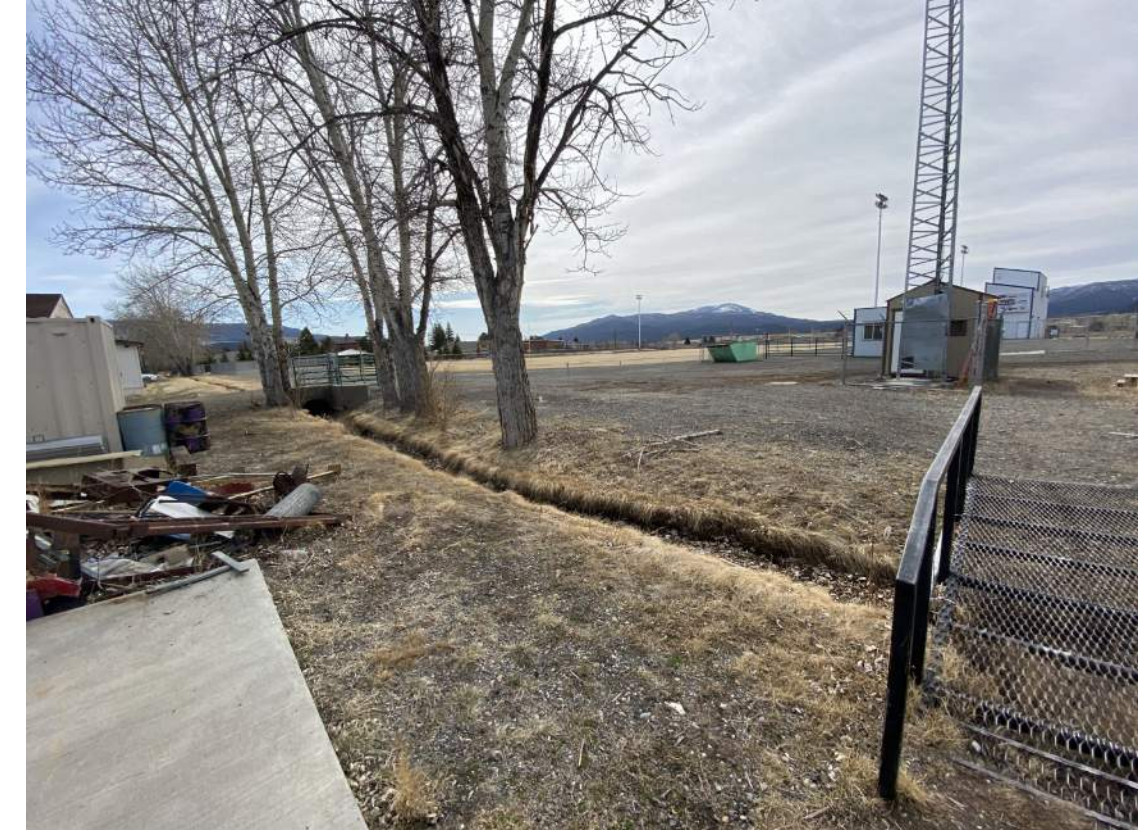
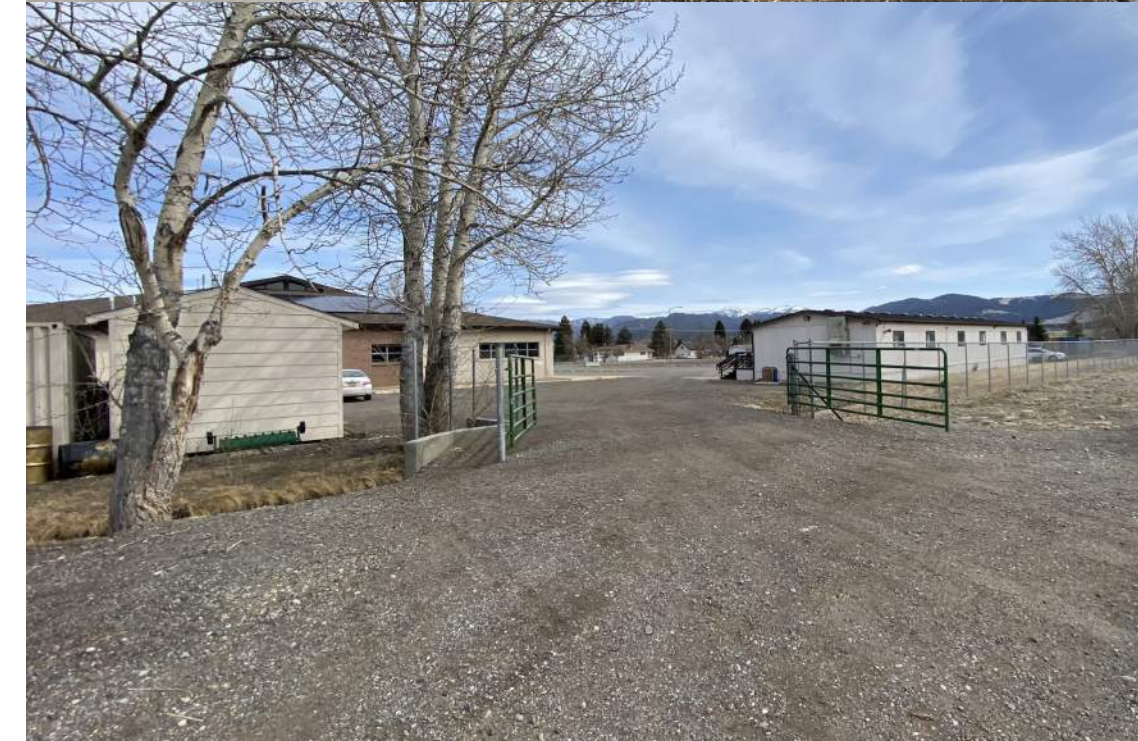
- Foundation in good condition
- Some Roof drains do not direct water away from foundation. Add splash blocks or other to direct water away from building.
- Exterior concrete stairs and exterior concrete flatwork is spalling and cracking.
- Entrance accessibility is good.
- Some damage or discoloration of exterior finishes, but otherwise in good condition.
- Exterior doors and windows in good condition.
- Security:
  - Not able to see visitors as they approach building

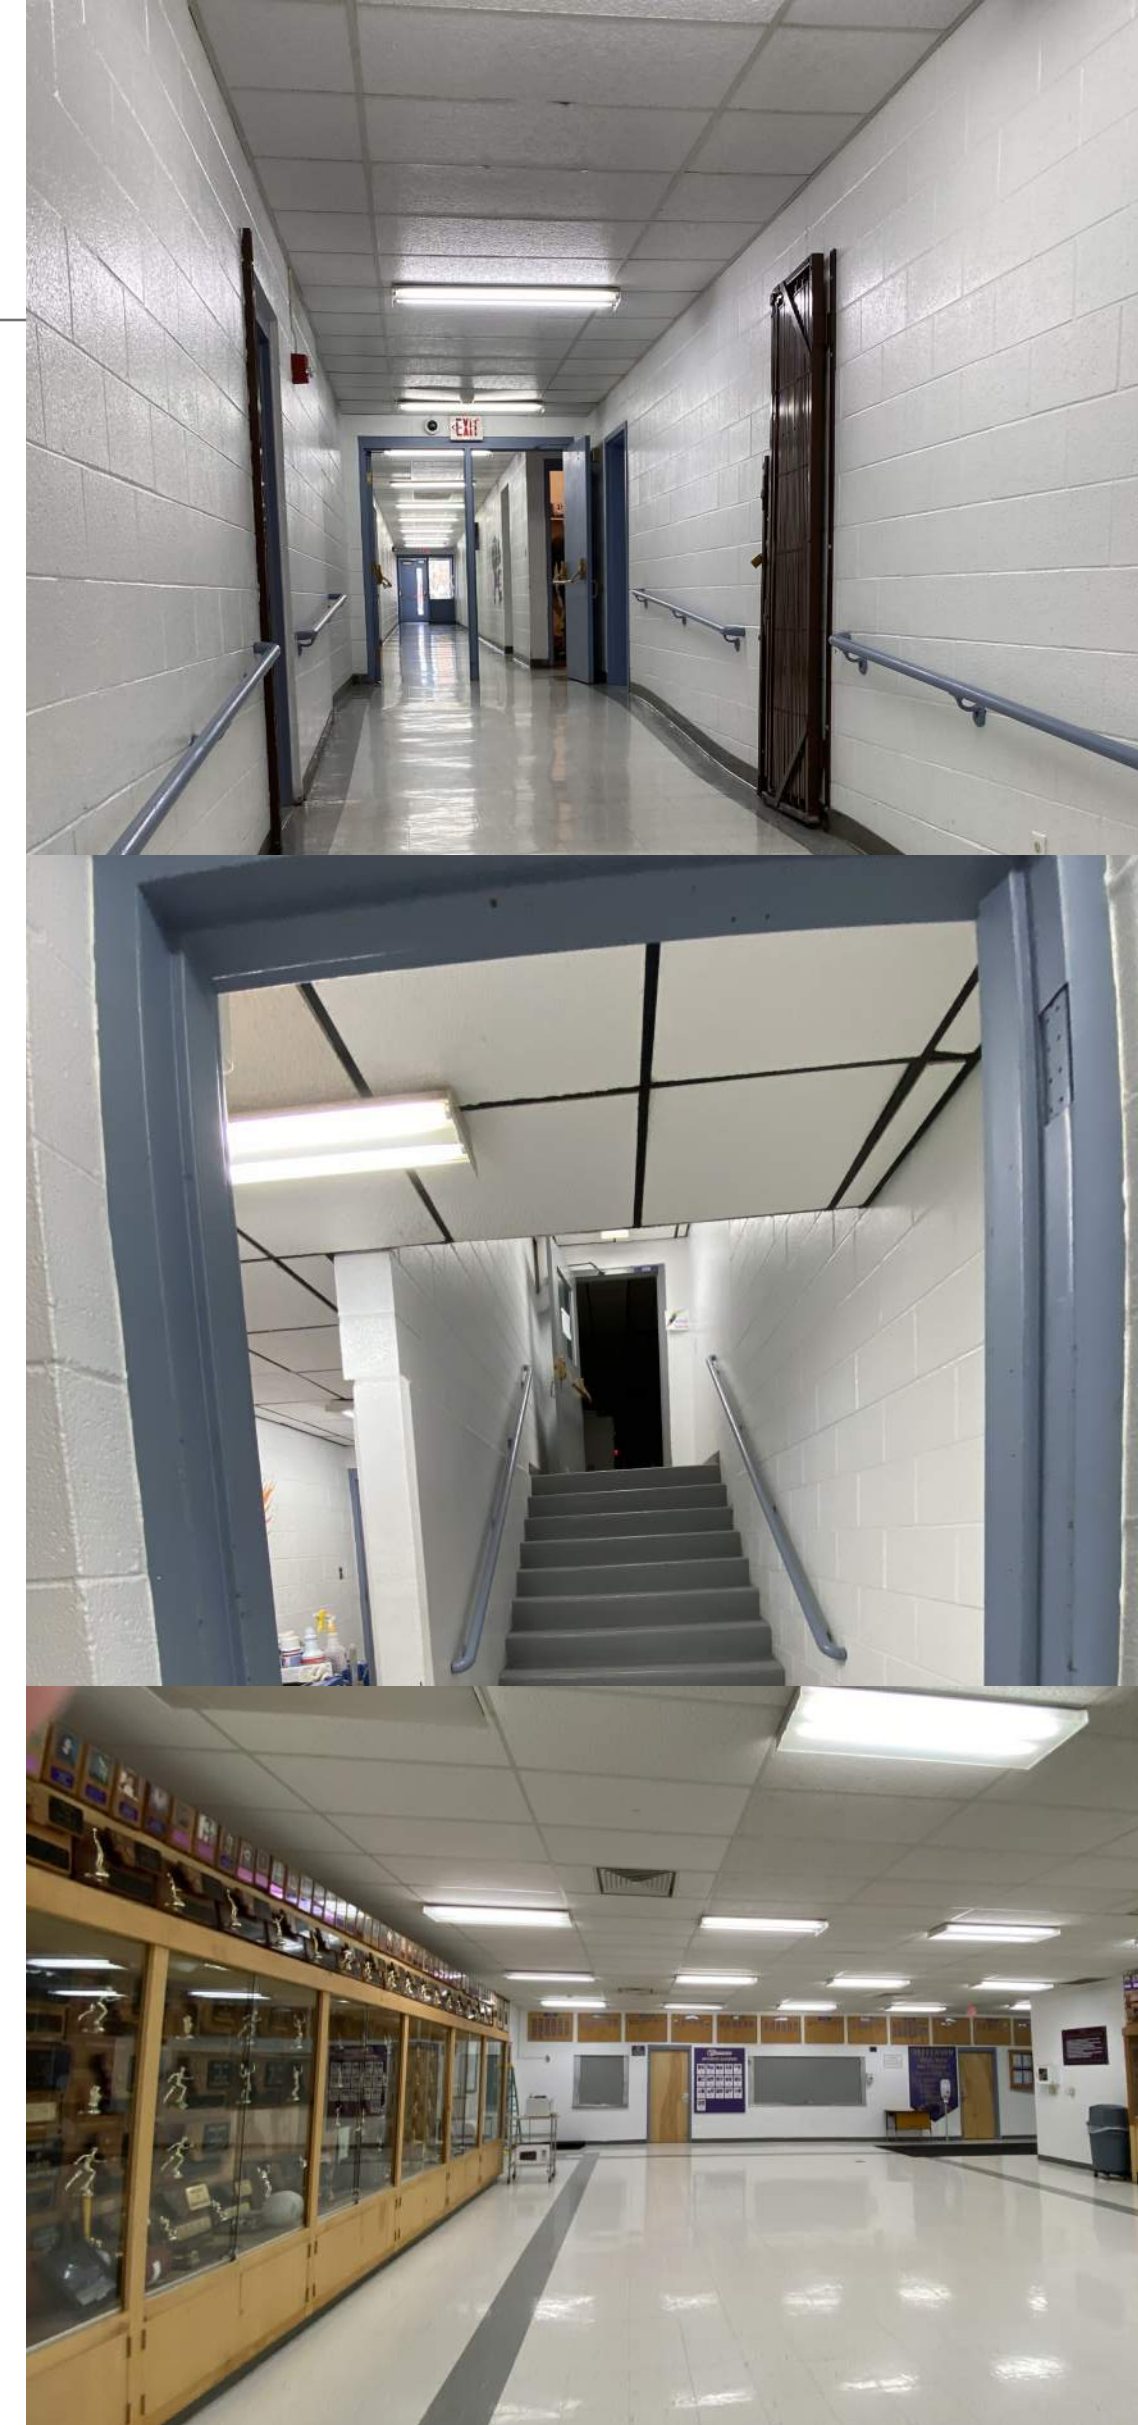
- Primarily in good condition, with regular maintenance.
- Cohesive feeling despite multiple additions
- Finishes overall fair to good
- Acoustical ceiling tiles are worn and need replacement in some areas.
- Flooring: mix of vinyl composition tile, wood gym, masonry block and gypsum board finishes.
- No Hazardous Material Inspection completed, however in our experience many are likely to be Asbestos Containing Materials.

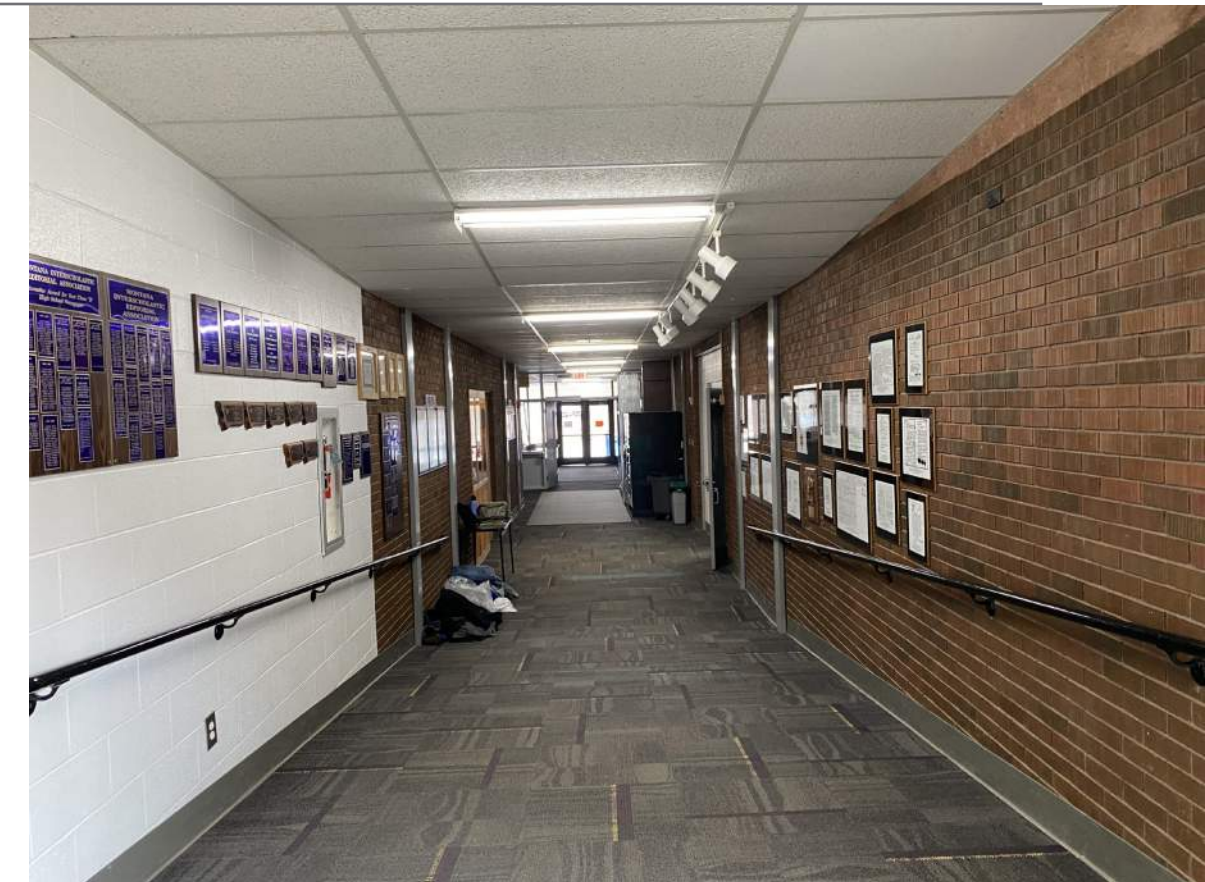
- Width of hallways is narrow for modern school. Typical width: 8', with lockers on both sides 10'. East Middle School has 12' hallways.
- Ceiling tile showing age with moisture damage
- Walls are CMU block that is durable and vandal-resistant, but poses problems with echoing and an institutional look.
- Flooring is largely vinyl composition tile that holds up well but requires significant maintenance.
- Lockers in good condition.
- Hallways lack common or flexible “breakout spaces” that support many 21st Century Learning principles.
- Current Cafeteria/Multi-Purpose Space does not have exterior views, is fairly small, and is not very inviting.

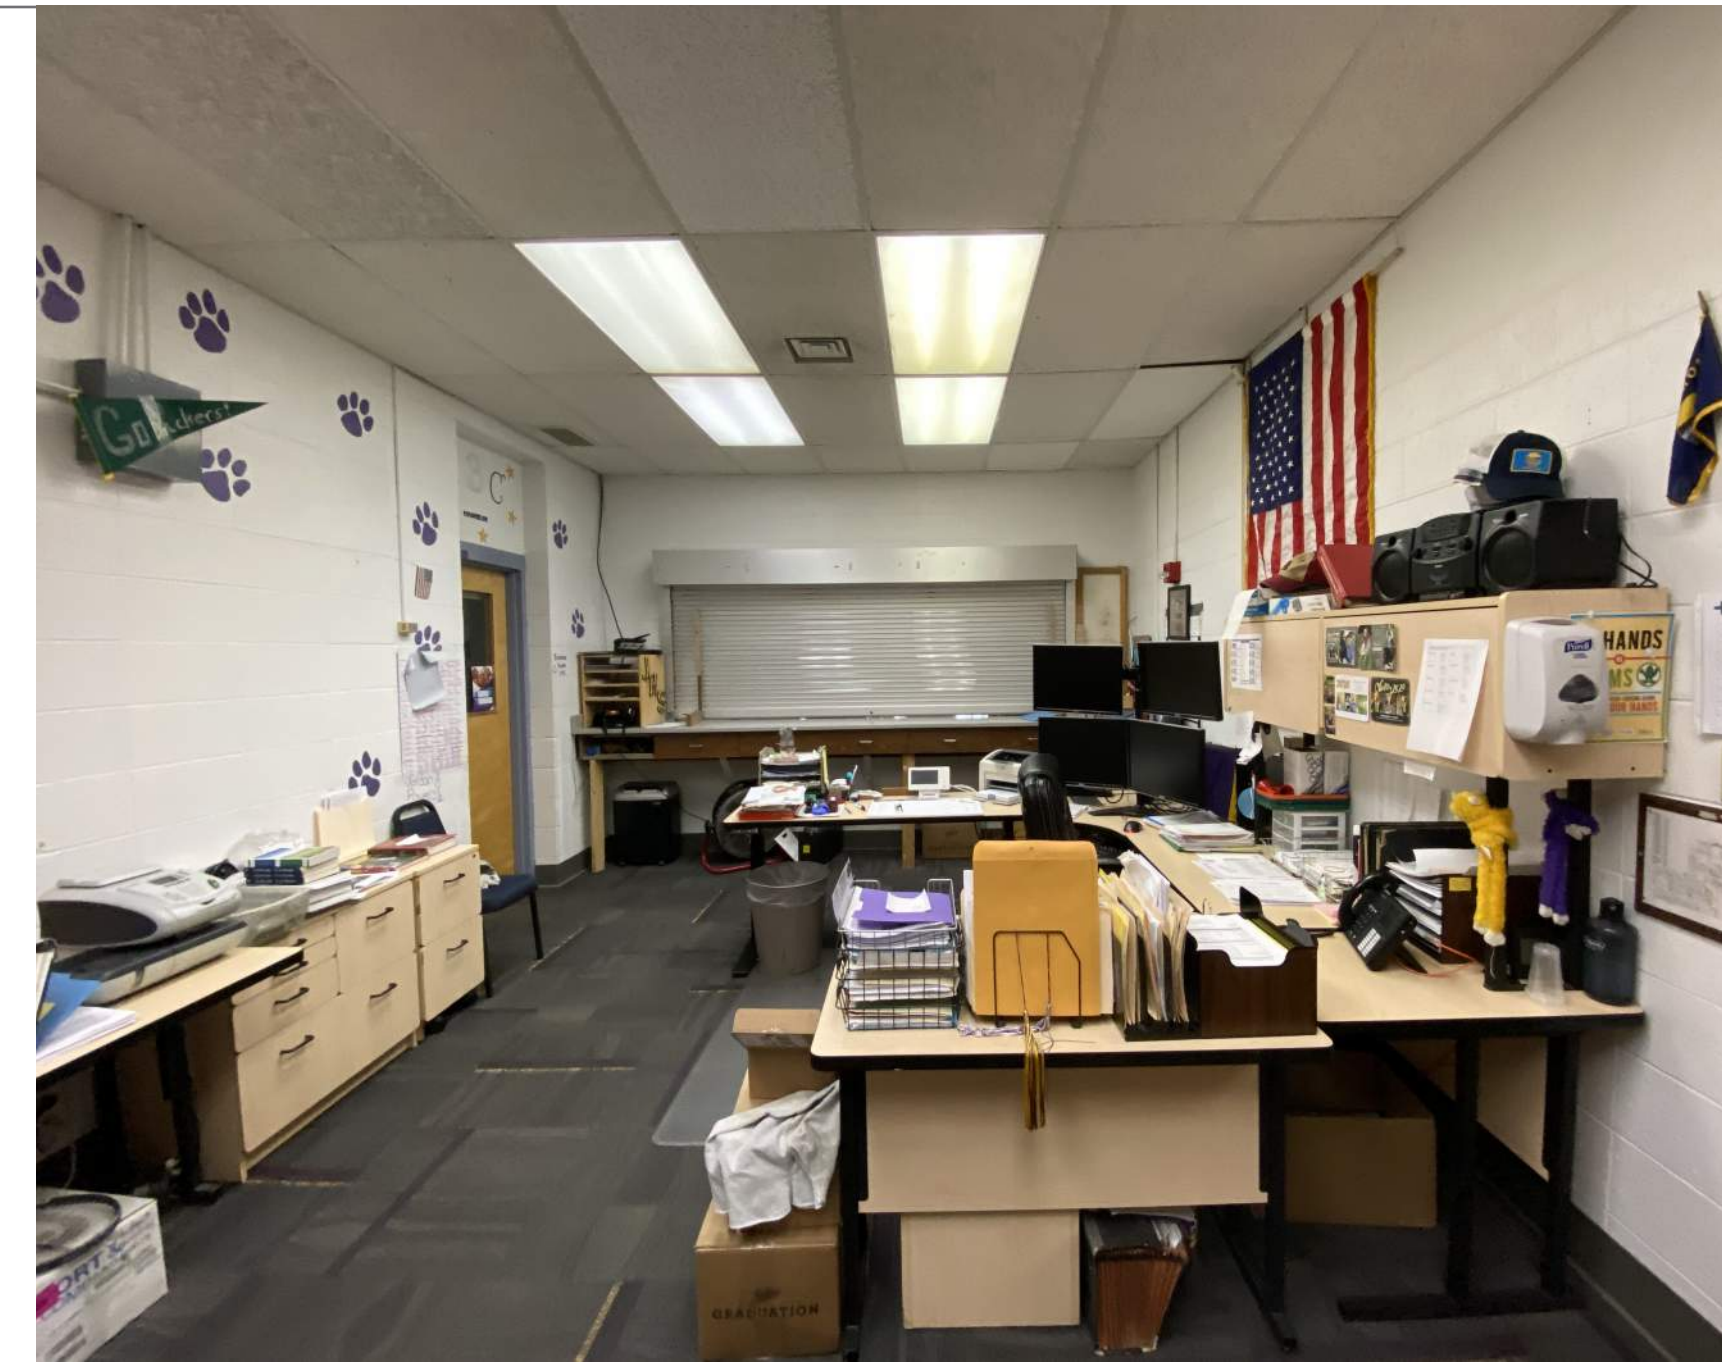
- Busy, central location with high traffic.
- Carpet helps acoustic control, as does acoustic ceiling.
- Ceiling is dated and worn.
- Seating/Waiting Area does not provide privacy
- No conference room for larger group meetings or private conversations
- Principal's office is small and could be more welcoming
- Office location does not meet typical security needed in a 21st Century School
- An intruder can access the school once allowed through main entry doors.
- Main office does not have secure interior vestibule to buzz visitors in.

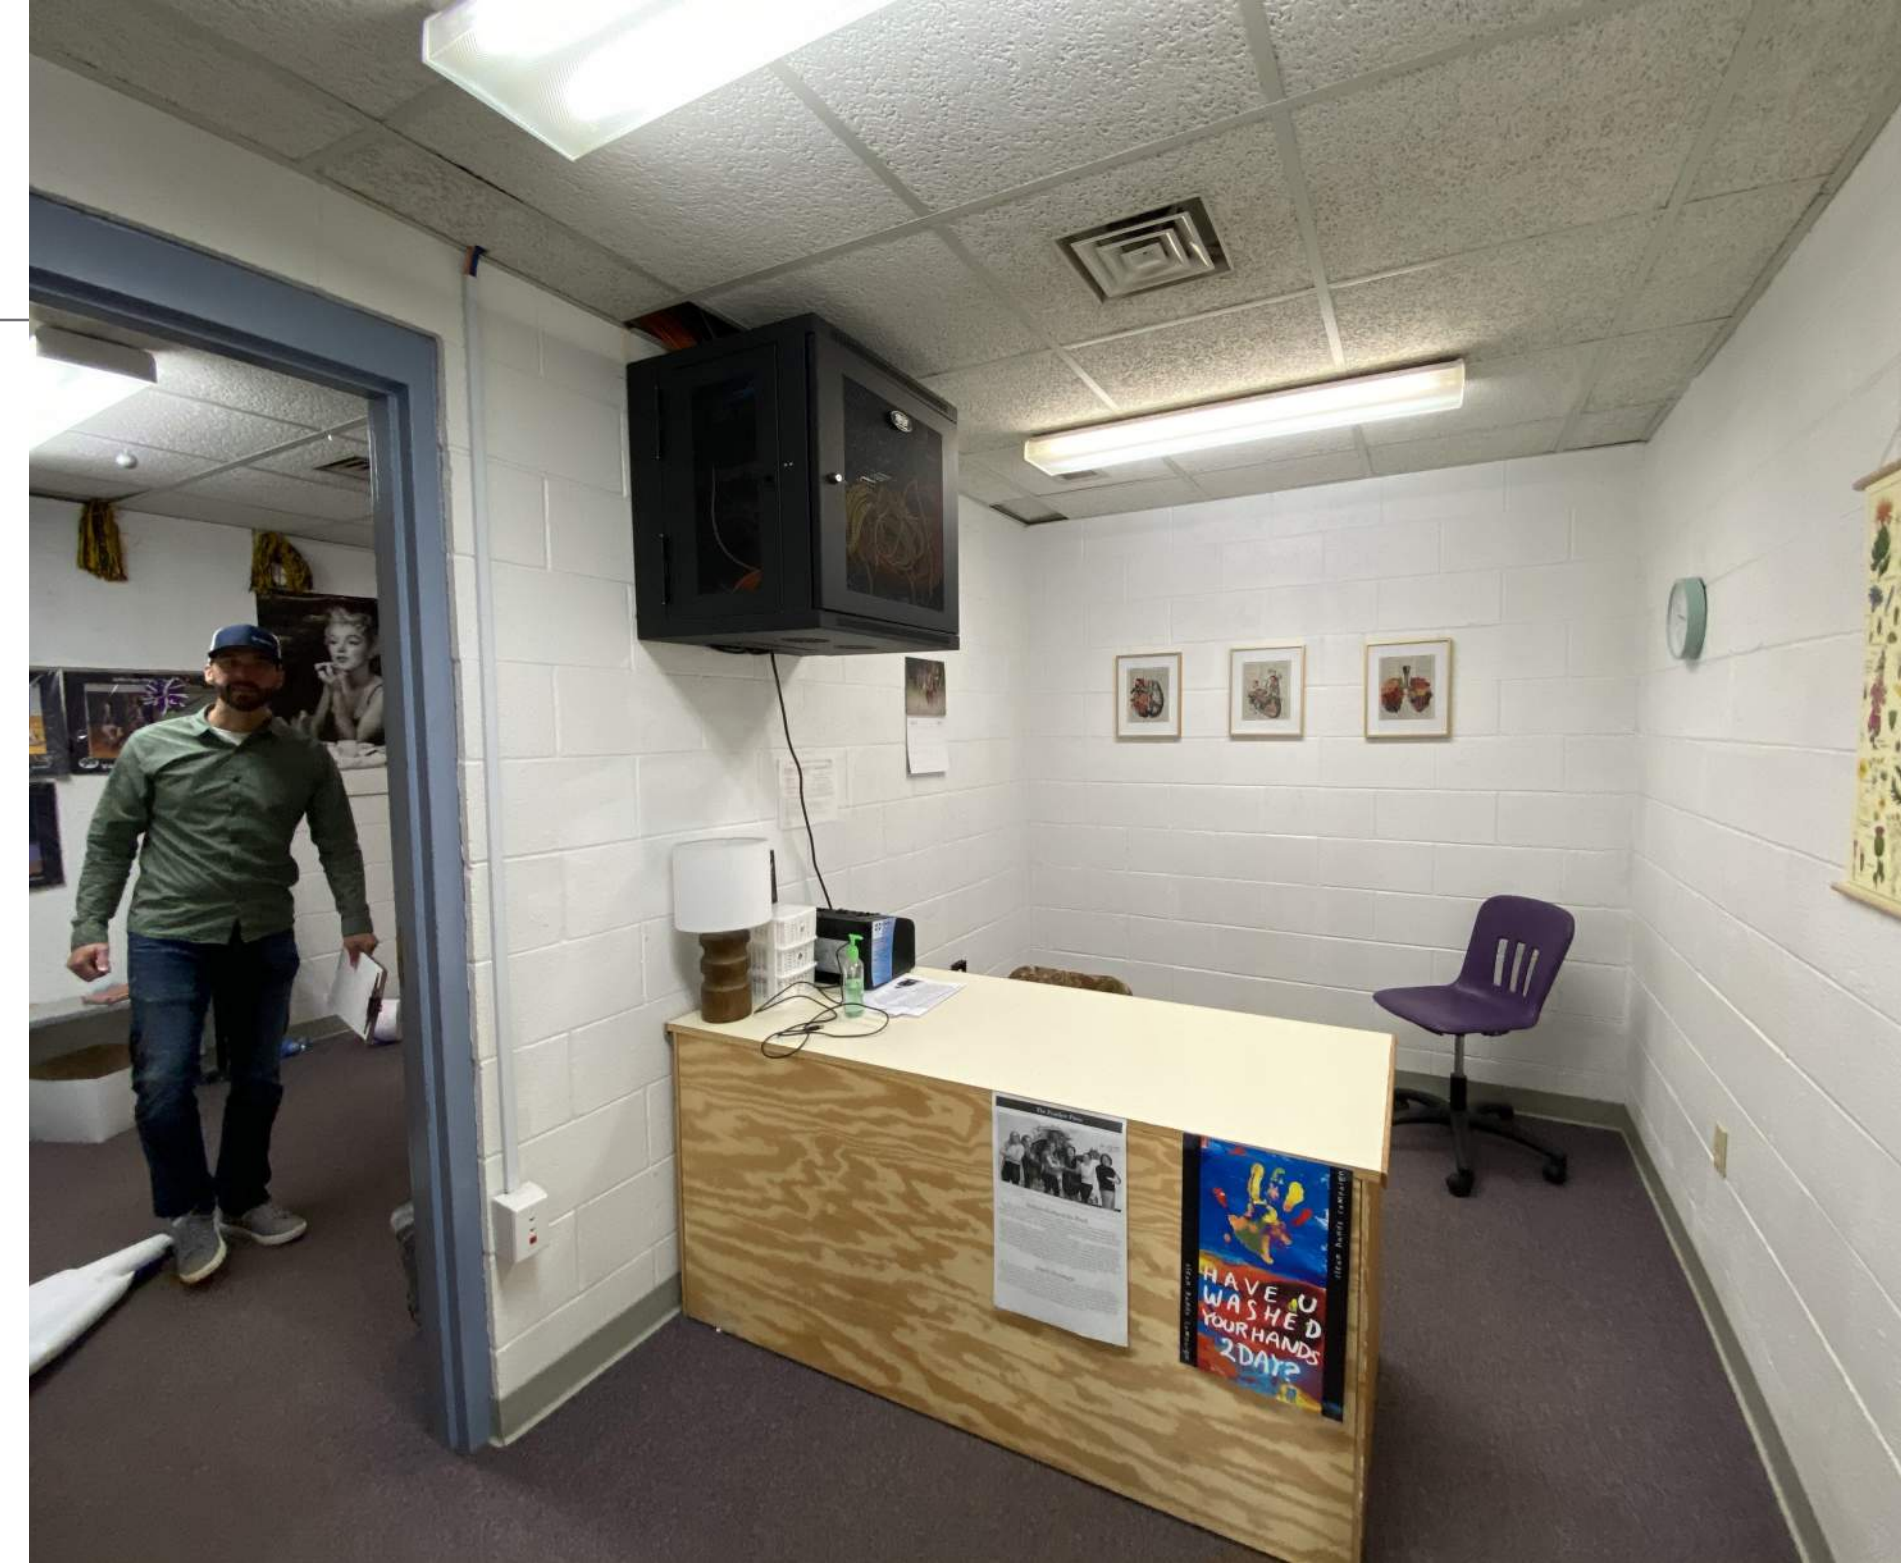
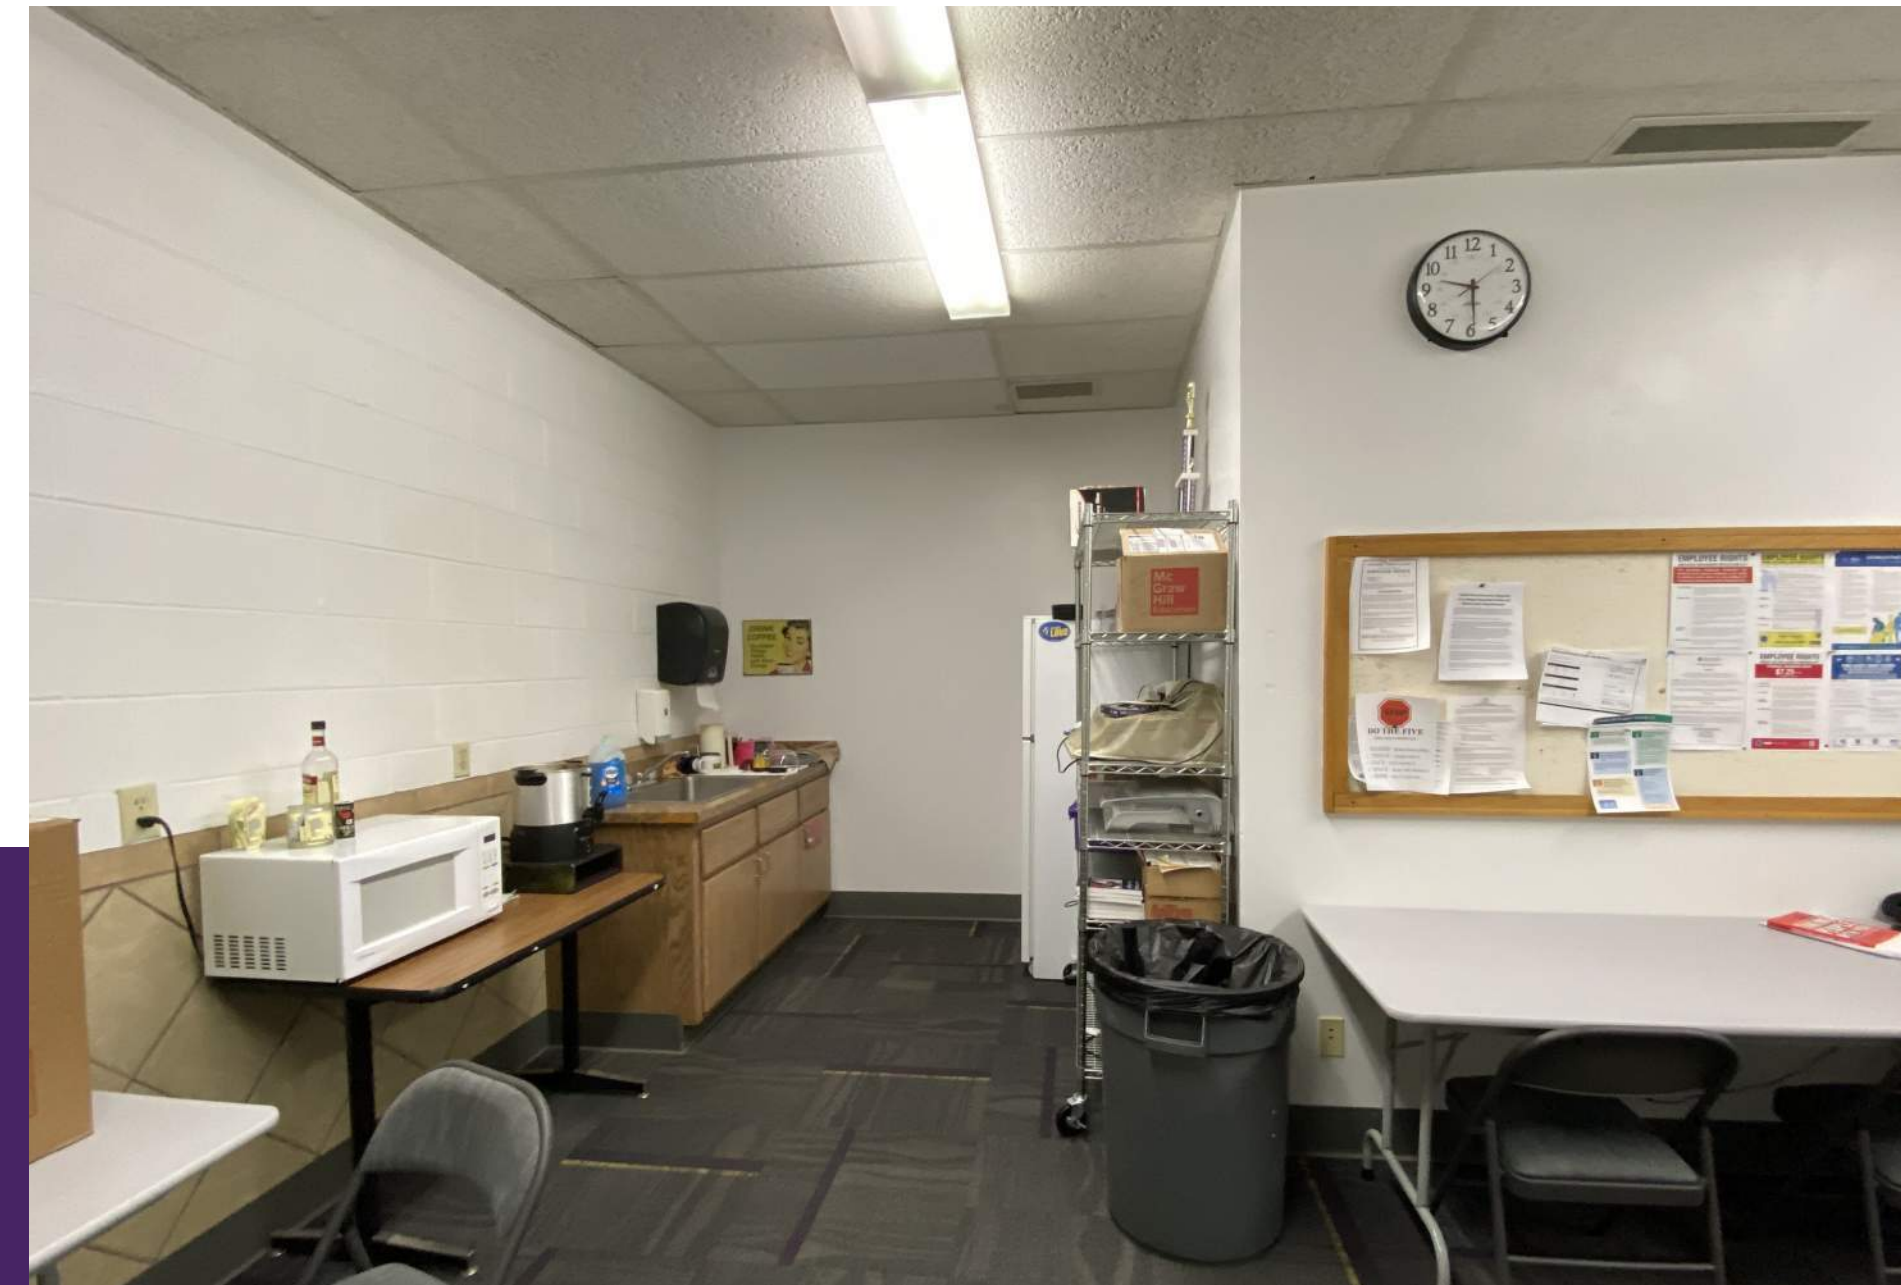
- Many of these rooms appear to have been retrofitted into existing rooms
- No visibility from front desk to sick bay for secretary to monitor while fulfilling both duties
- Lack of private conference area
- Central Office located here and is busy, difficult to get work done next to main circulation

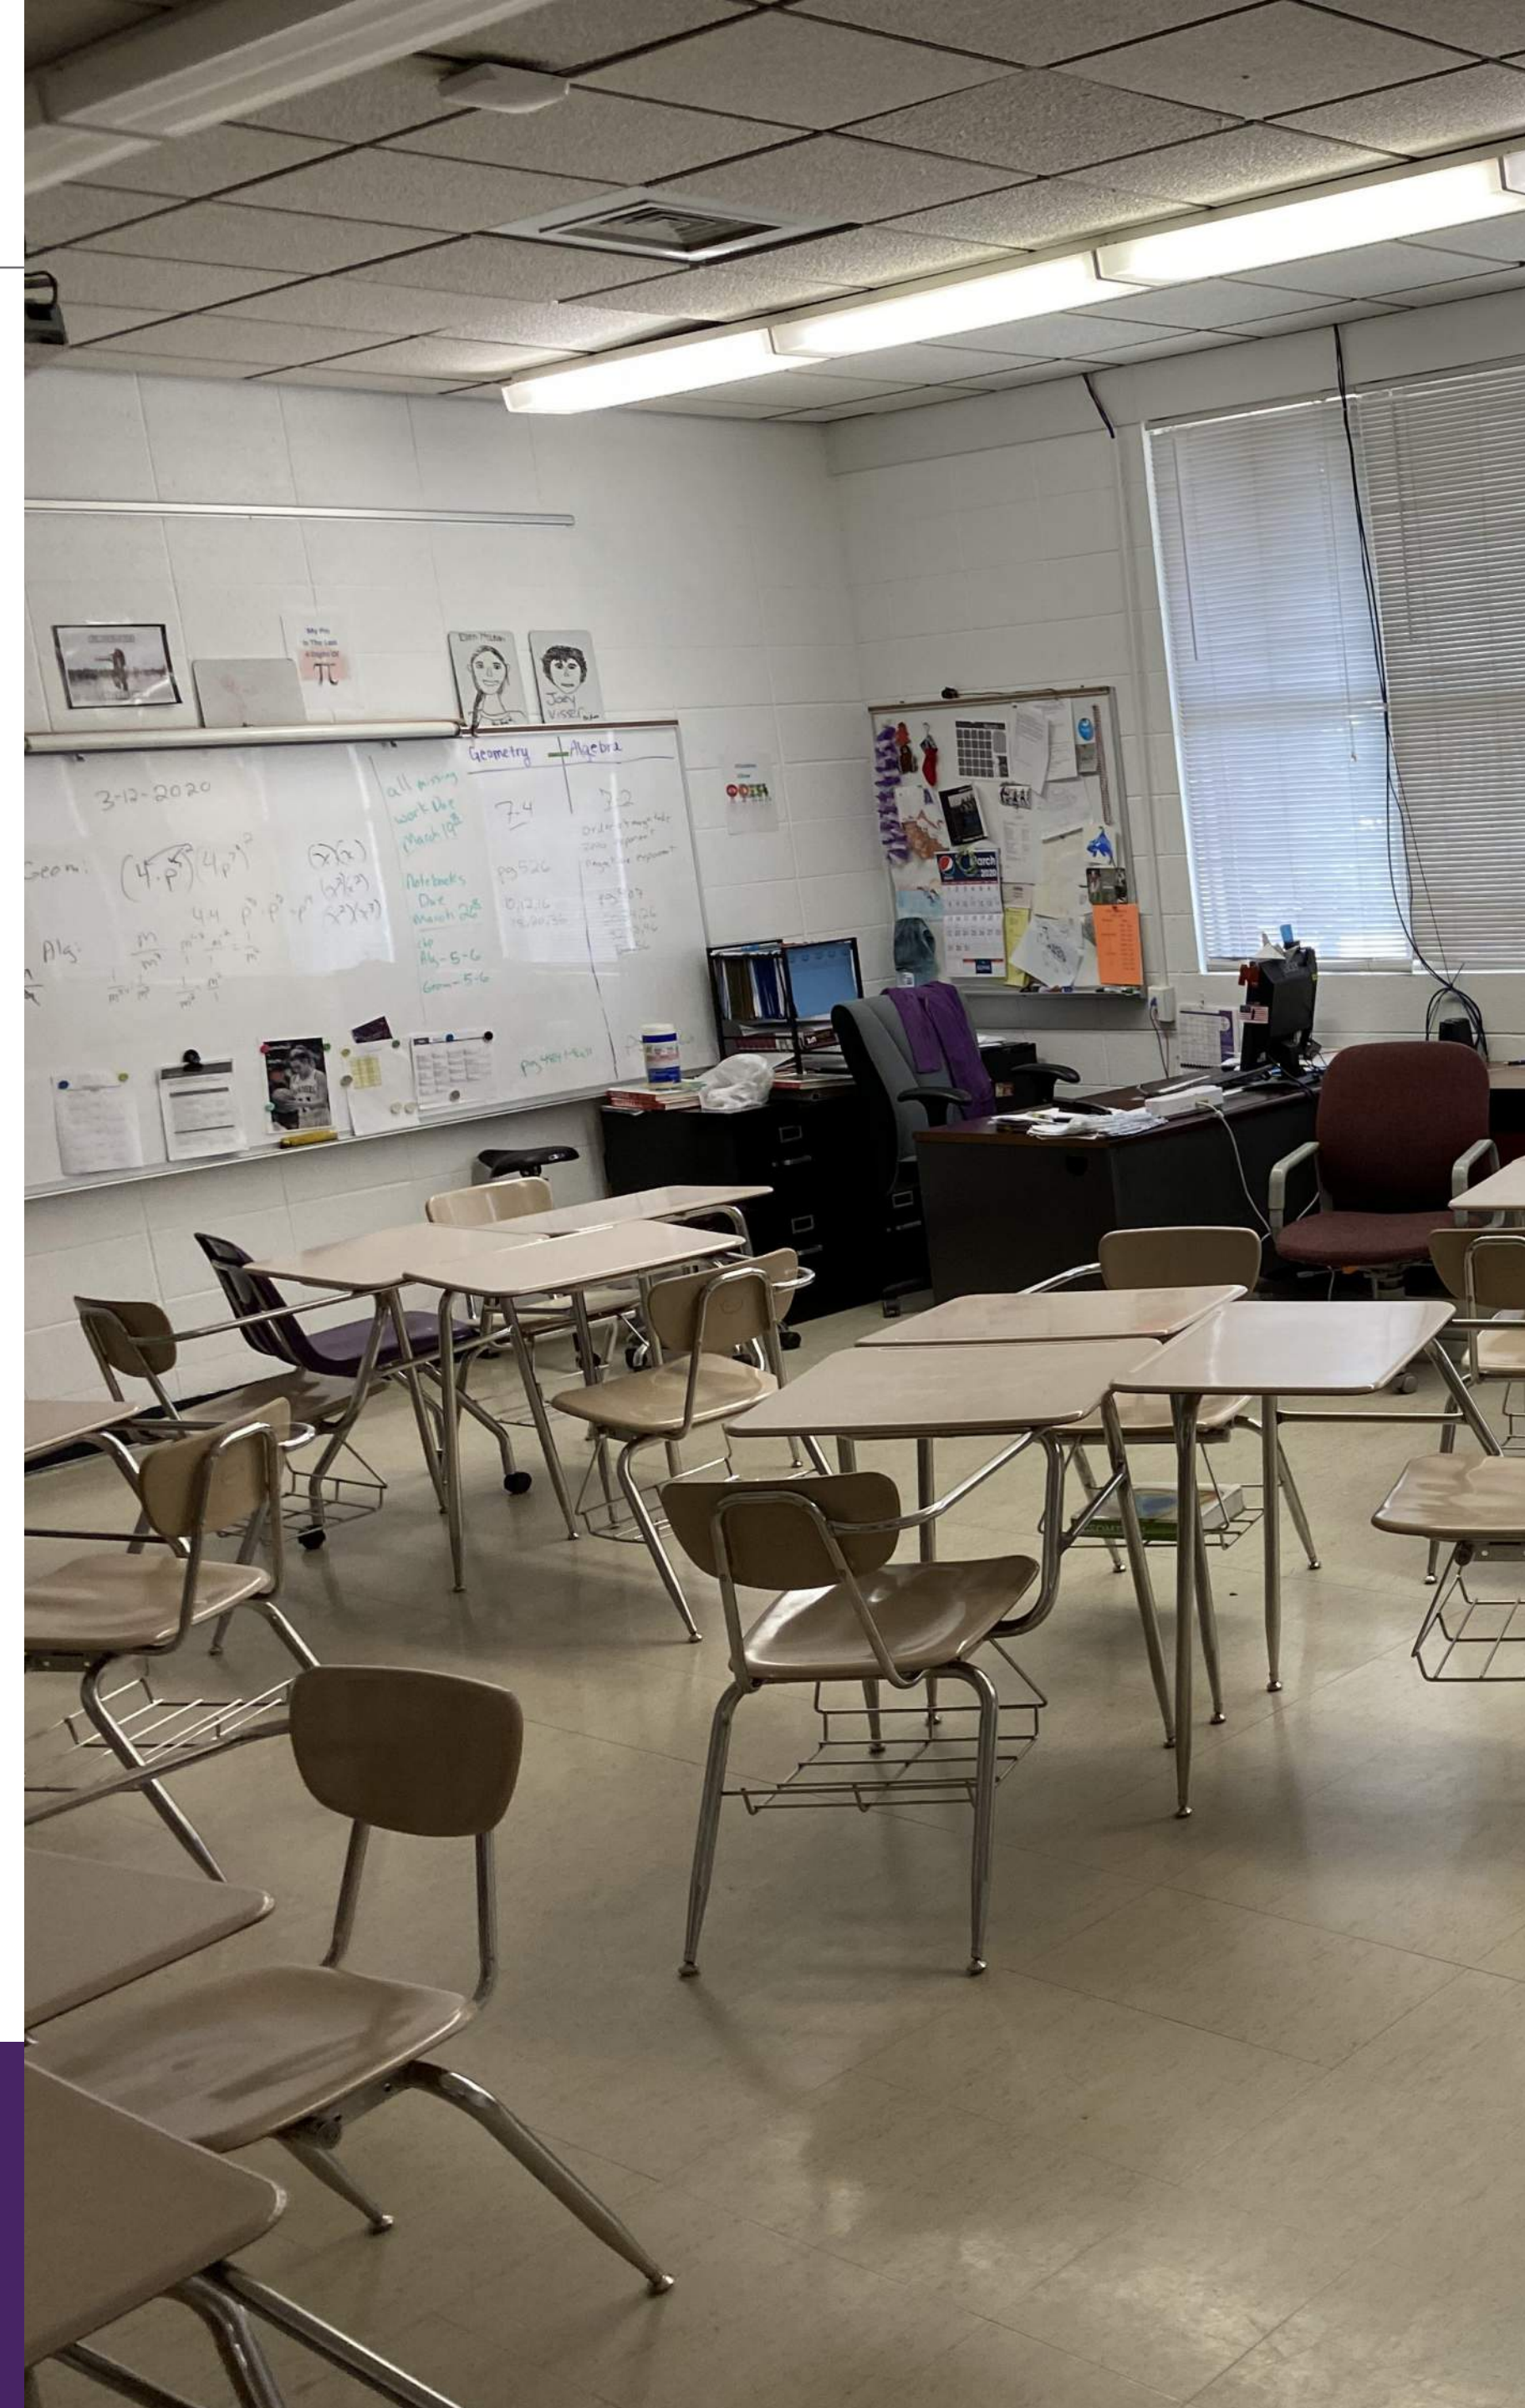
- In general, functioning well, most teachers spoke positively about their space
- Handful of teachers reported their classrooms are too small
- Current classroom SF are adequate for most class sizes, but do not meet 21st century classroom recommendations and cannot accommodate growing class numbers.
  - Maximum students per class, per State of MT is 30 students.
  - Recommended SF/student is 45-55sf for general classrooms per Association for Learning Environments.

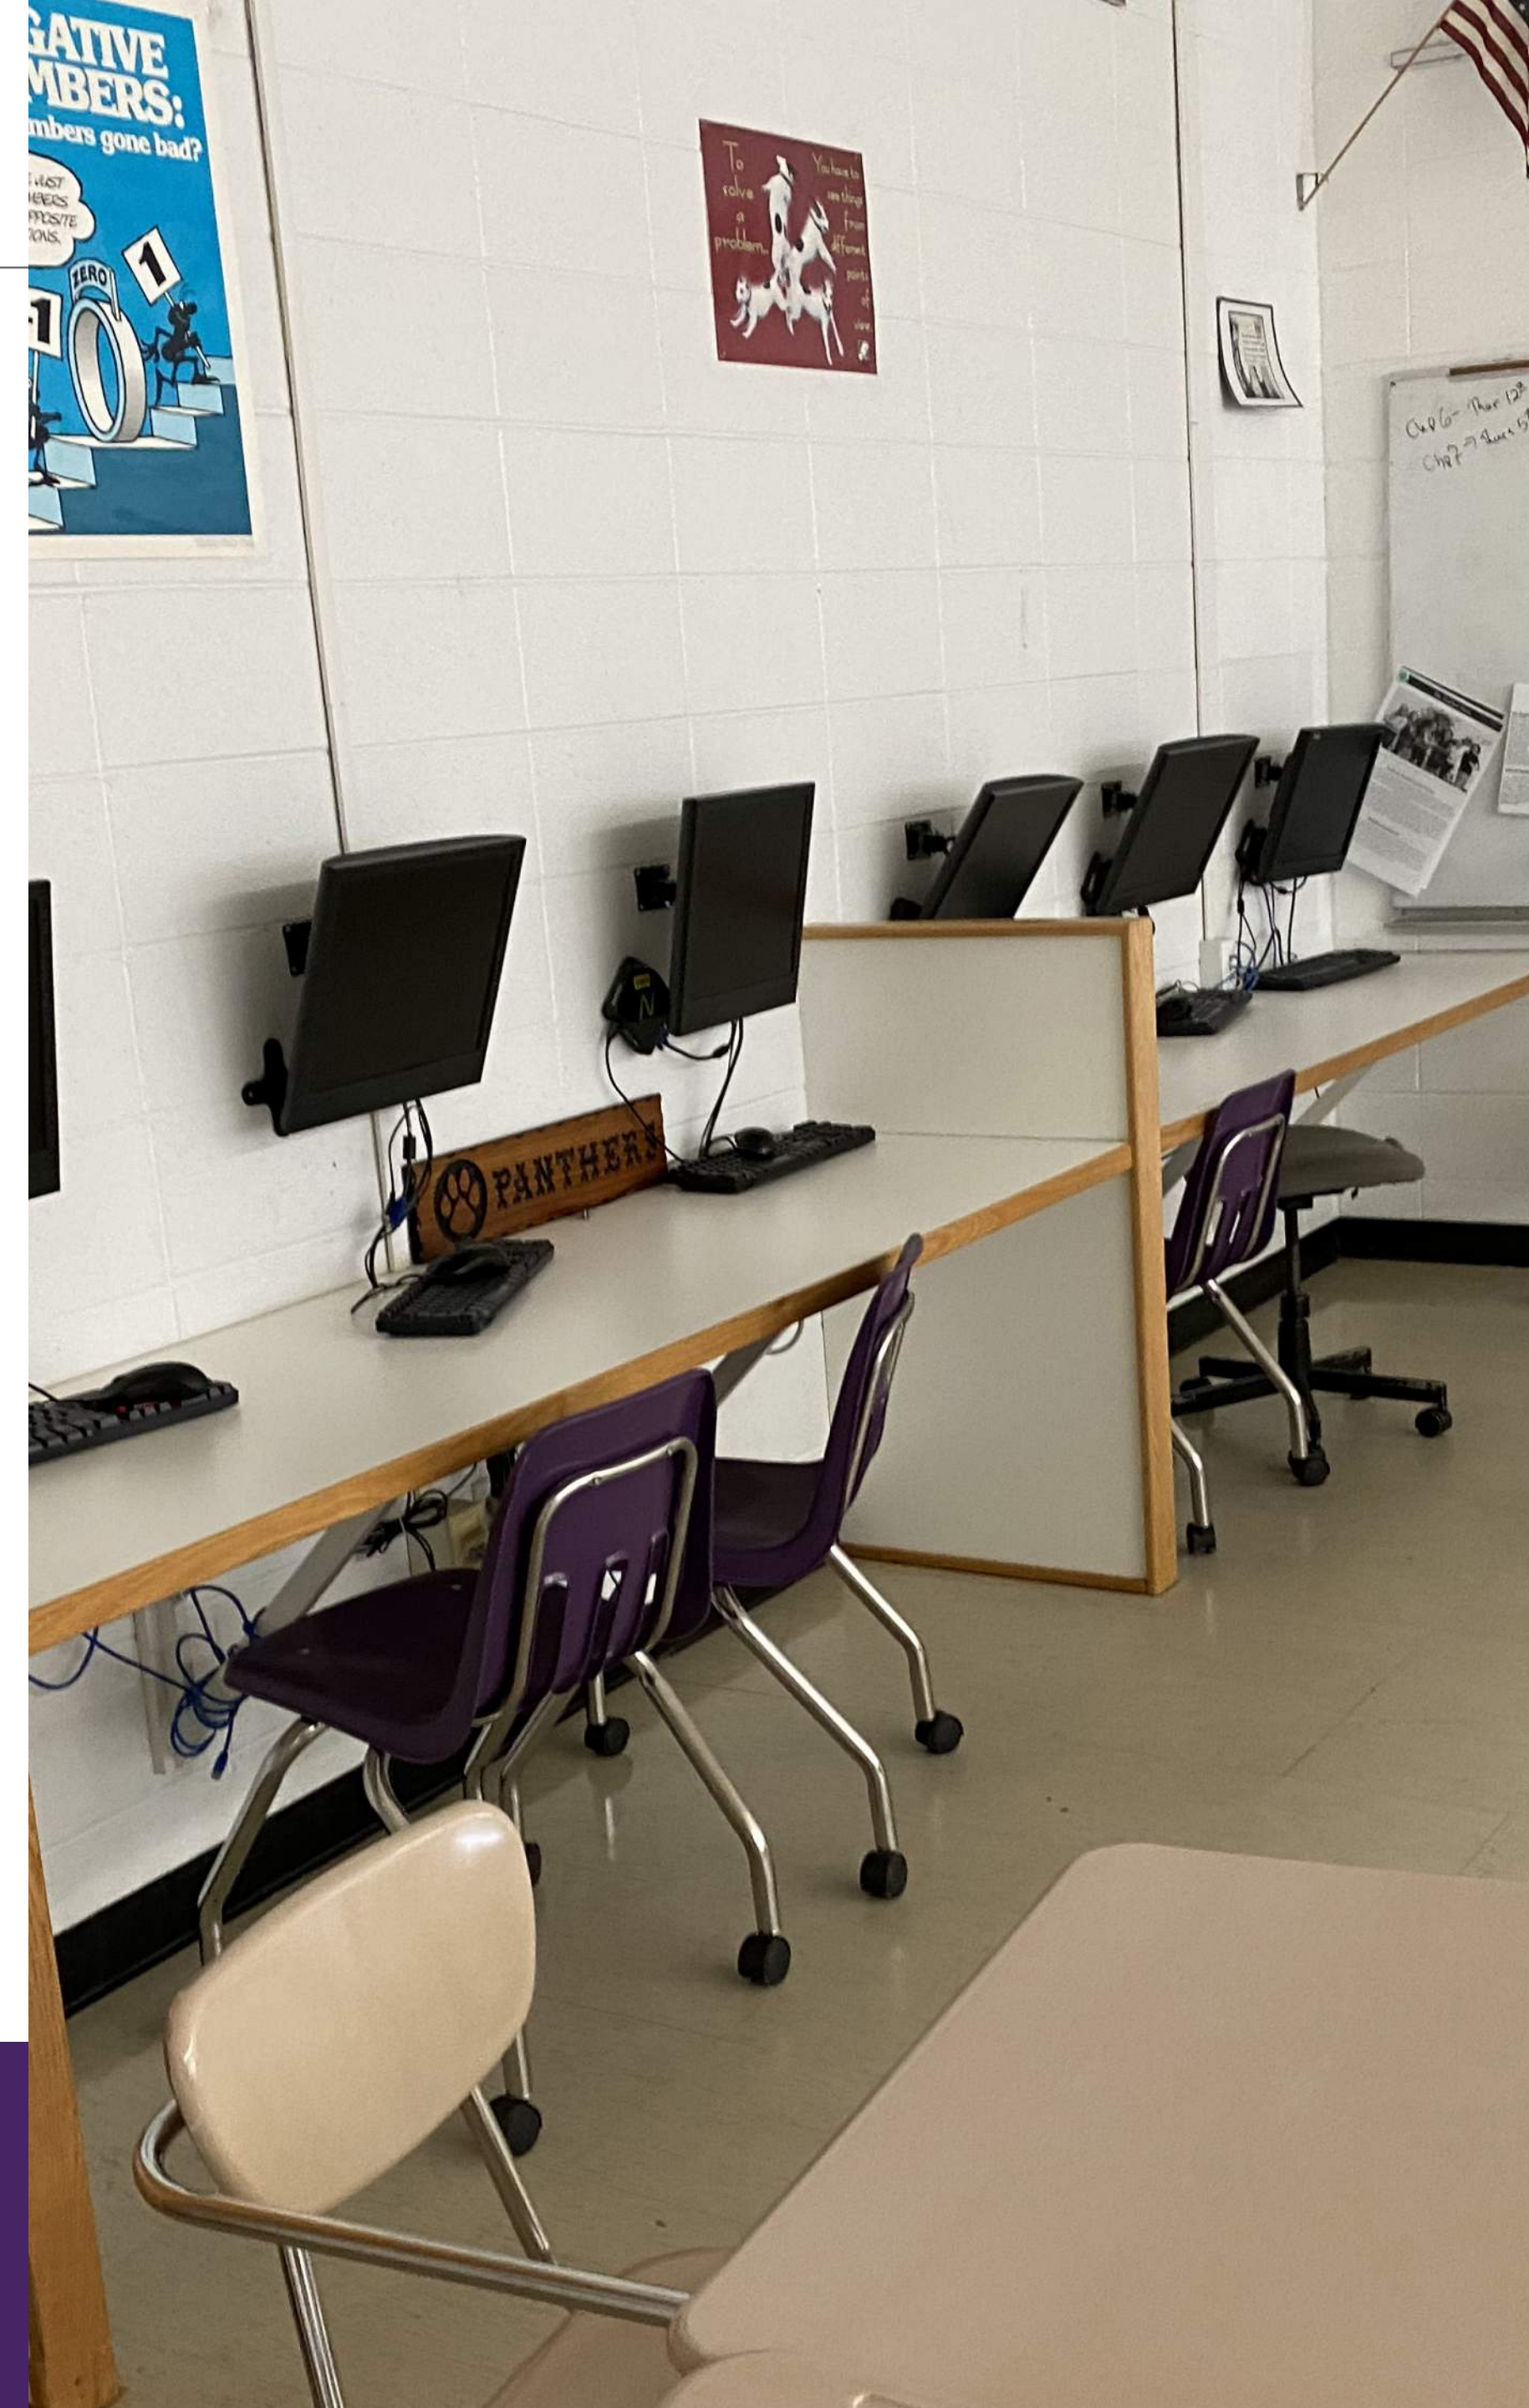
- District has retrofitted classrooms with many modern amenities, some technologies still lacking [ex: short throw projectors, USB, smart boards, TVs/AV systems]
- Clock/Bell system is aged
- Severe lack of electrical outlets throughout all classrooms – reported by teachers
- Ceiling tiles also have worn condition
