# BUILDING CONDITION REPORT

**JEFFERSON HIGH  
SCHOOL DISTRICT #1**  
July 21, 2020

SMA|ARCHITECTS

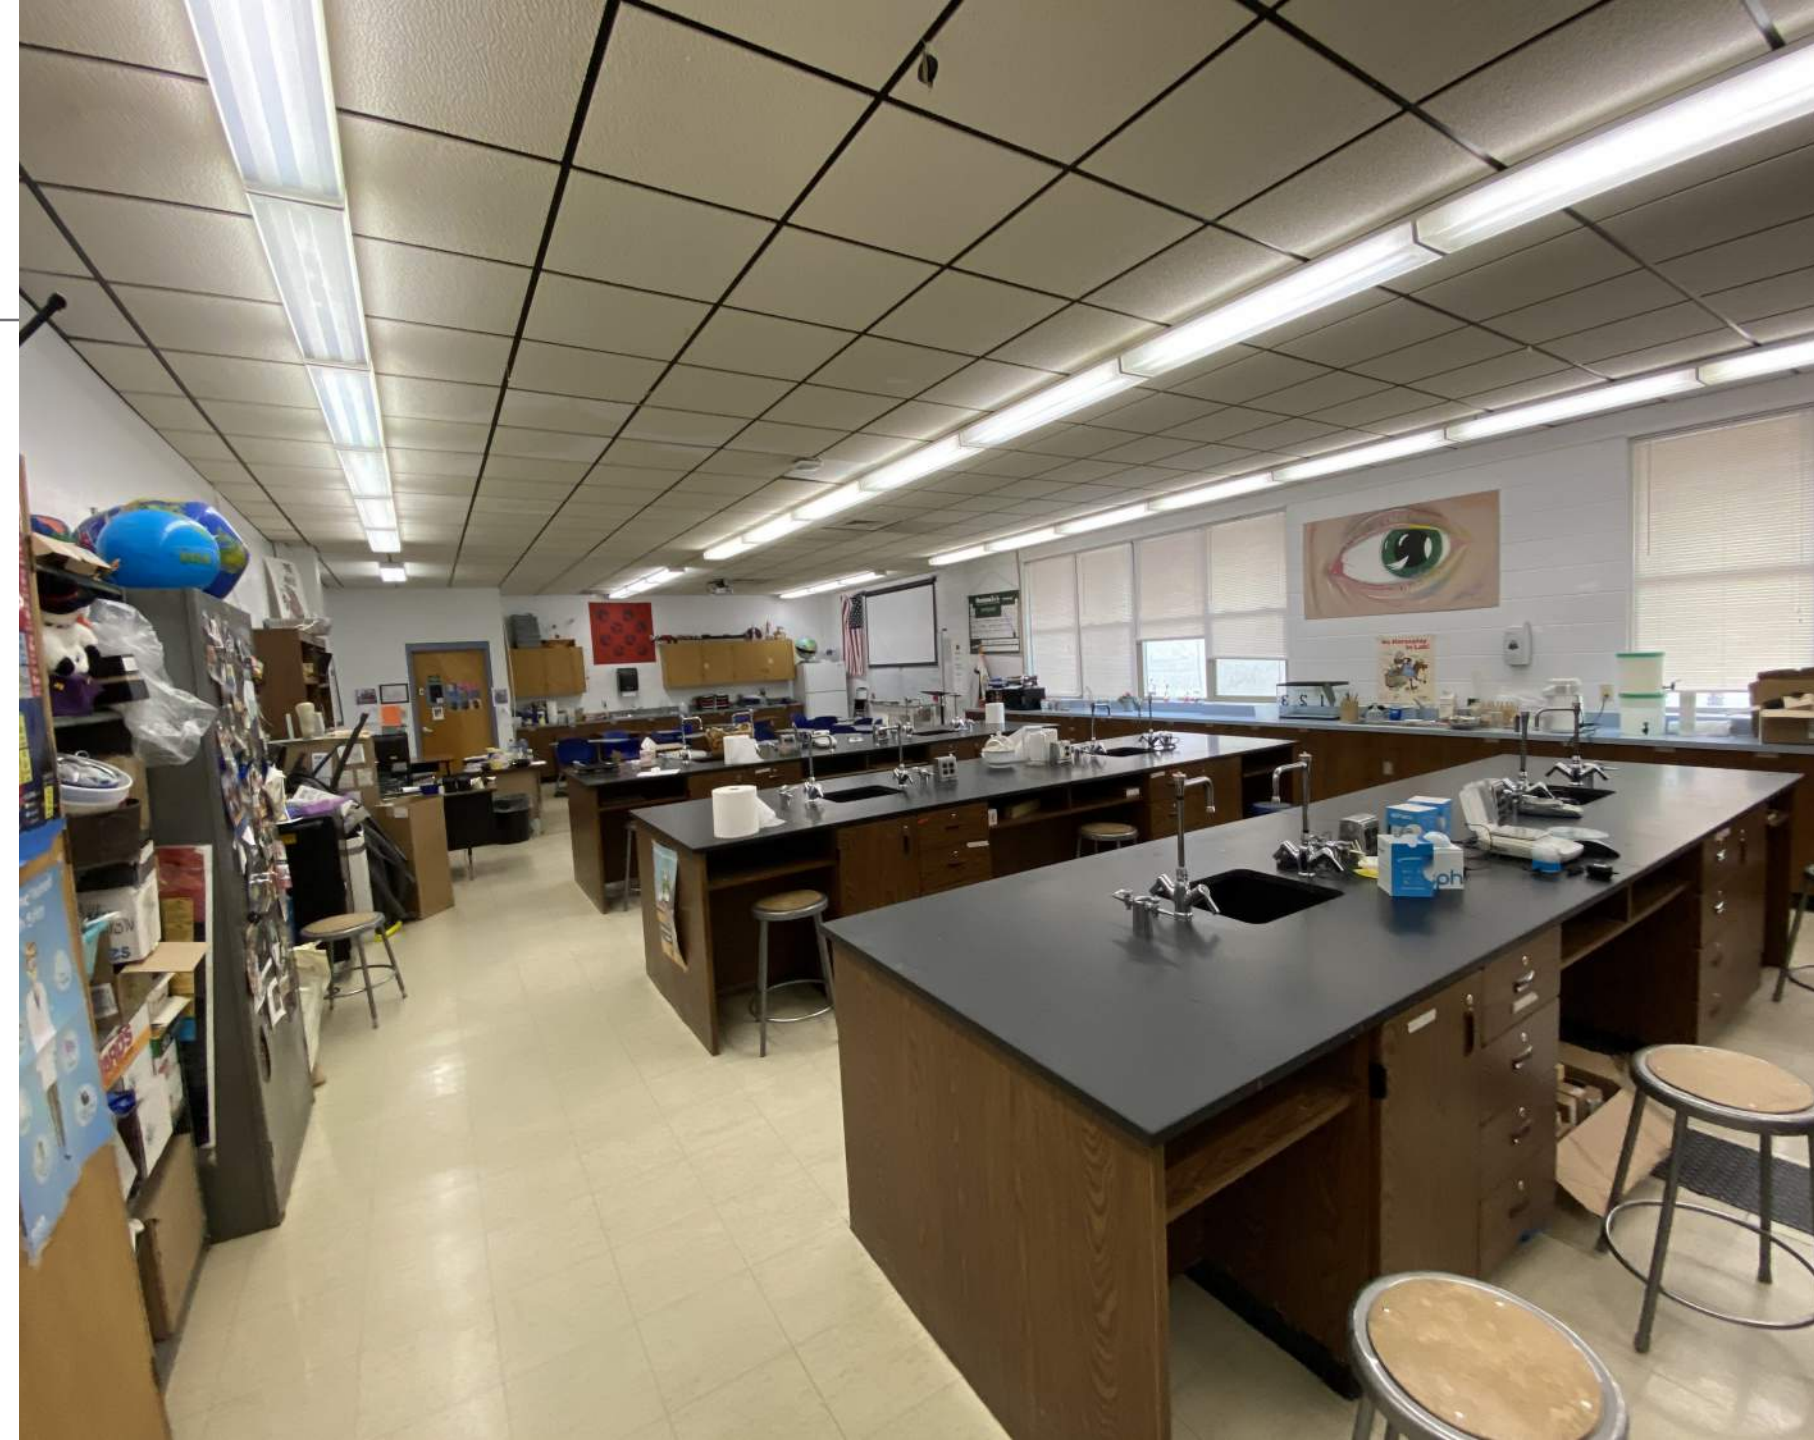
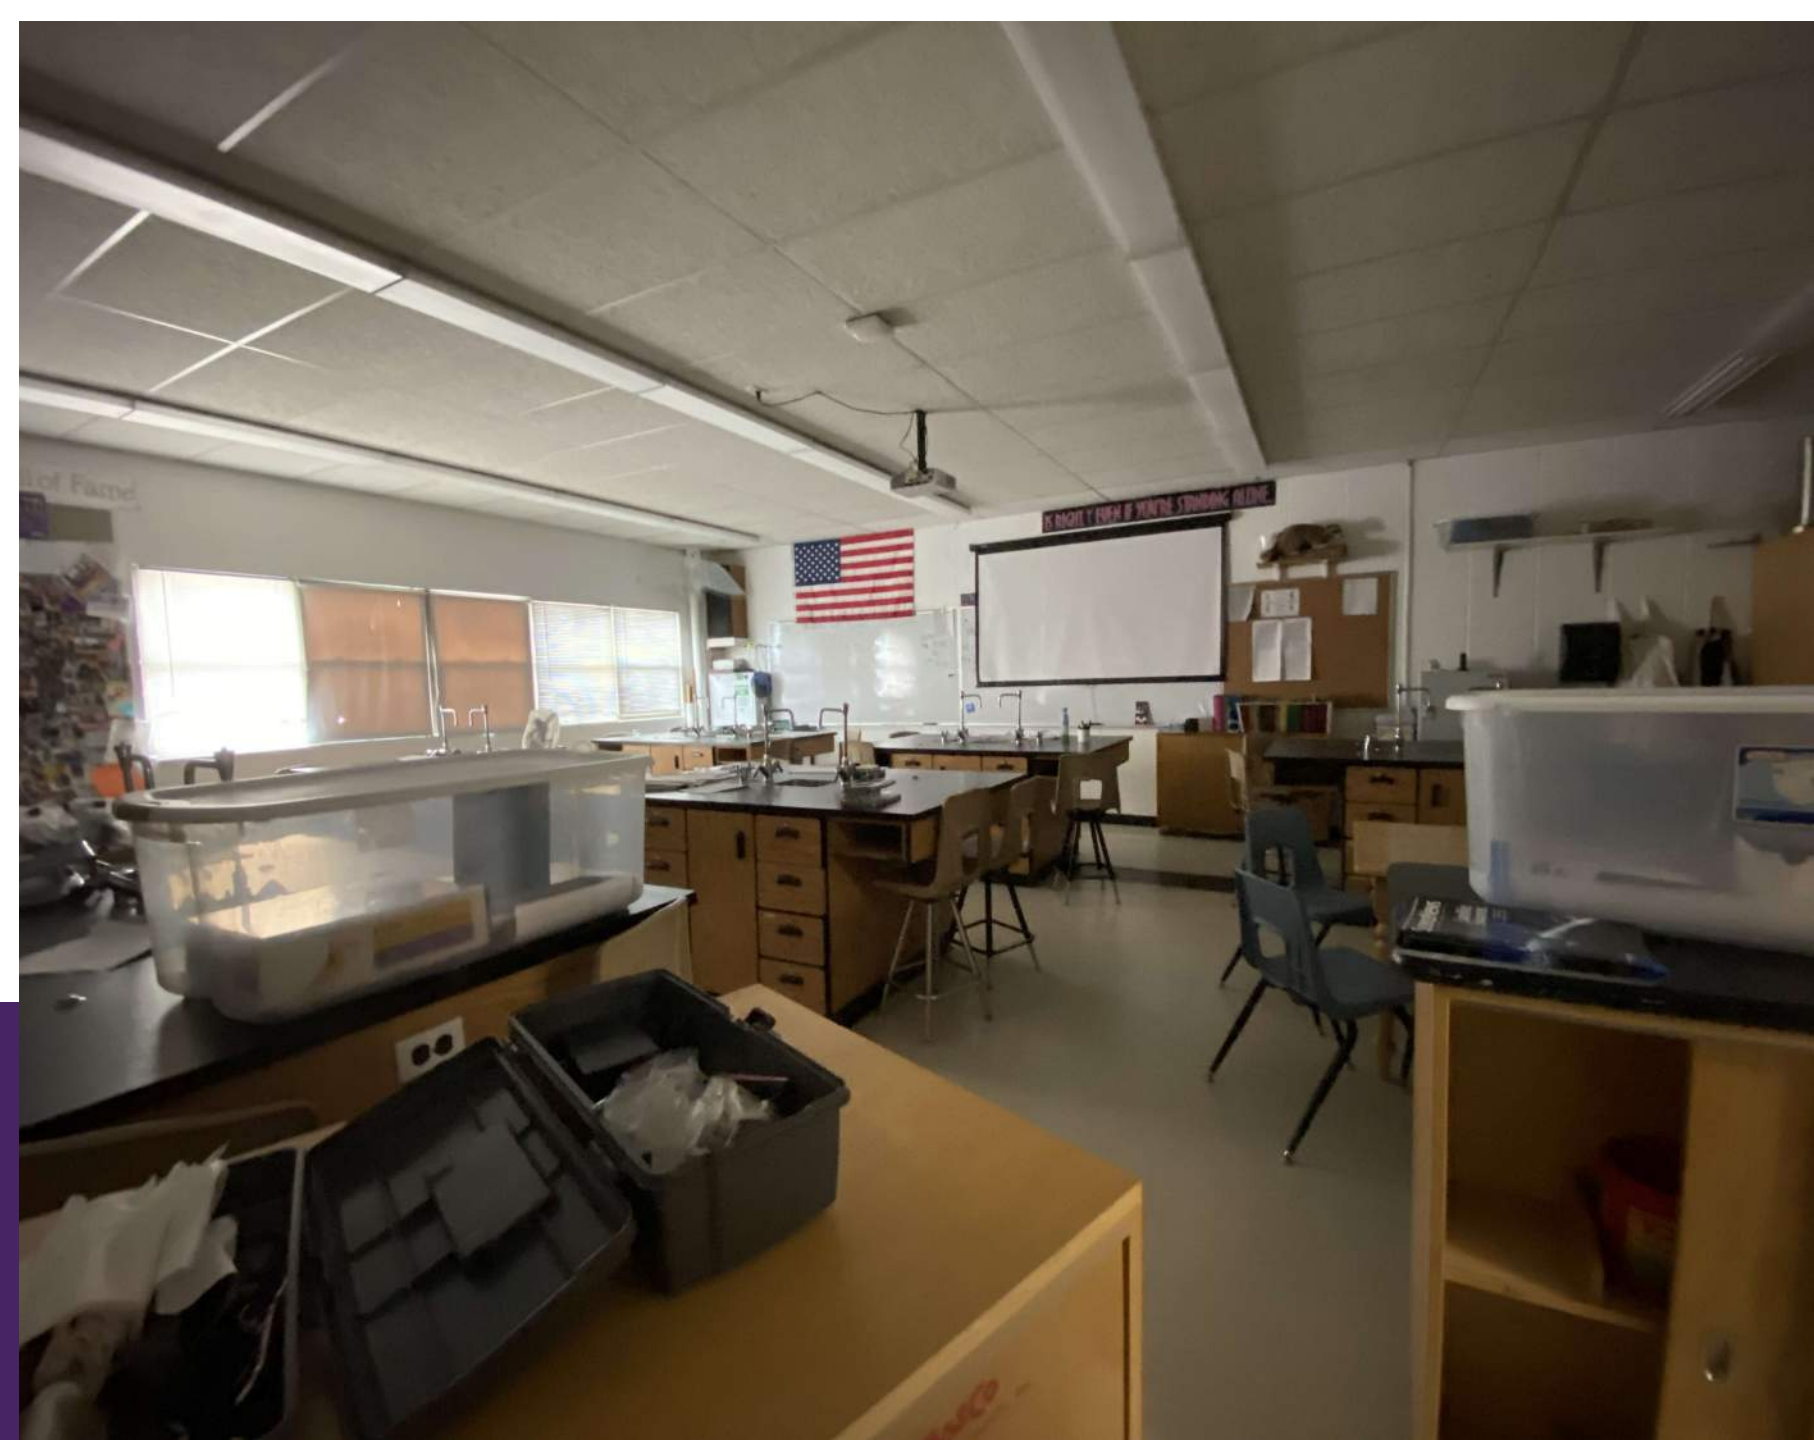
- Physical Science room is sized closely to modern schools at 1450sf
- Adequately equipped with eyewash and 2 exit doors
- Life Science is much smaller at 885 sf, including lecture and lab space = severely undersized
- Recommend 60 sf/person for science activities [MT standards of 1800sf for 30 max students]
- Inadequate exhaust

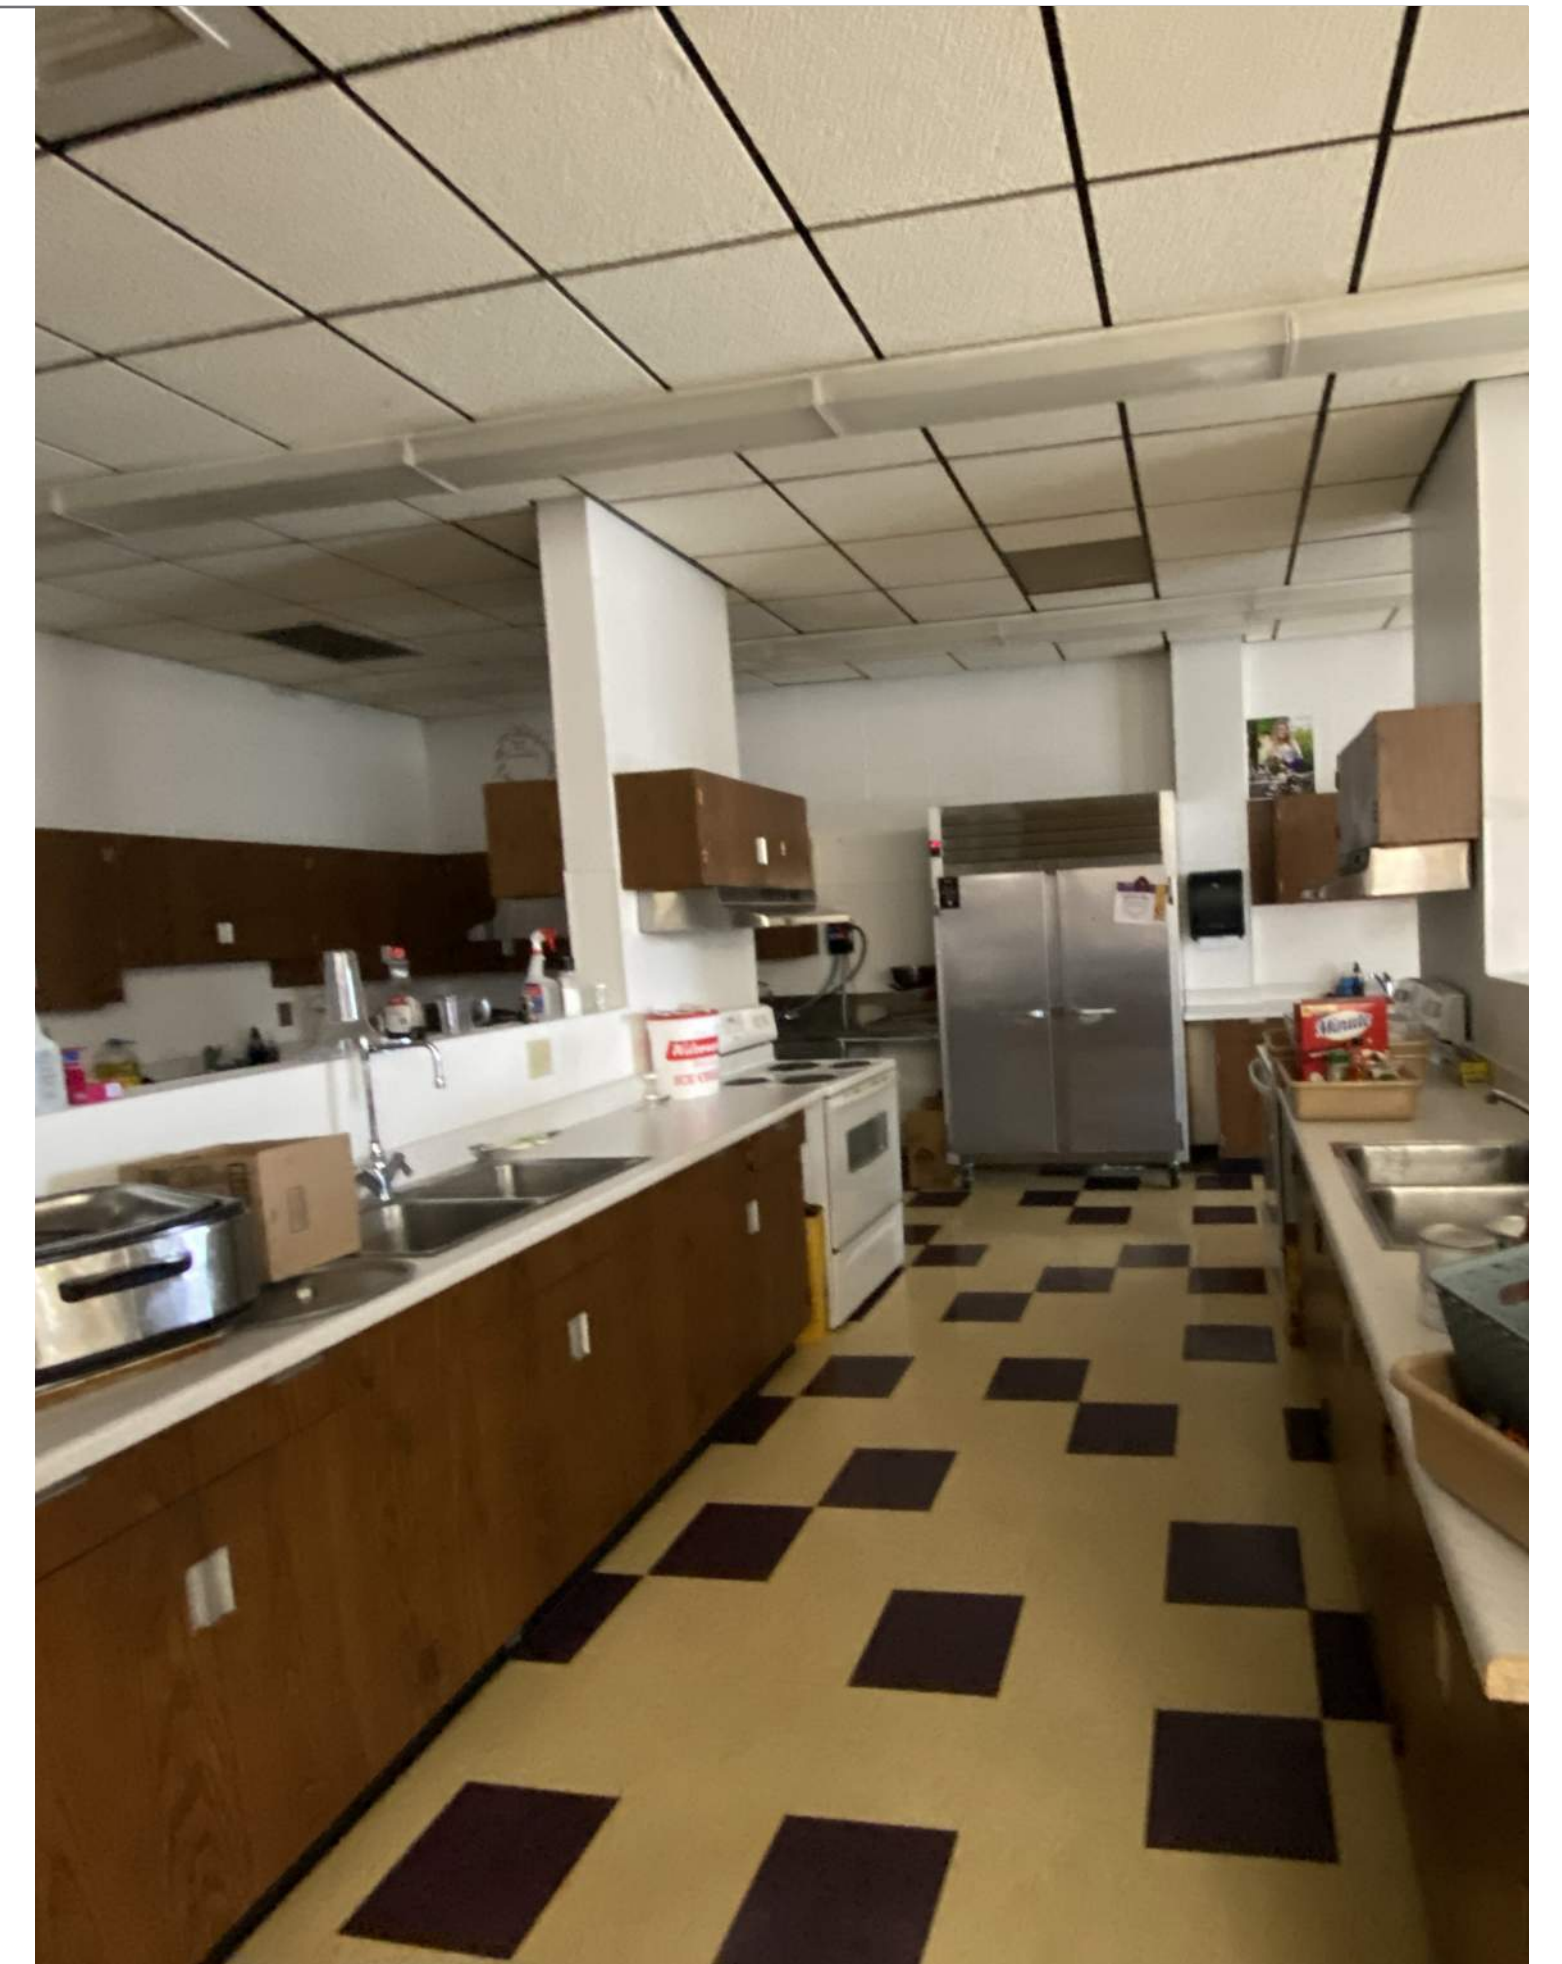
- 1800 sf is adequate by modern standards  
[recommend 60-65 sf/student]
- Quantity of equipment and frequent use by food pantry and breakfast program increases usage
- Finishes in moderate to worn condition
- Combination of consumer-grade and commercial-grade equipment
- User groups indicated additional kitchen units are needed and ventilation is a concern
- Program is growing in popularity and will need continued investment

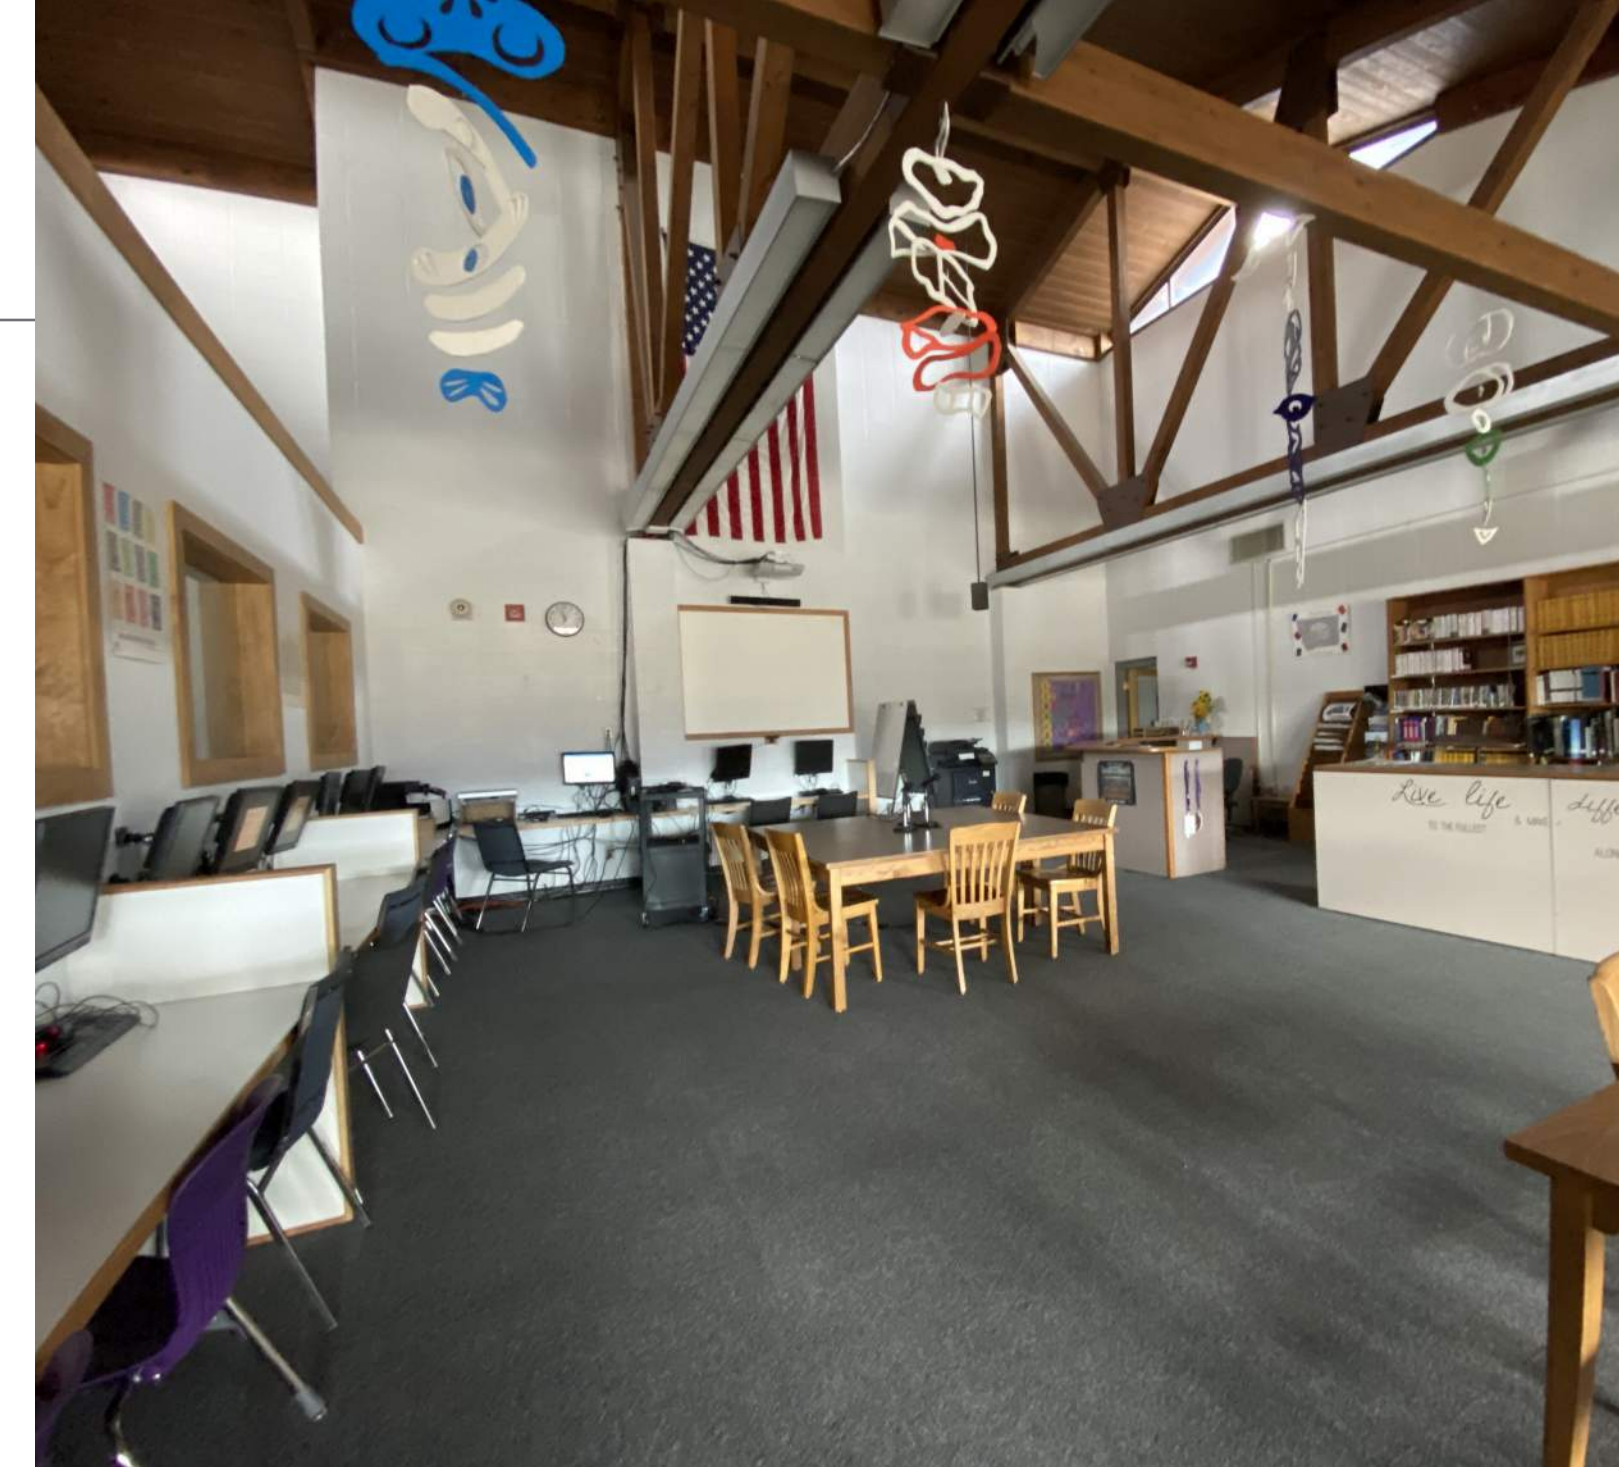
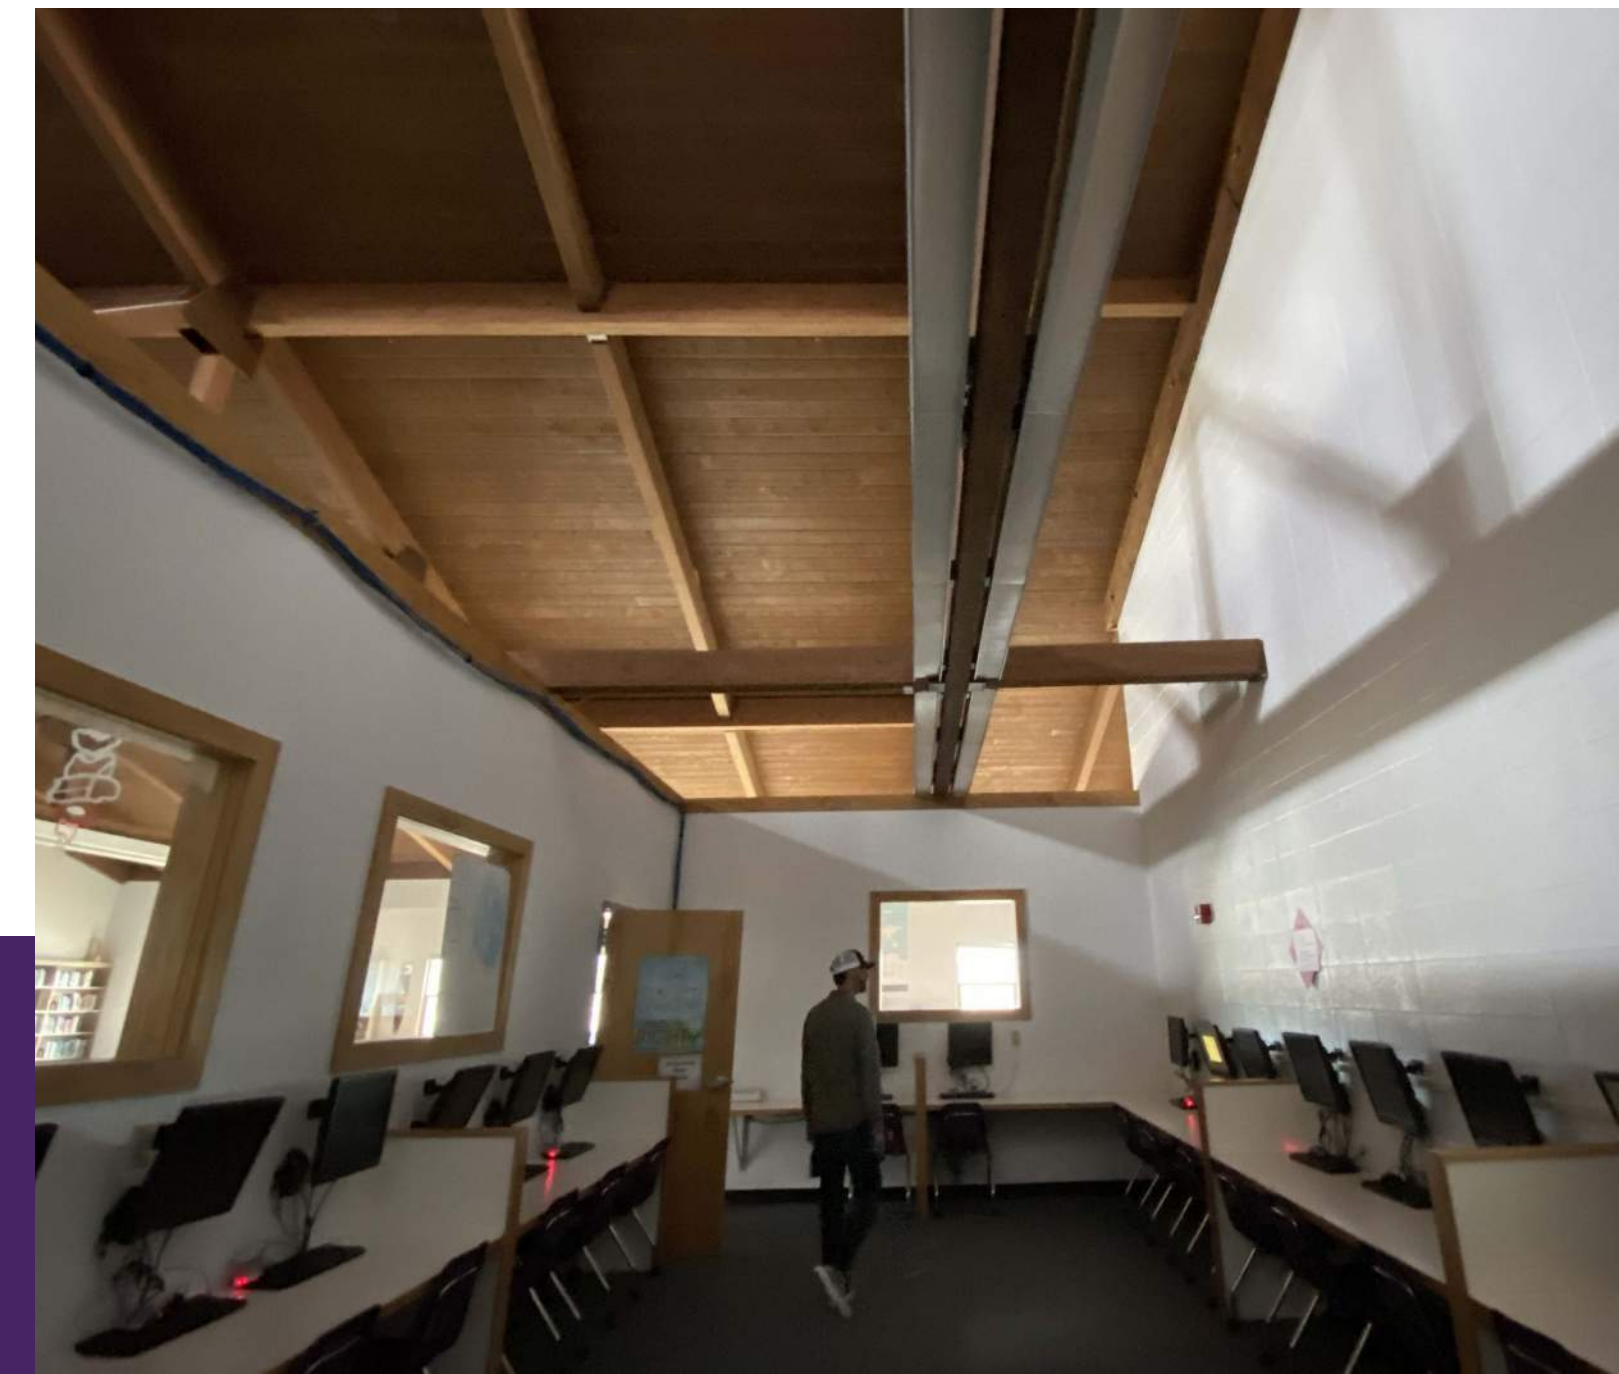
- Nice high ceilings, with nice finishes (wood truss and nice lighting)
- Main circulation counter not ADA
- Noise between the Library and Computer Lab are a common complaint
- Regulating temperature is difficult with computer and occupant heat. Unable to utilize windows if buses are queued outside

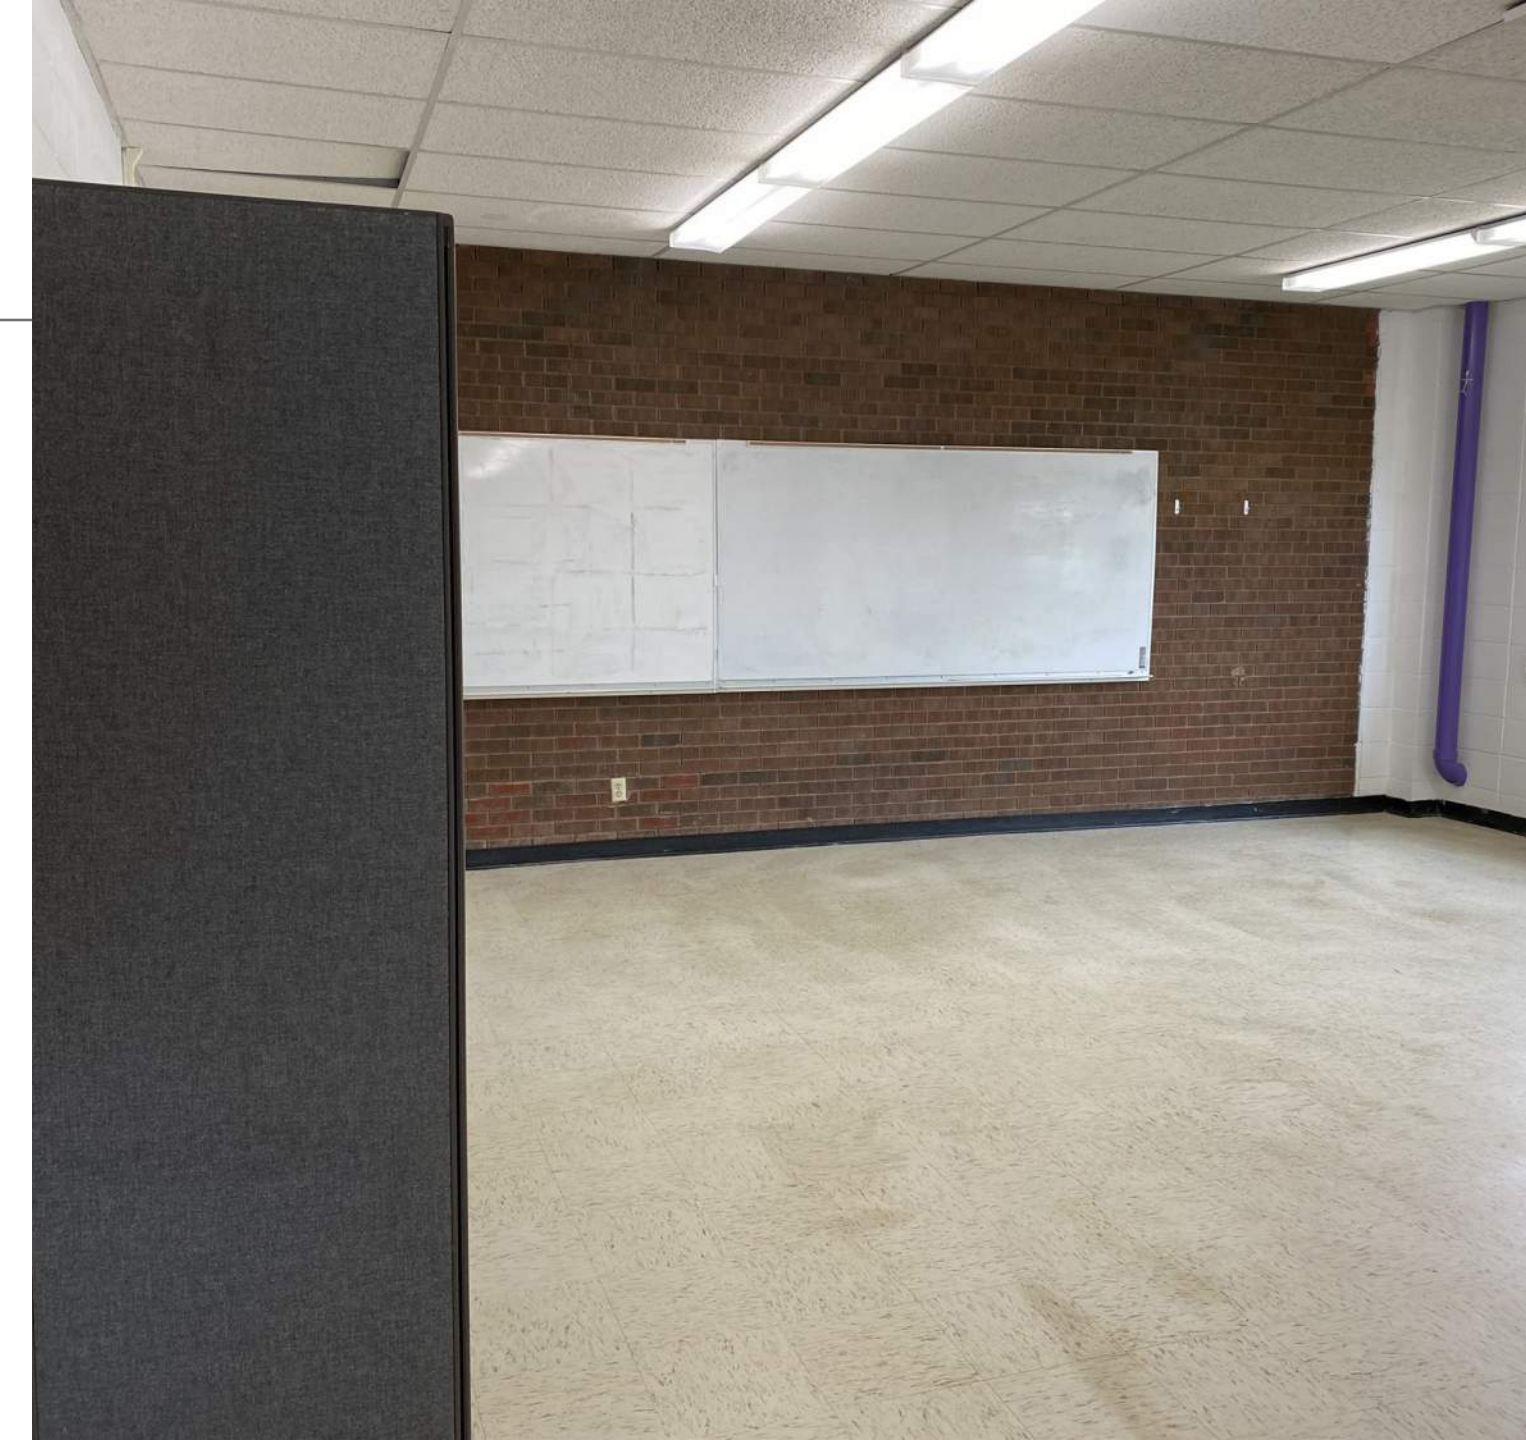
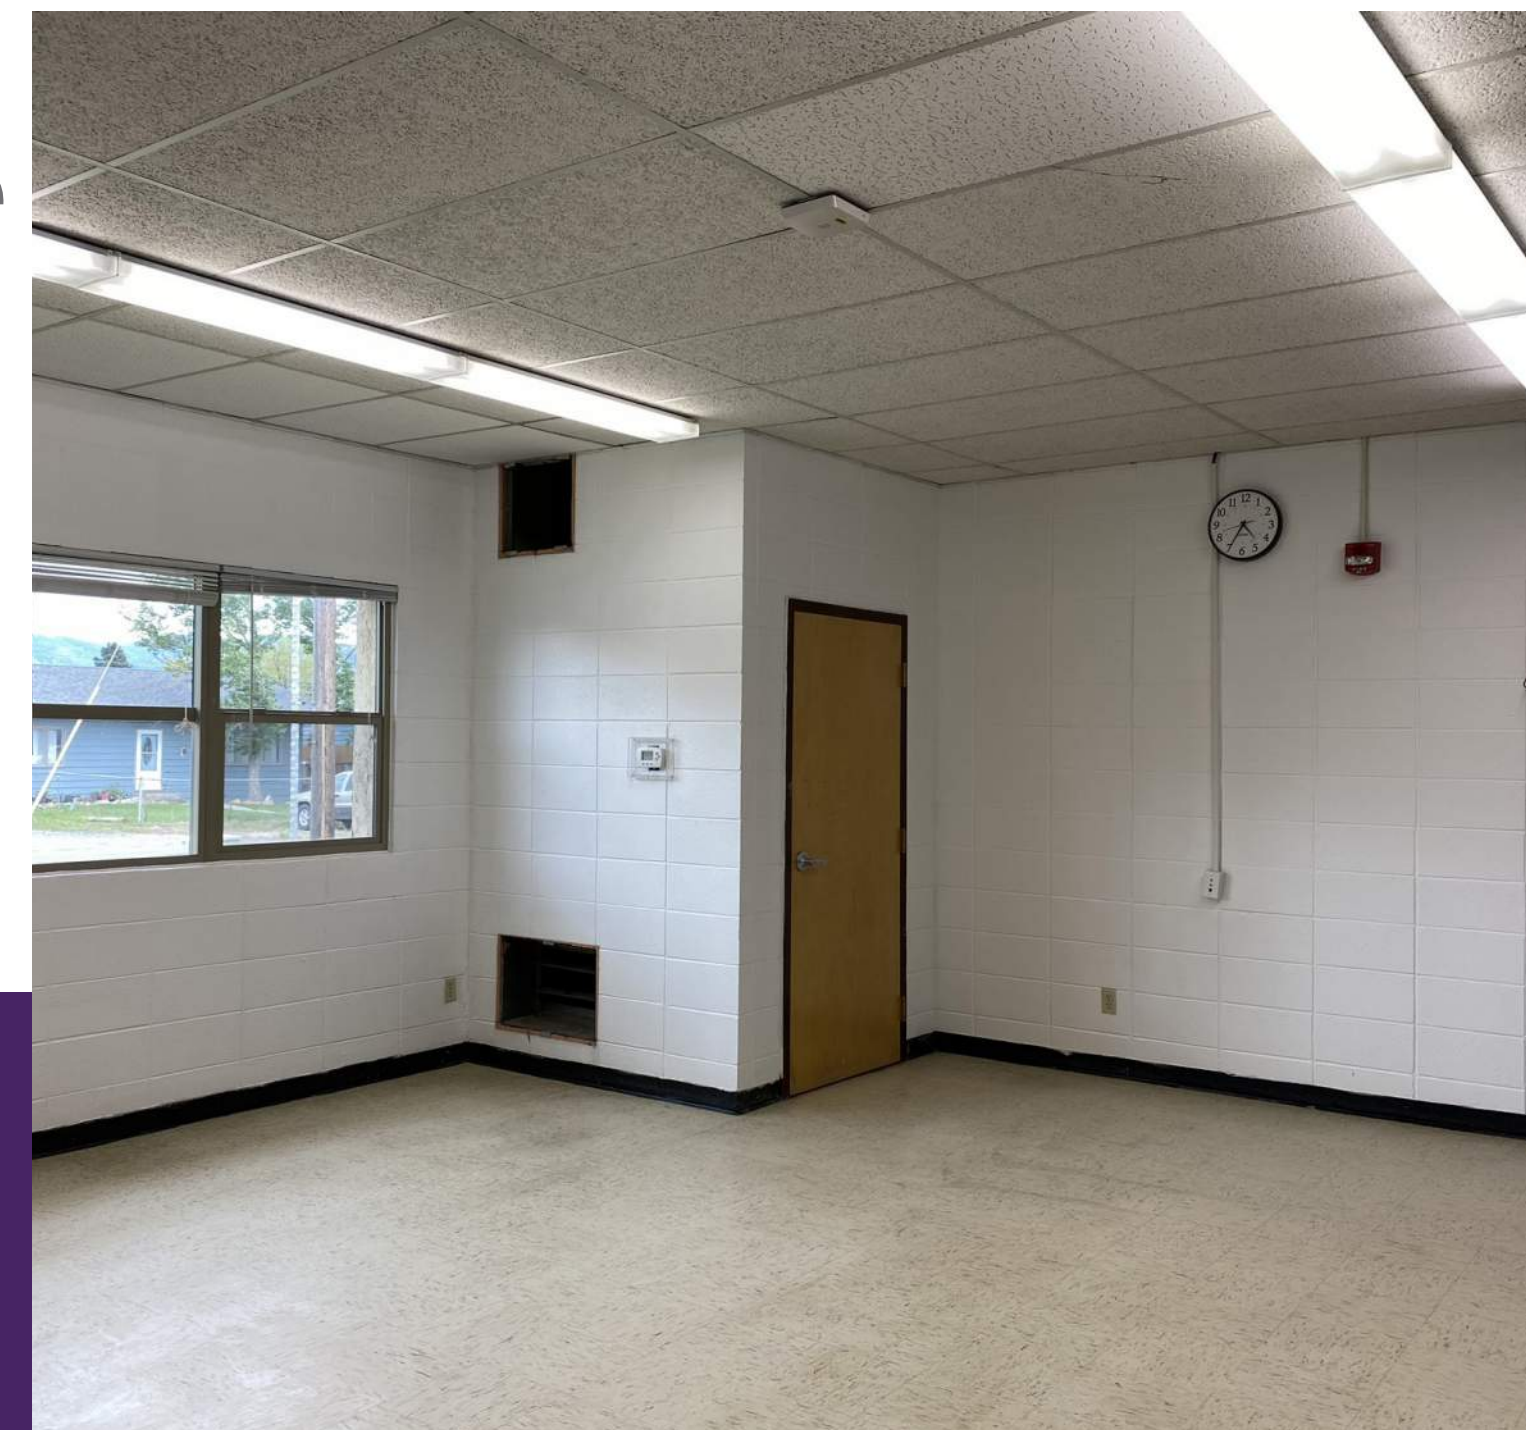
- Special Ed is not equipped with the spaces many modern schools have, including: separation spaces, calming rooms, life skills, private bathroom
- Privacy and crowding were heavily cited concerns
- Need for dedicated sensory room
- Better ventilation needed
- Dedicated restroom needed
- Life Skills opportunities would be a benefit (kitchenette and washer/dryer)
- Overall space is too small for student population.
  - Current room is ~400sf. Helena Elementaries have 1500-2000sf, EHHS has 1650sf = 80-110sf/student.

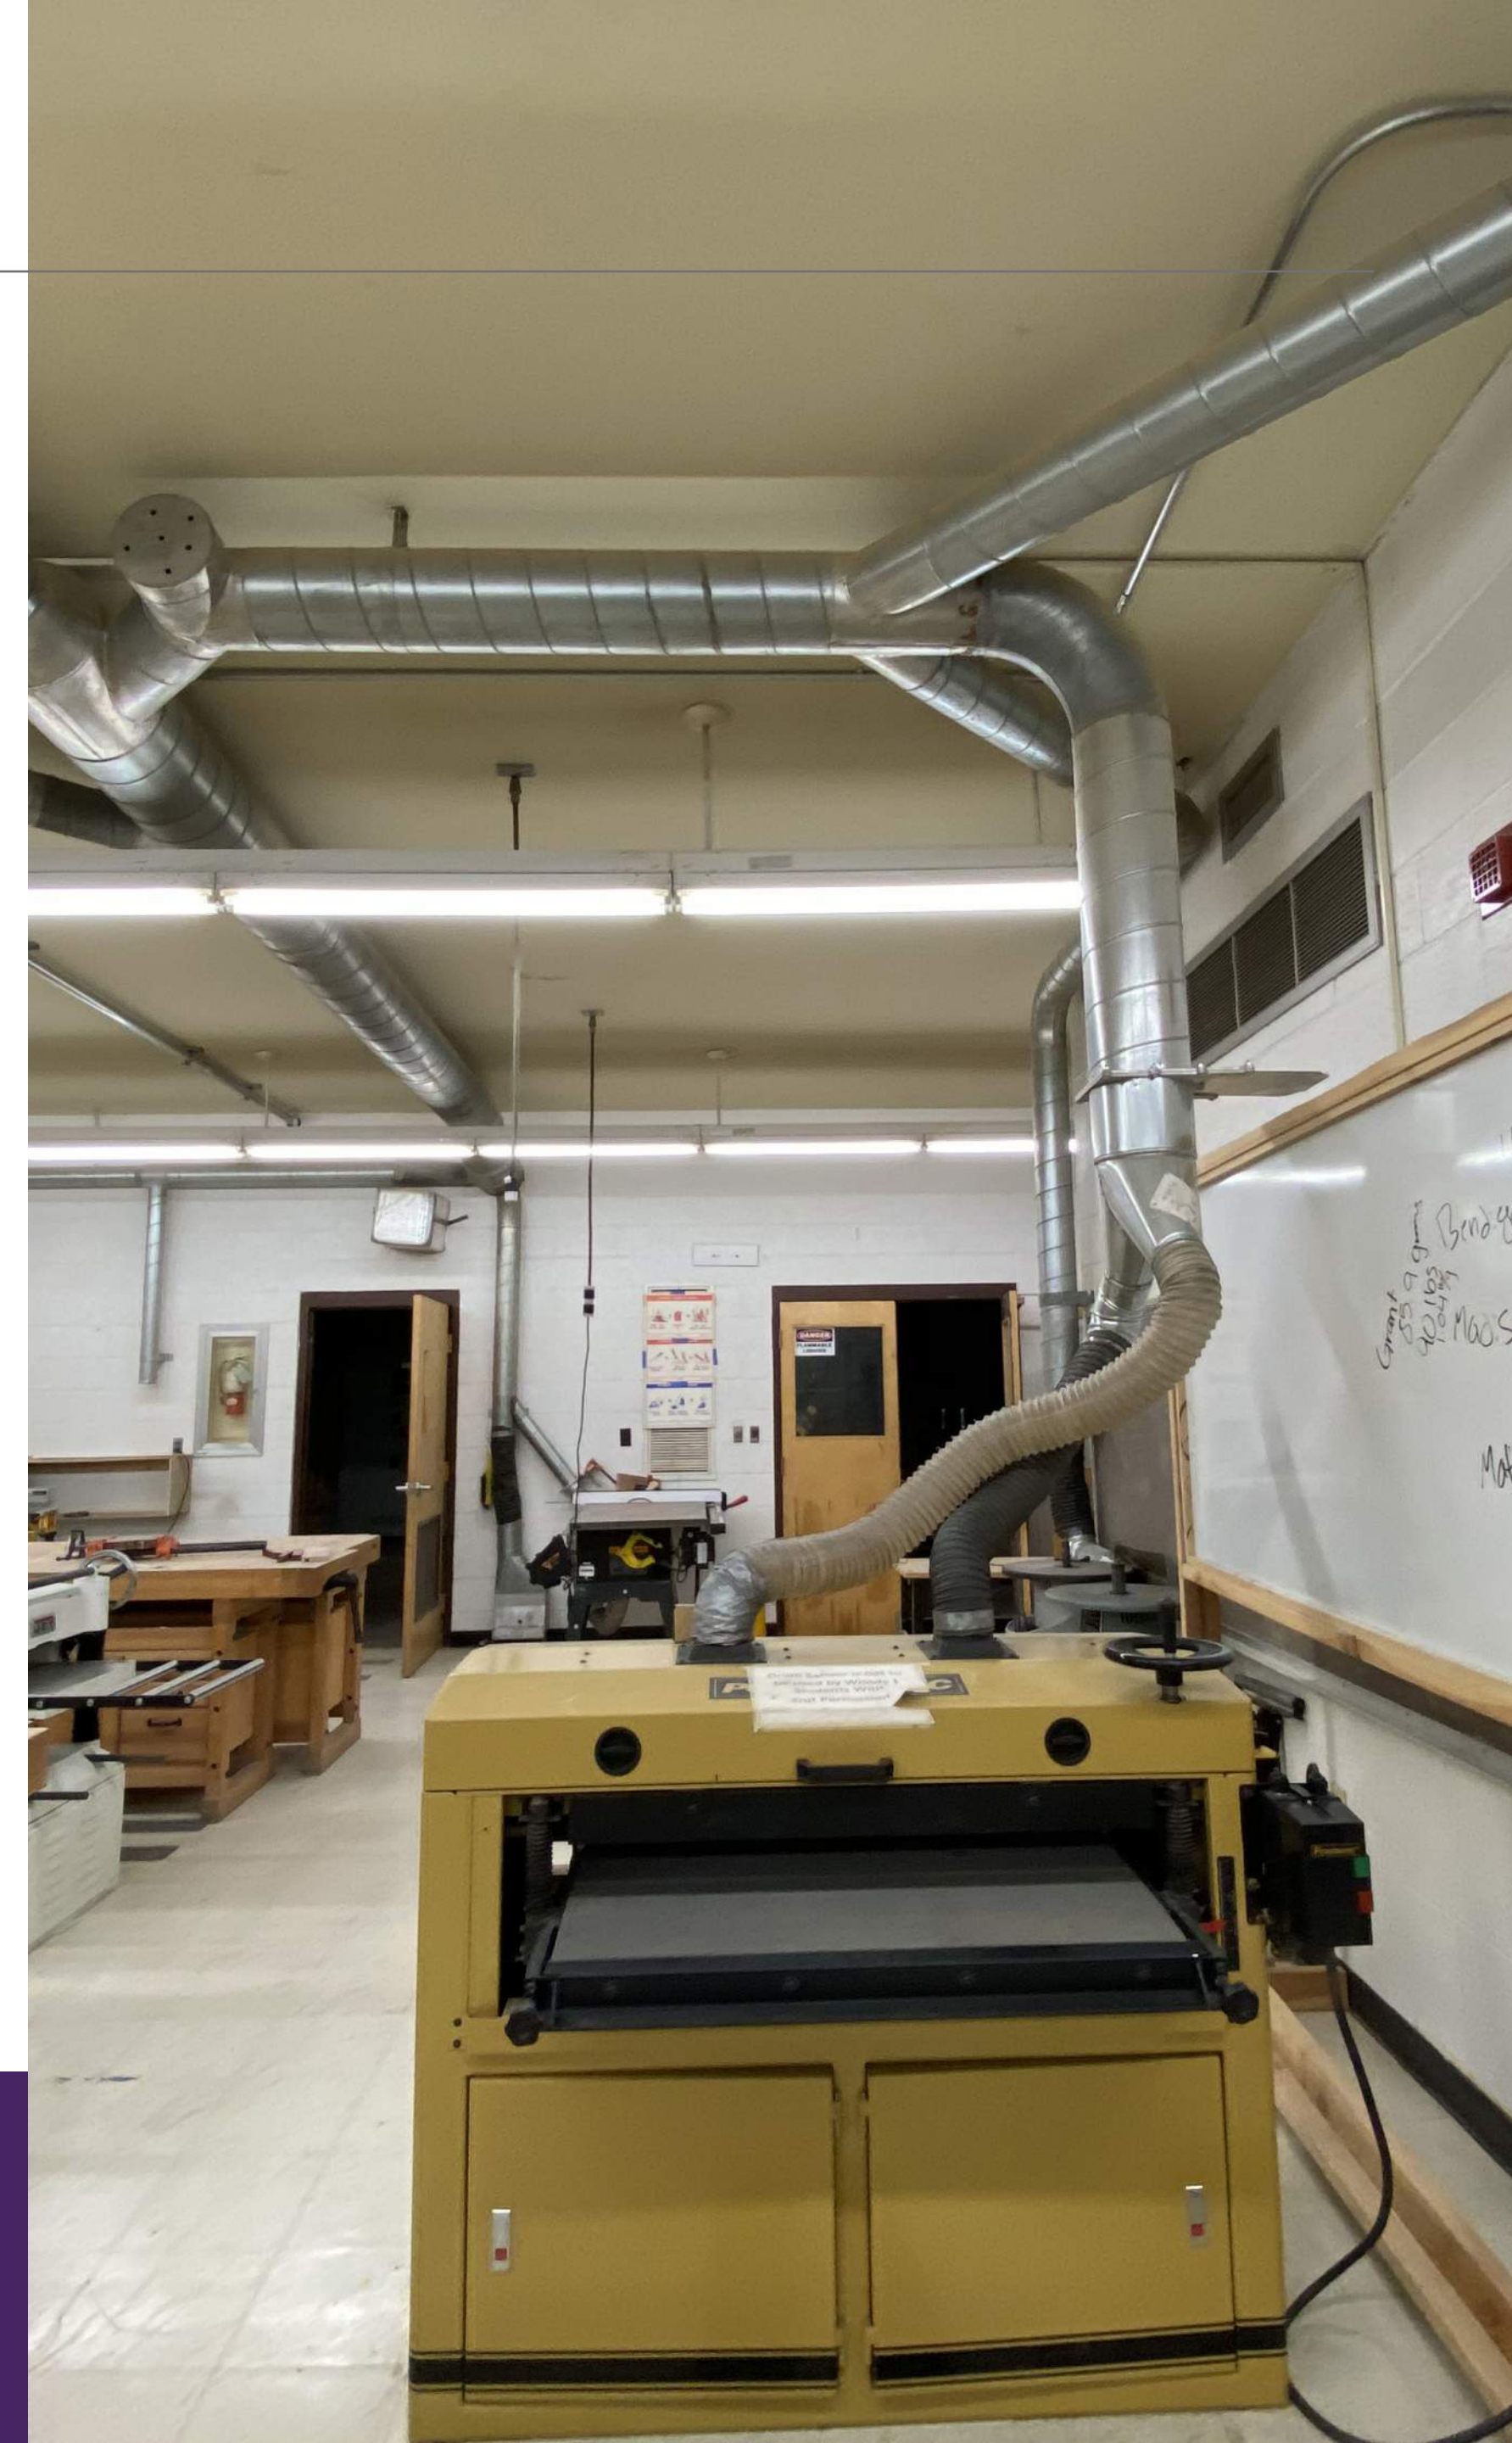
- Location and spaces currently serving their uses well, have good equipment and overall a good space for the programs overall.
- Floor finish can be hazardous in work conditions with sawdust present
- Light control for video presentations is needed
- Storage / spray room combination causes overspray issues
- Size of spaces appropriate for current class numbers
- Small Engines: ventilation of fuel vapors concern for danger of fire or explosion near welding
