# BUILDING CONDITION REPORT

**JEFFERSON HIGH  
SCHOOL DISTRICT #1**  
July 21, 2020

SMA|ARCHITECTS

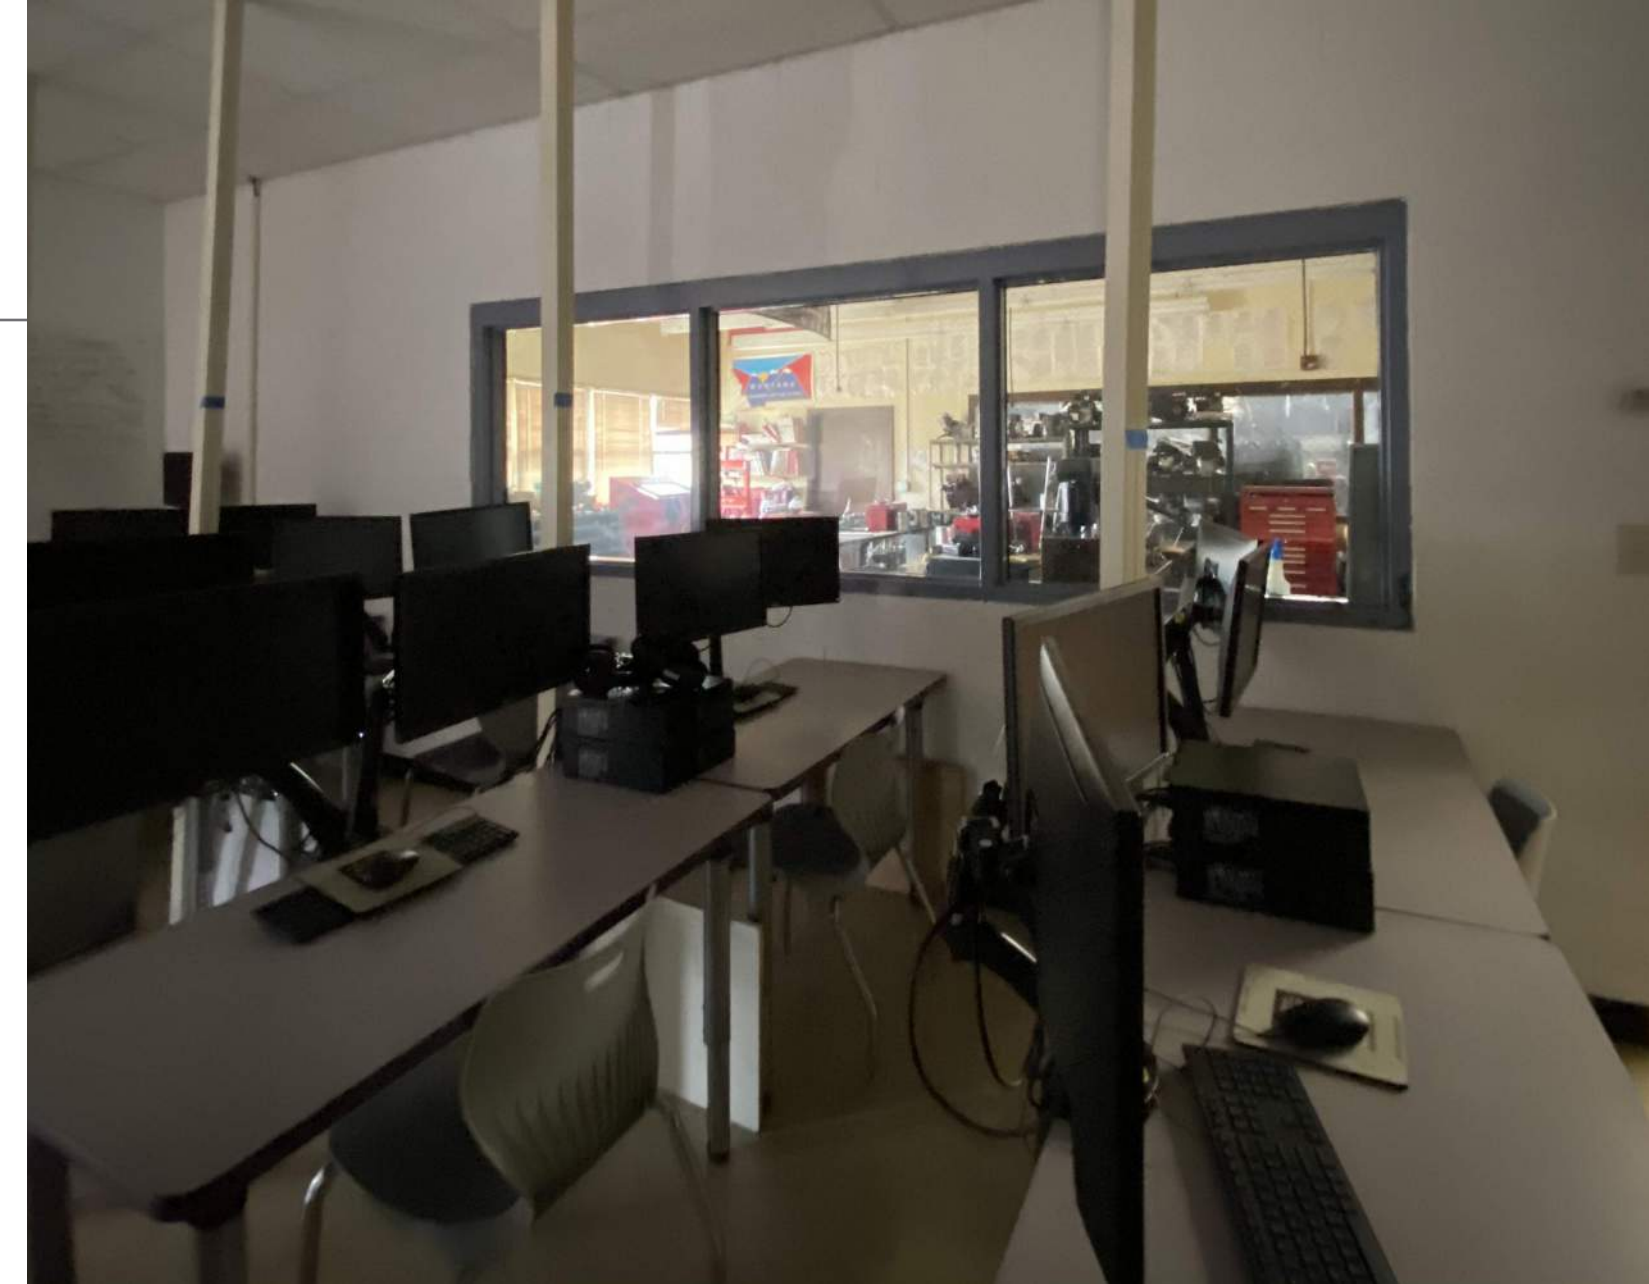
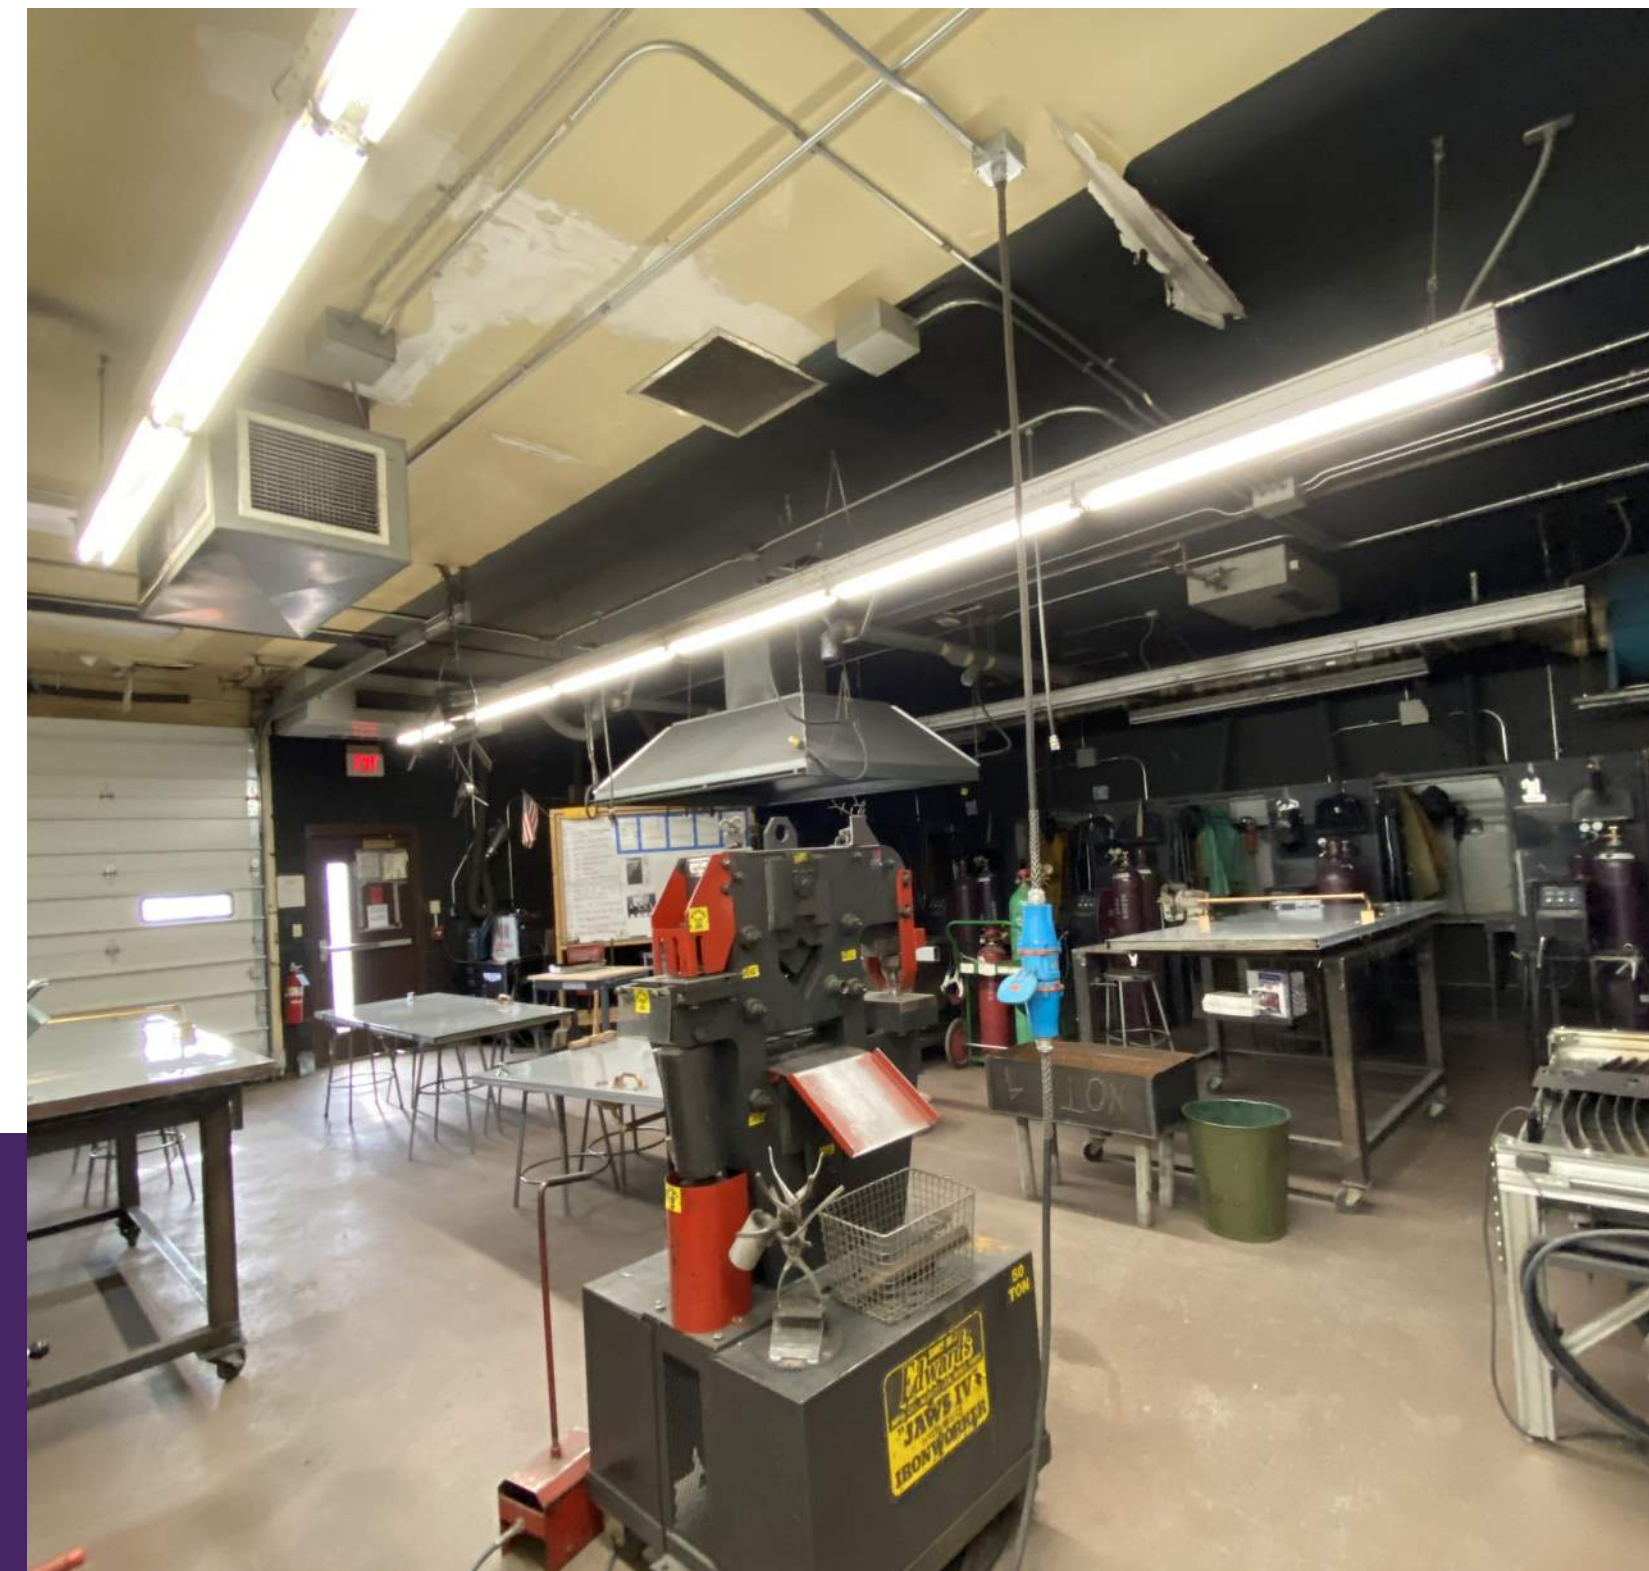
- Welding: room limits arrangements, # of welding booths is not enough, fabrication capabilities limited
- CAD Lab: good equipment/technology, access and circulation due to floor plan is difficult and can be busy
- Overall
  - Electrical outlets severely limited
  - Lighting dated and inefficient
  - Storage is undersized
  - Number of breakers in shop area makes it difficult to track down a failure

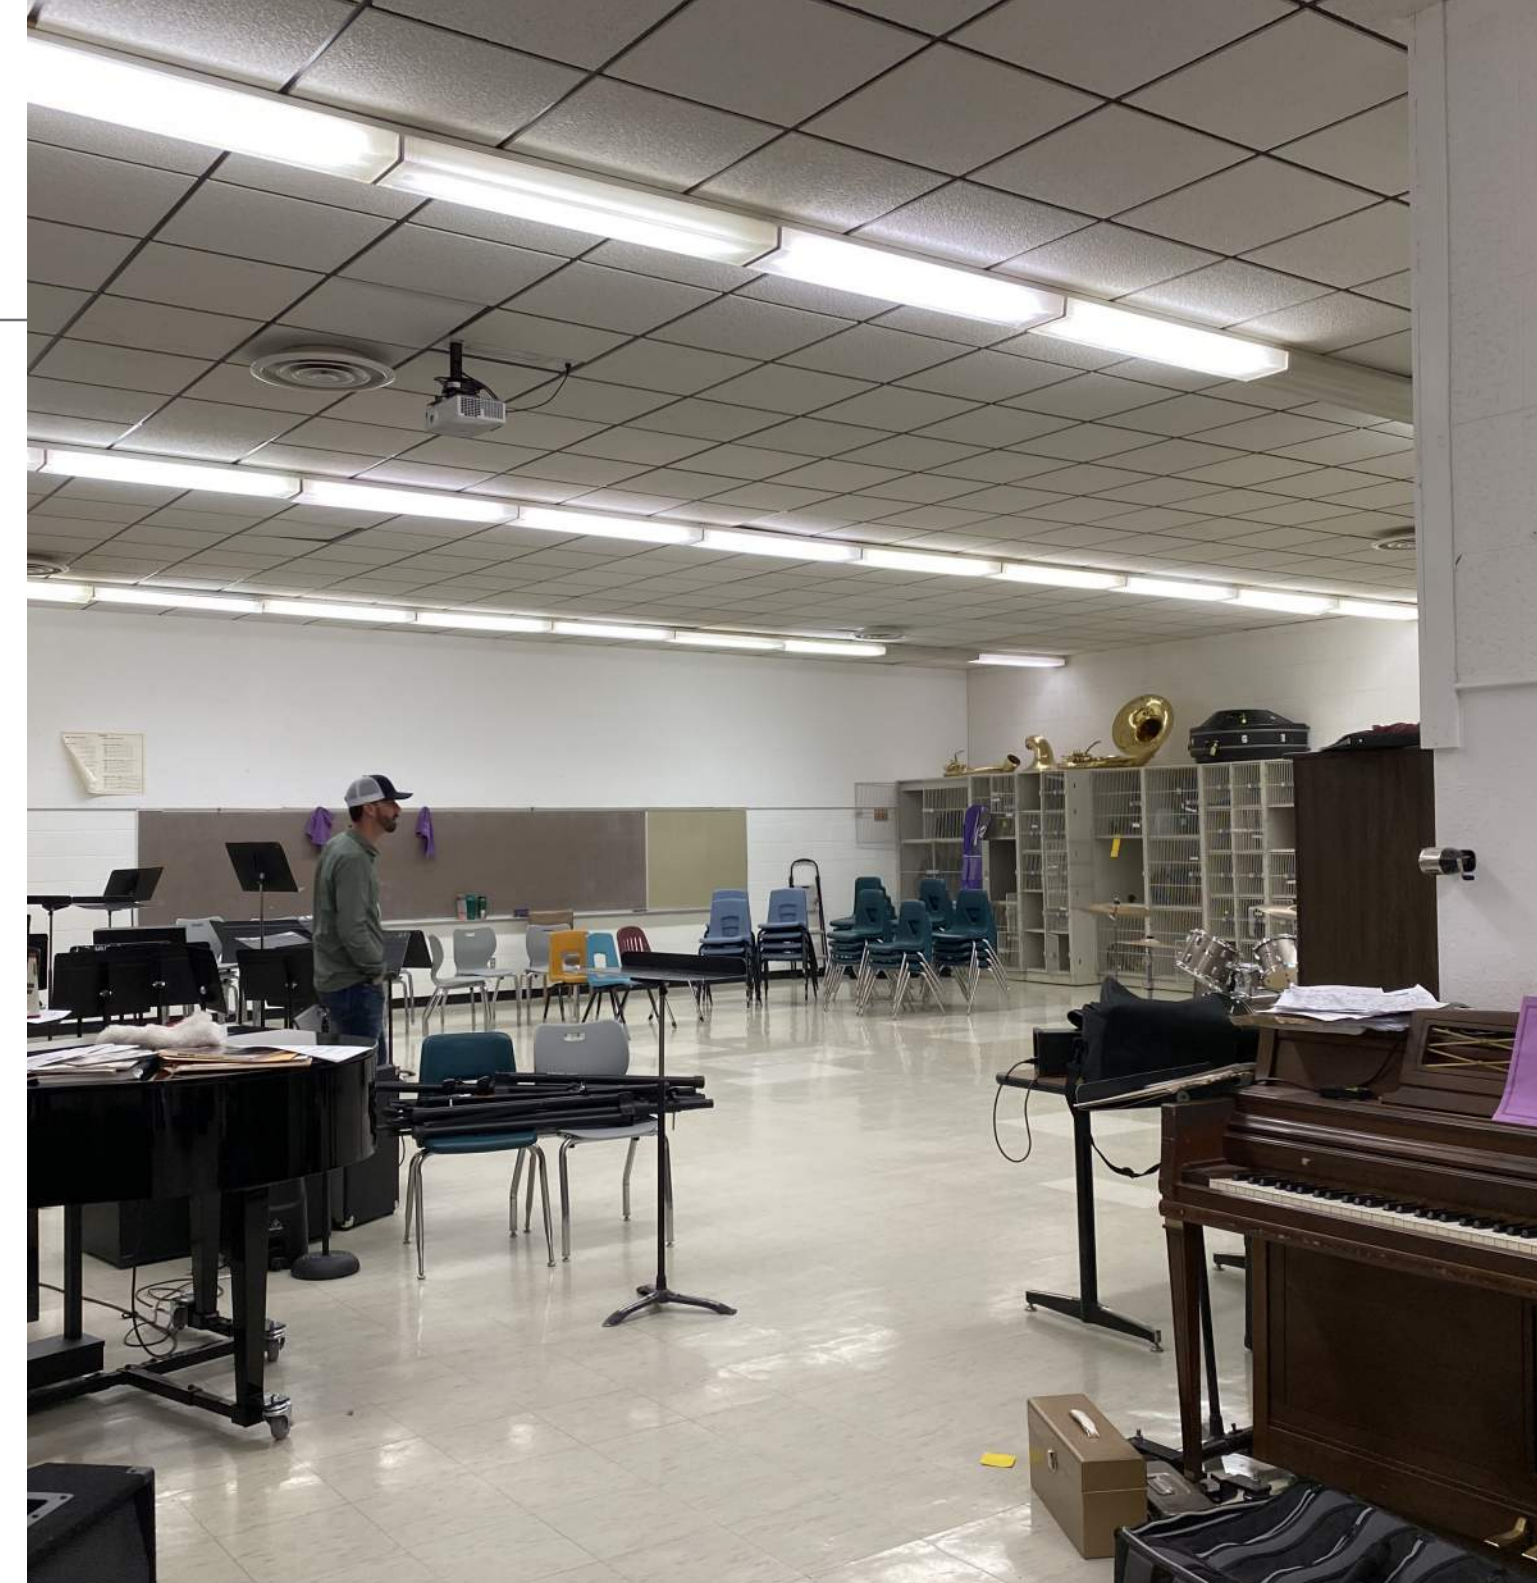
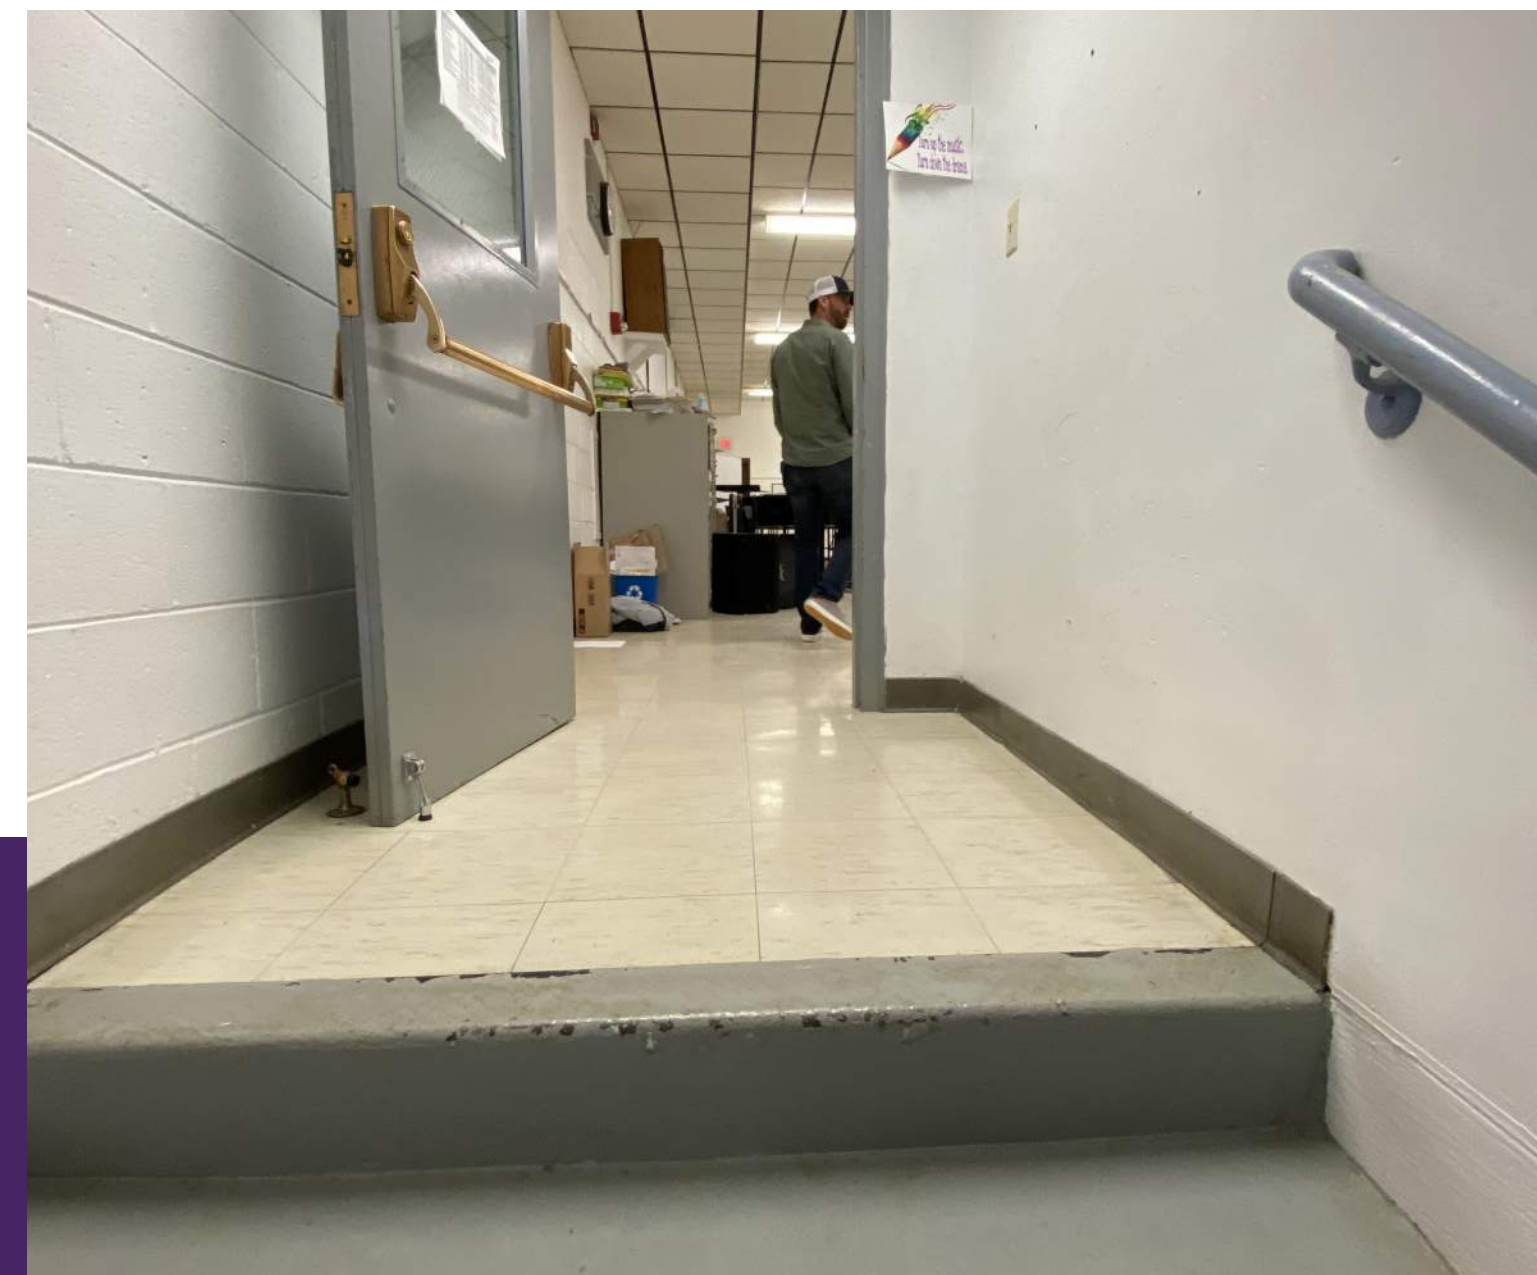
- 2700 sf total with adequate space for seating, storage, chairs and office space
- Acoustical treatment is adequate but could use some improvements if sound quality dictated
- Room/s not ADA accessible

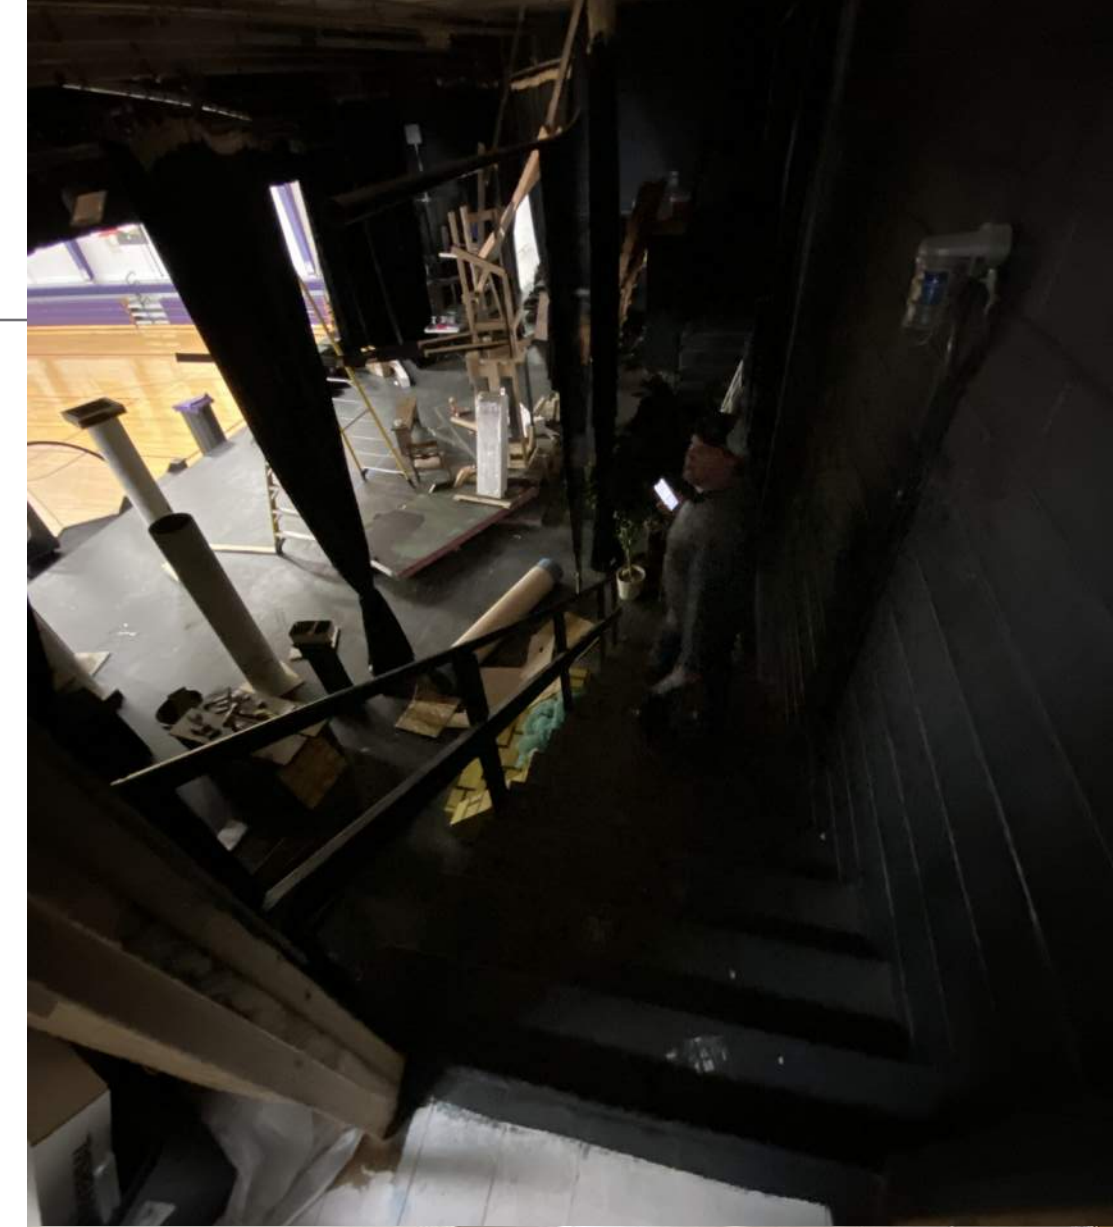
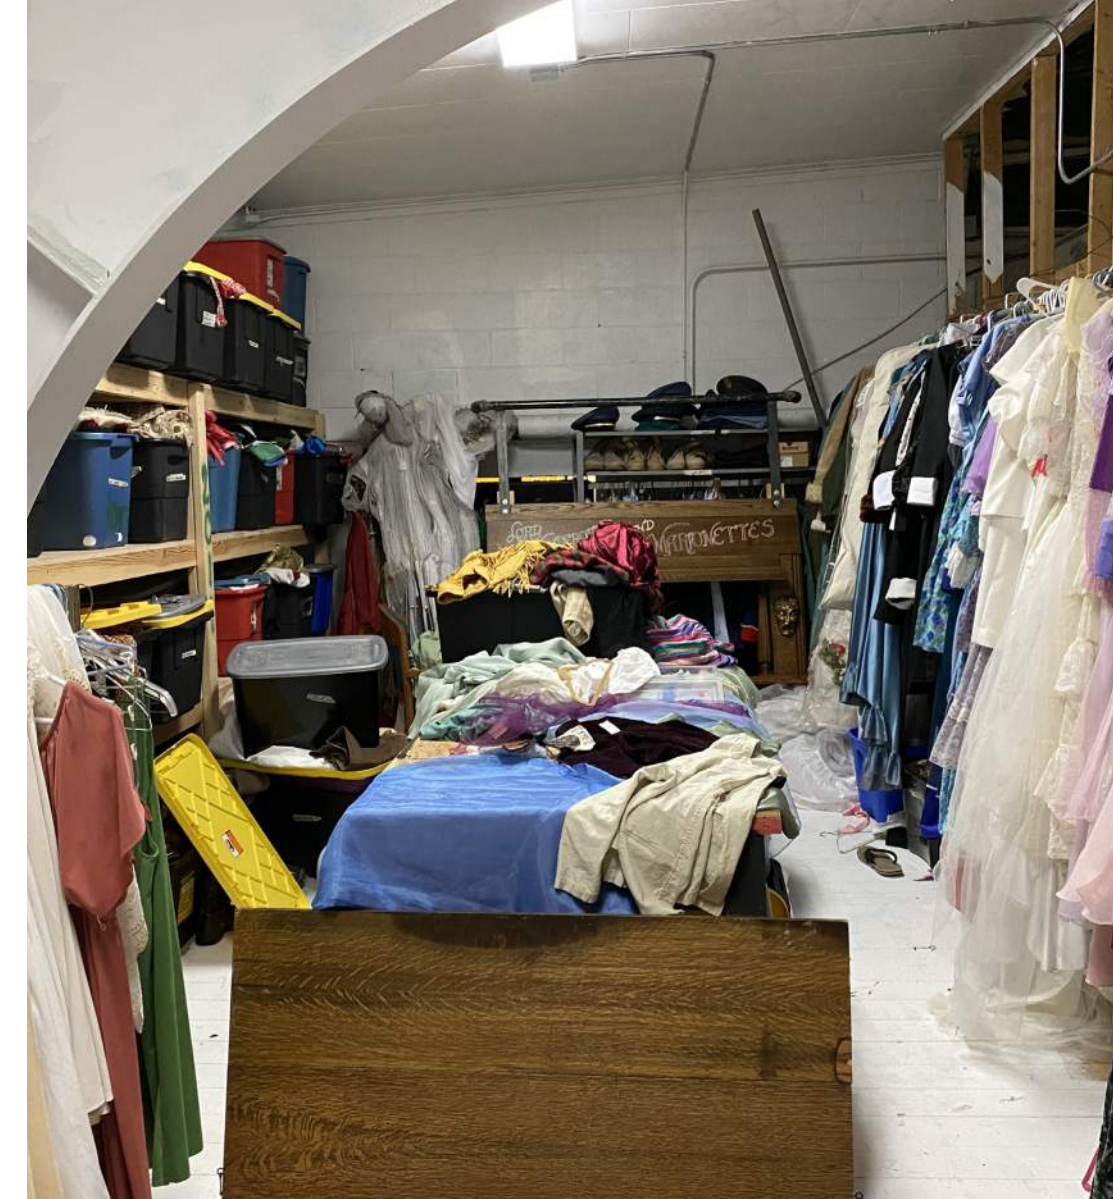
- Popular and successful program at school and within community
- Currently using stage in the original existing South Gym
- Gym/Stage area has reported acoustic challenges from the hard surfaces in the gym
- Space is limited on stage and in storage areas
- Wooden stairs to storage areas are aging and limit accessibility
- Access to construction materials for set design is limited and poses challenges
- Sound & lighting need upgrades
- Theater classes/rehearsals limit usability of gym purposes or athletic practices

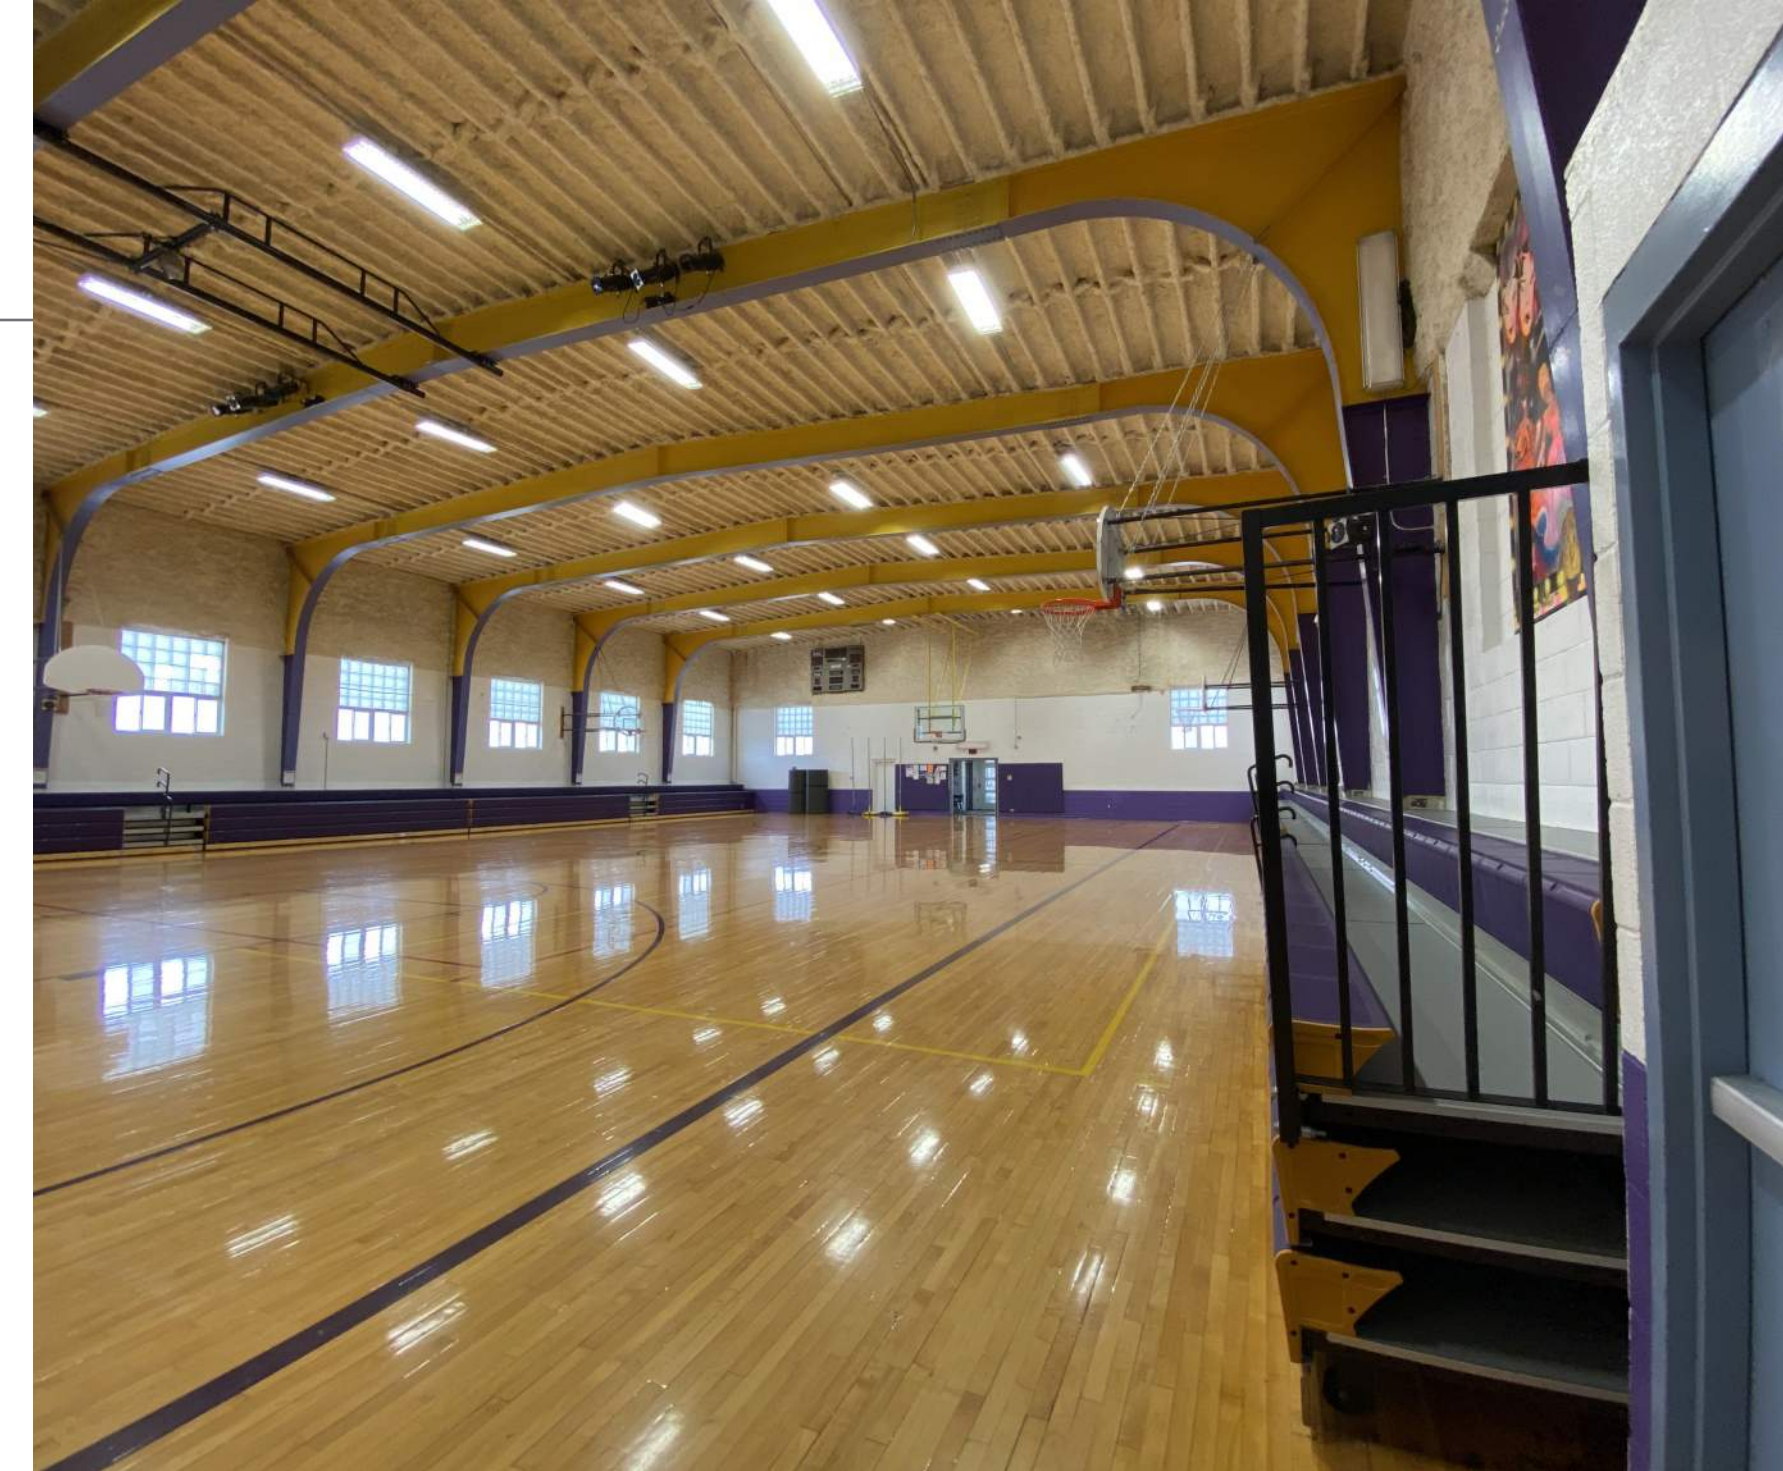
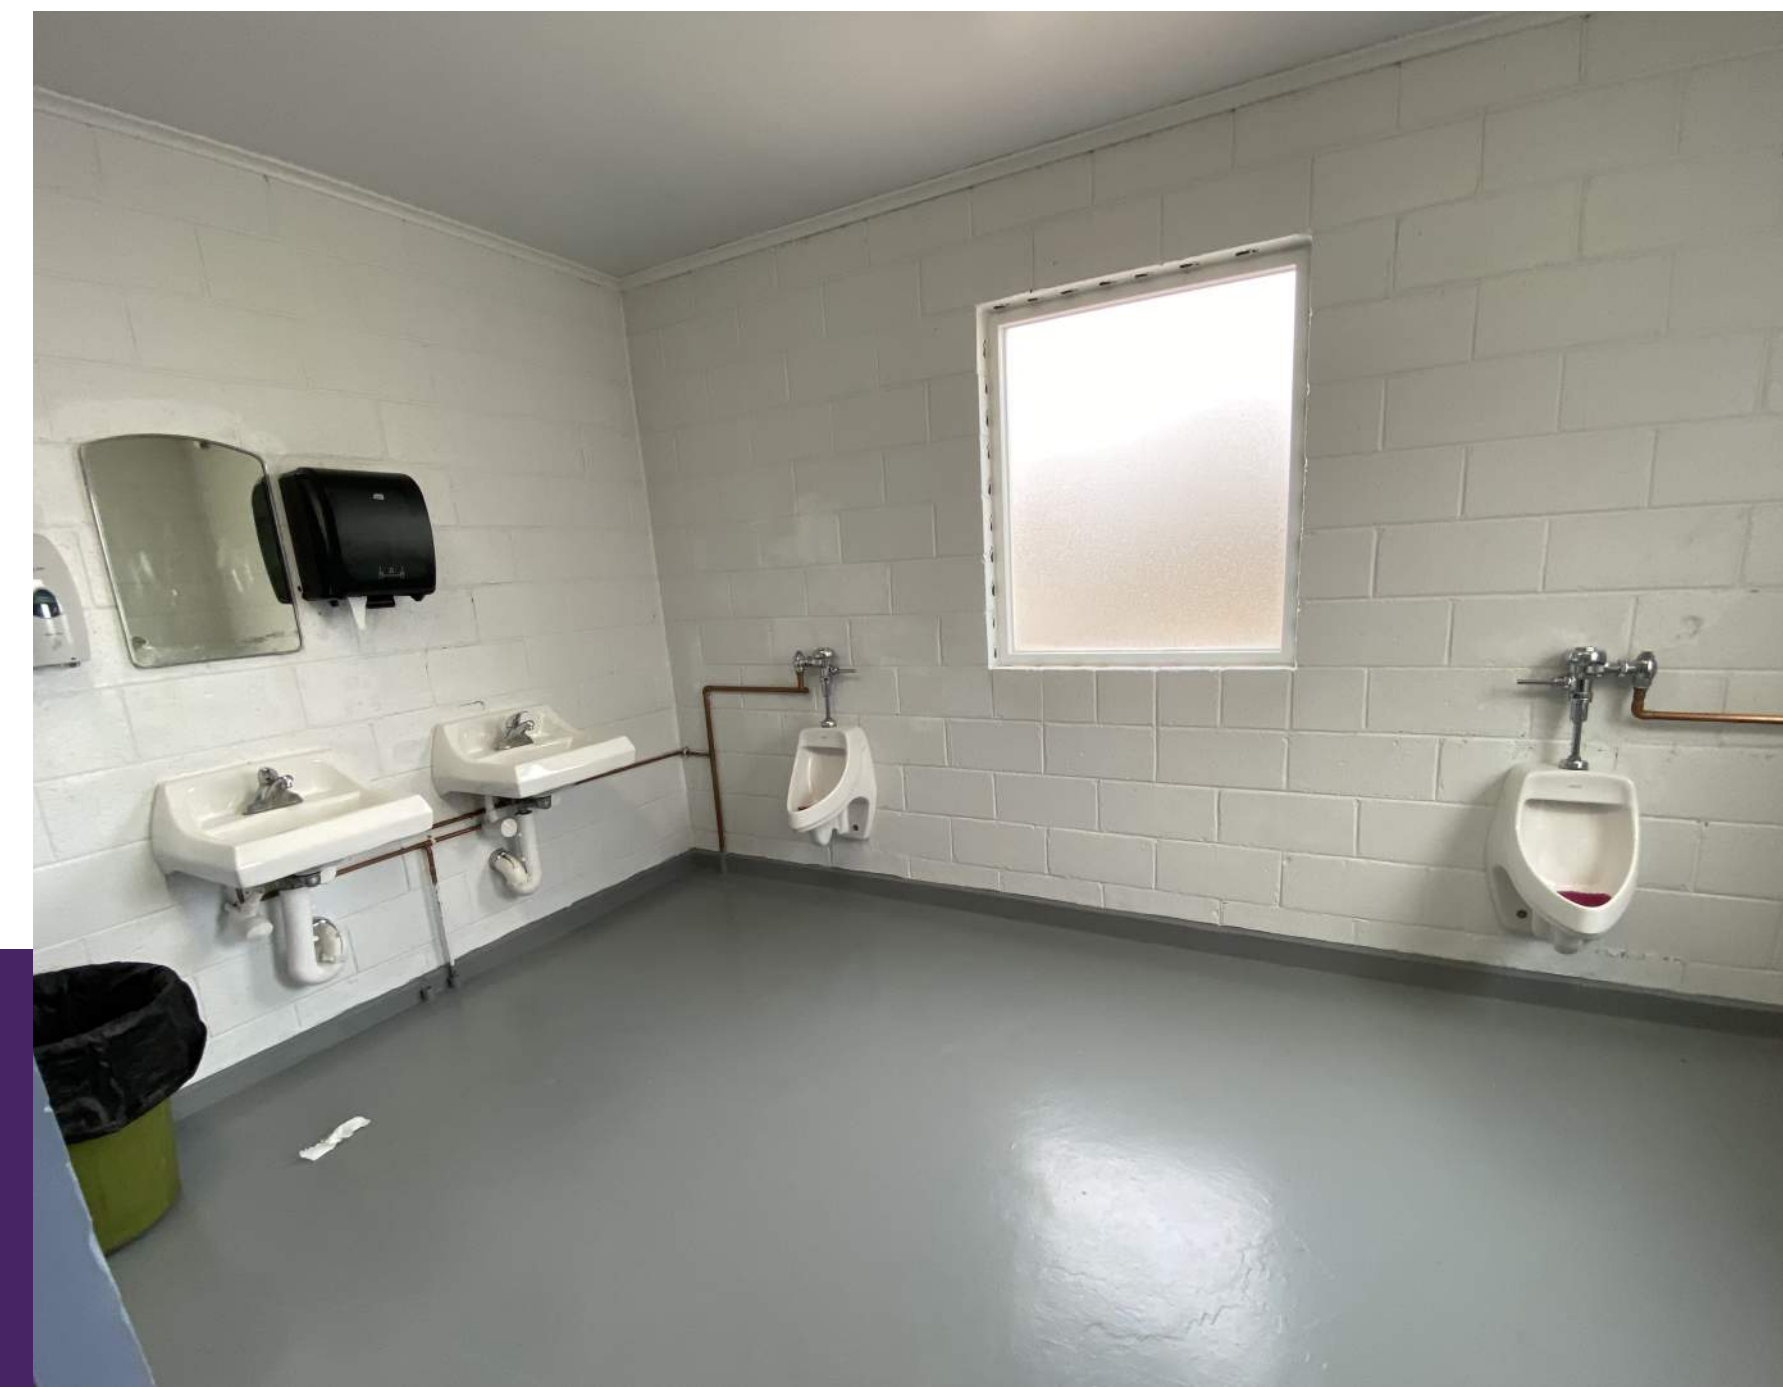
- Gym floor in good condition and was recently refinished
- Lighting is high-bay fluorescent and does not meet sufficient lumen output
- Acoustics for athletics, drama and theater have added spray insulation but still inadequate. Material may be flammable.
- Restrooms in vestibule lack privacy and are not ADA
- Additional gym is an asset but cannot be used to full potential with scheduling conflicts with drama/theater
