# BUILDING CONDITION REPORT

**JEFFERSON HIGH  
SCHOOL DISTRICT #1**  
July 21, 2020

SMA|ARCHITECTS

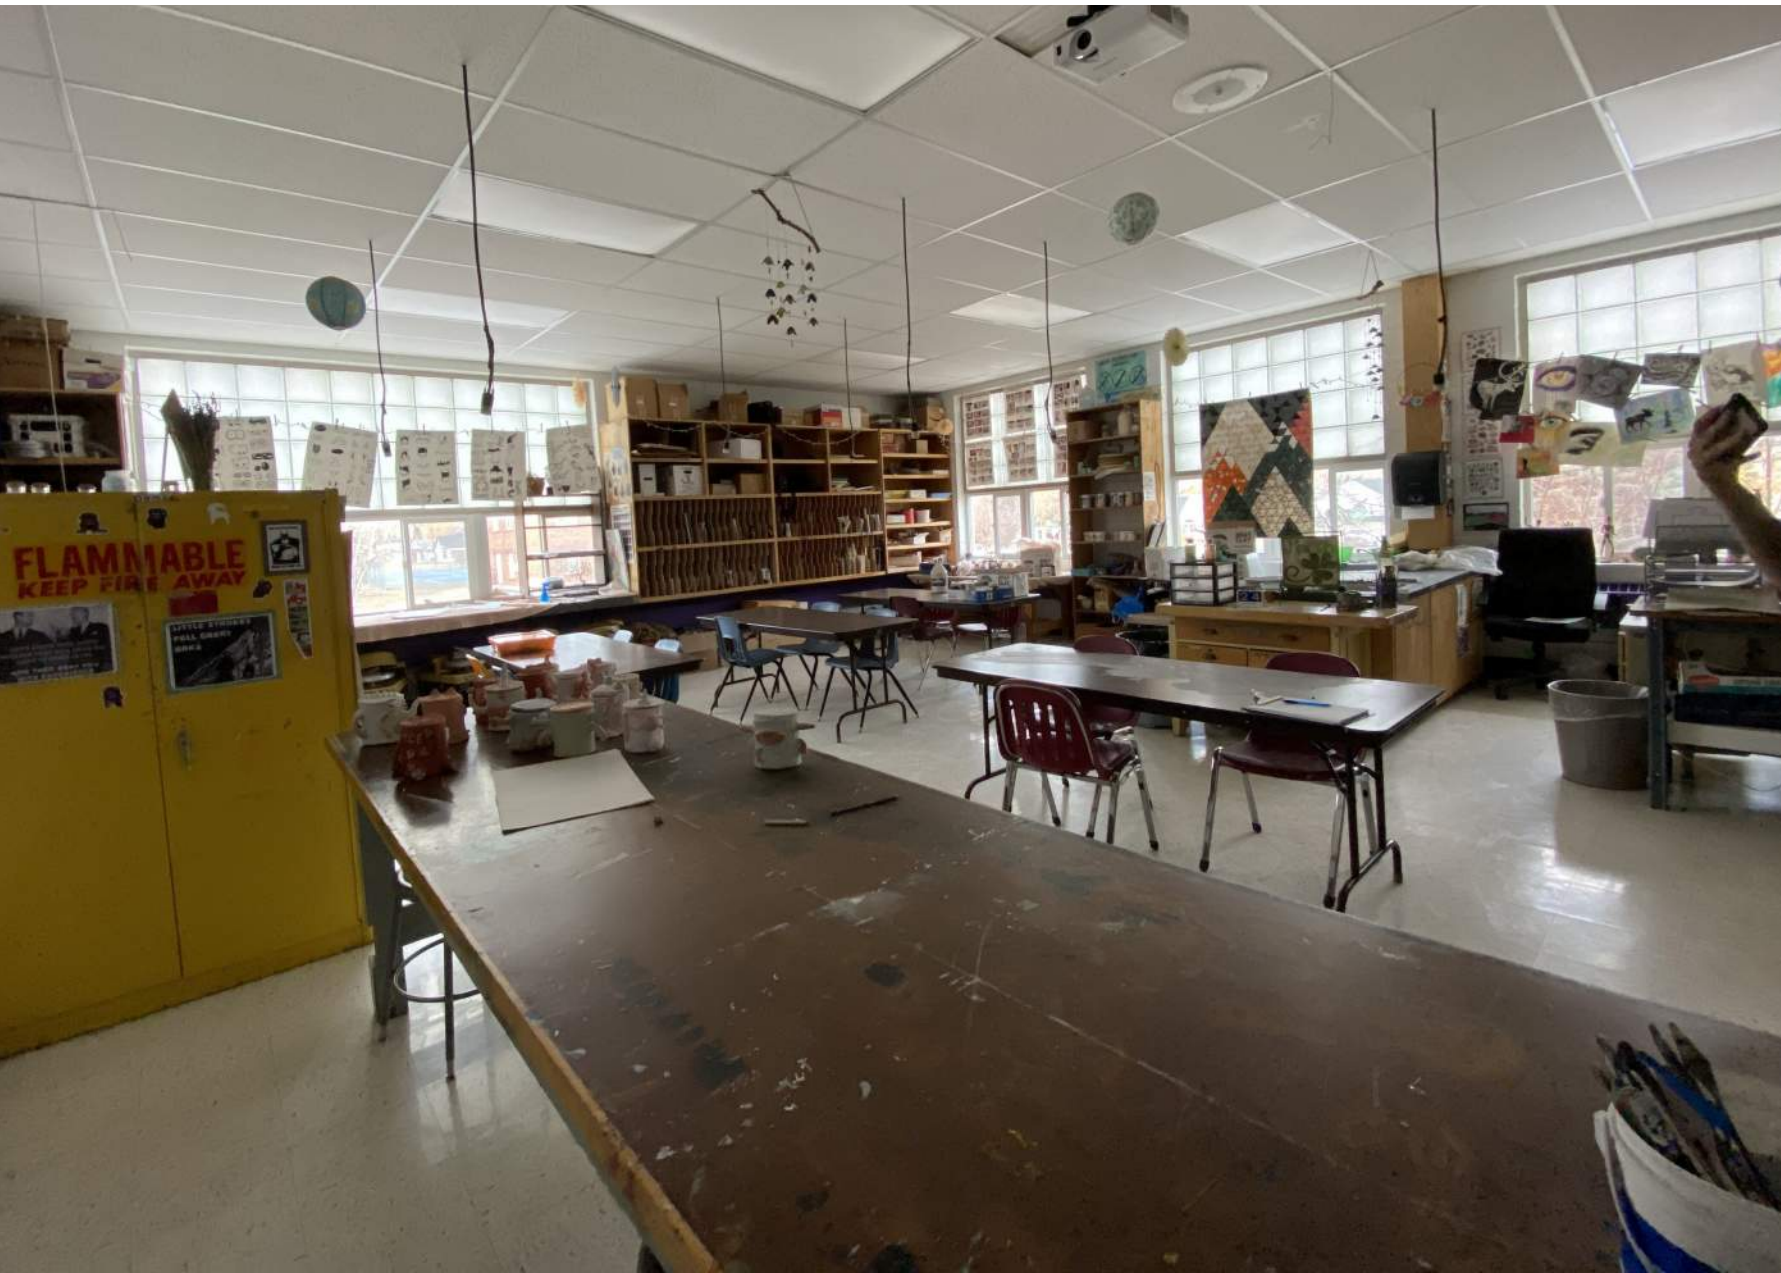
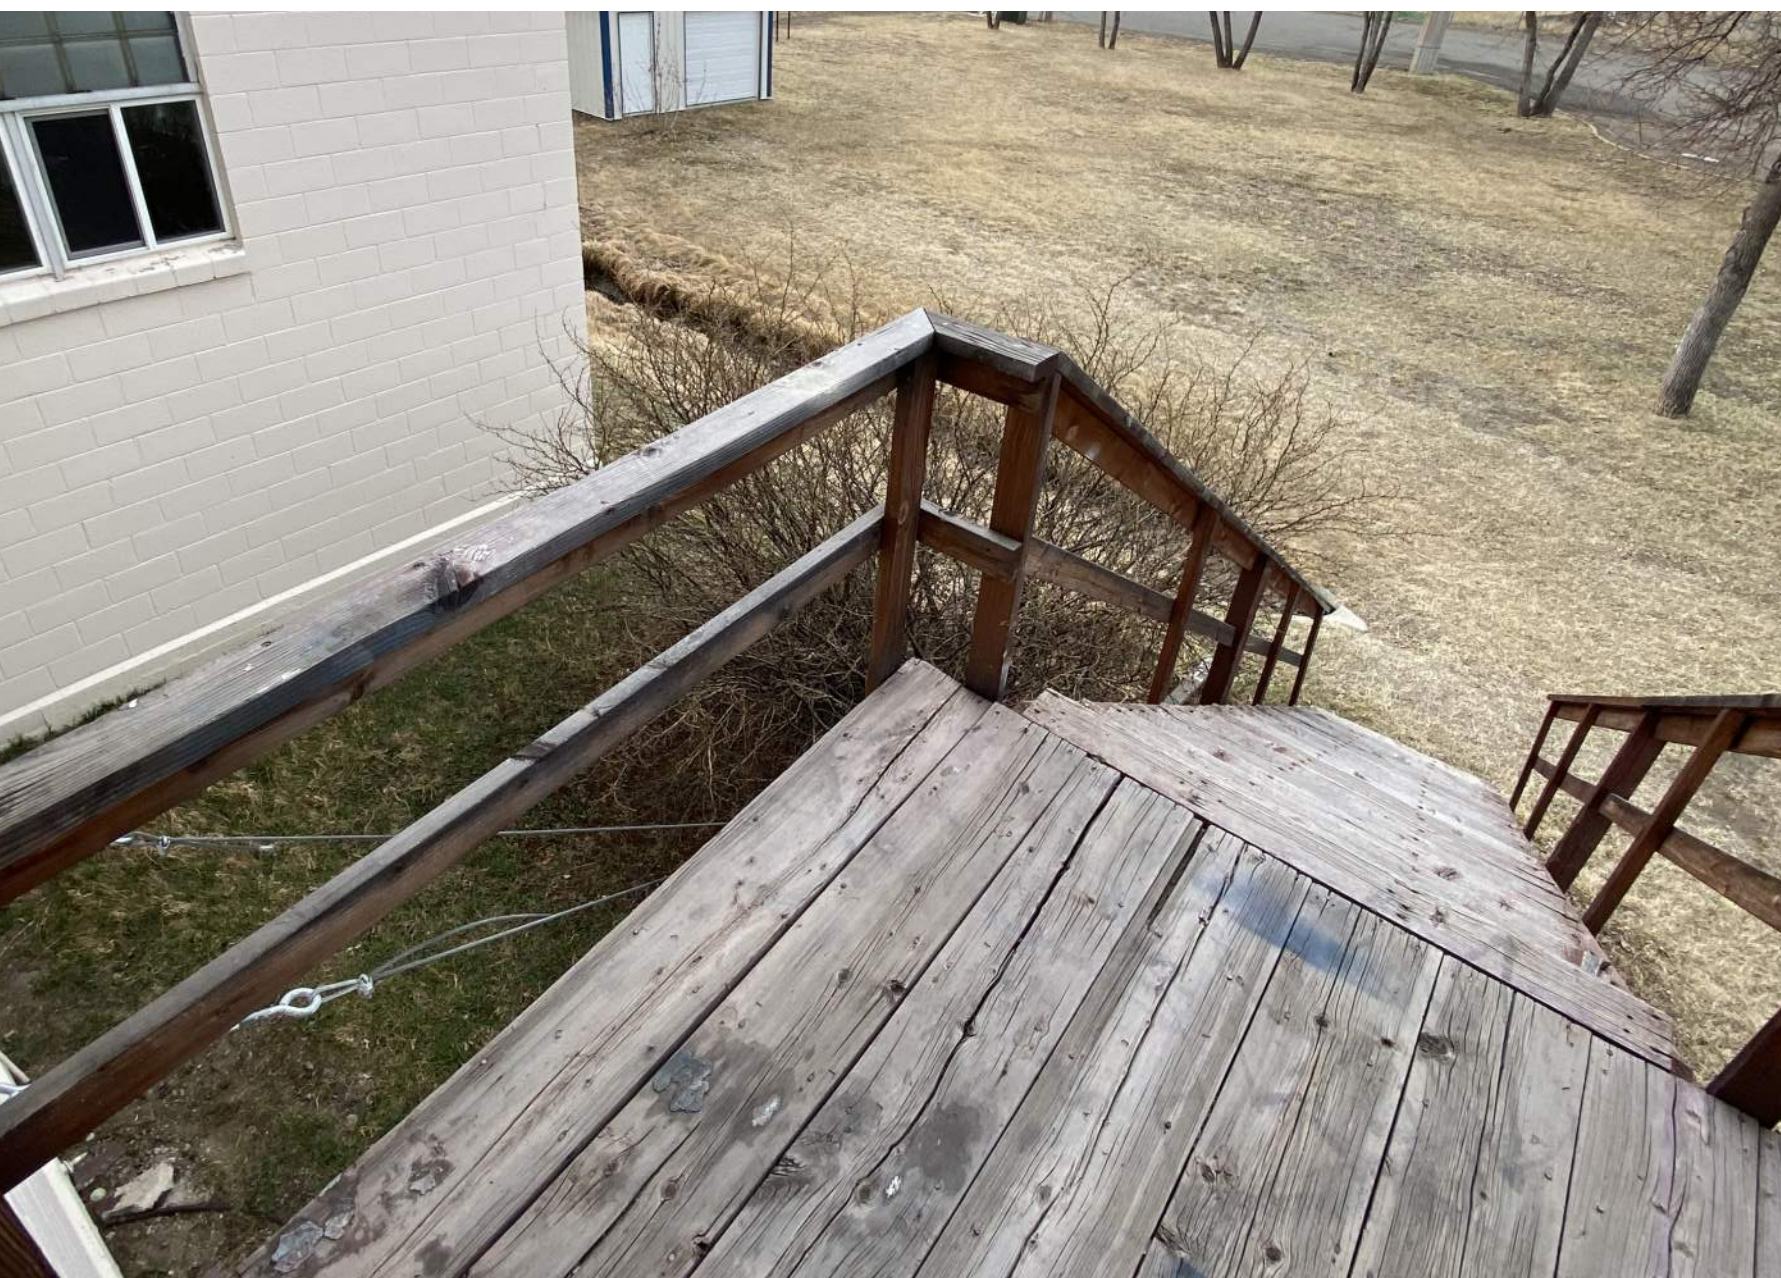
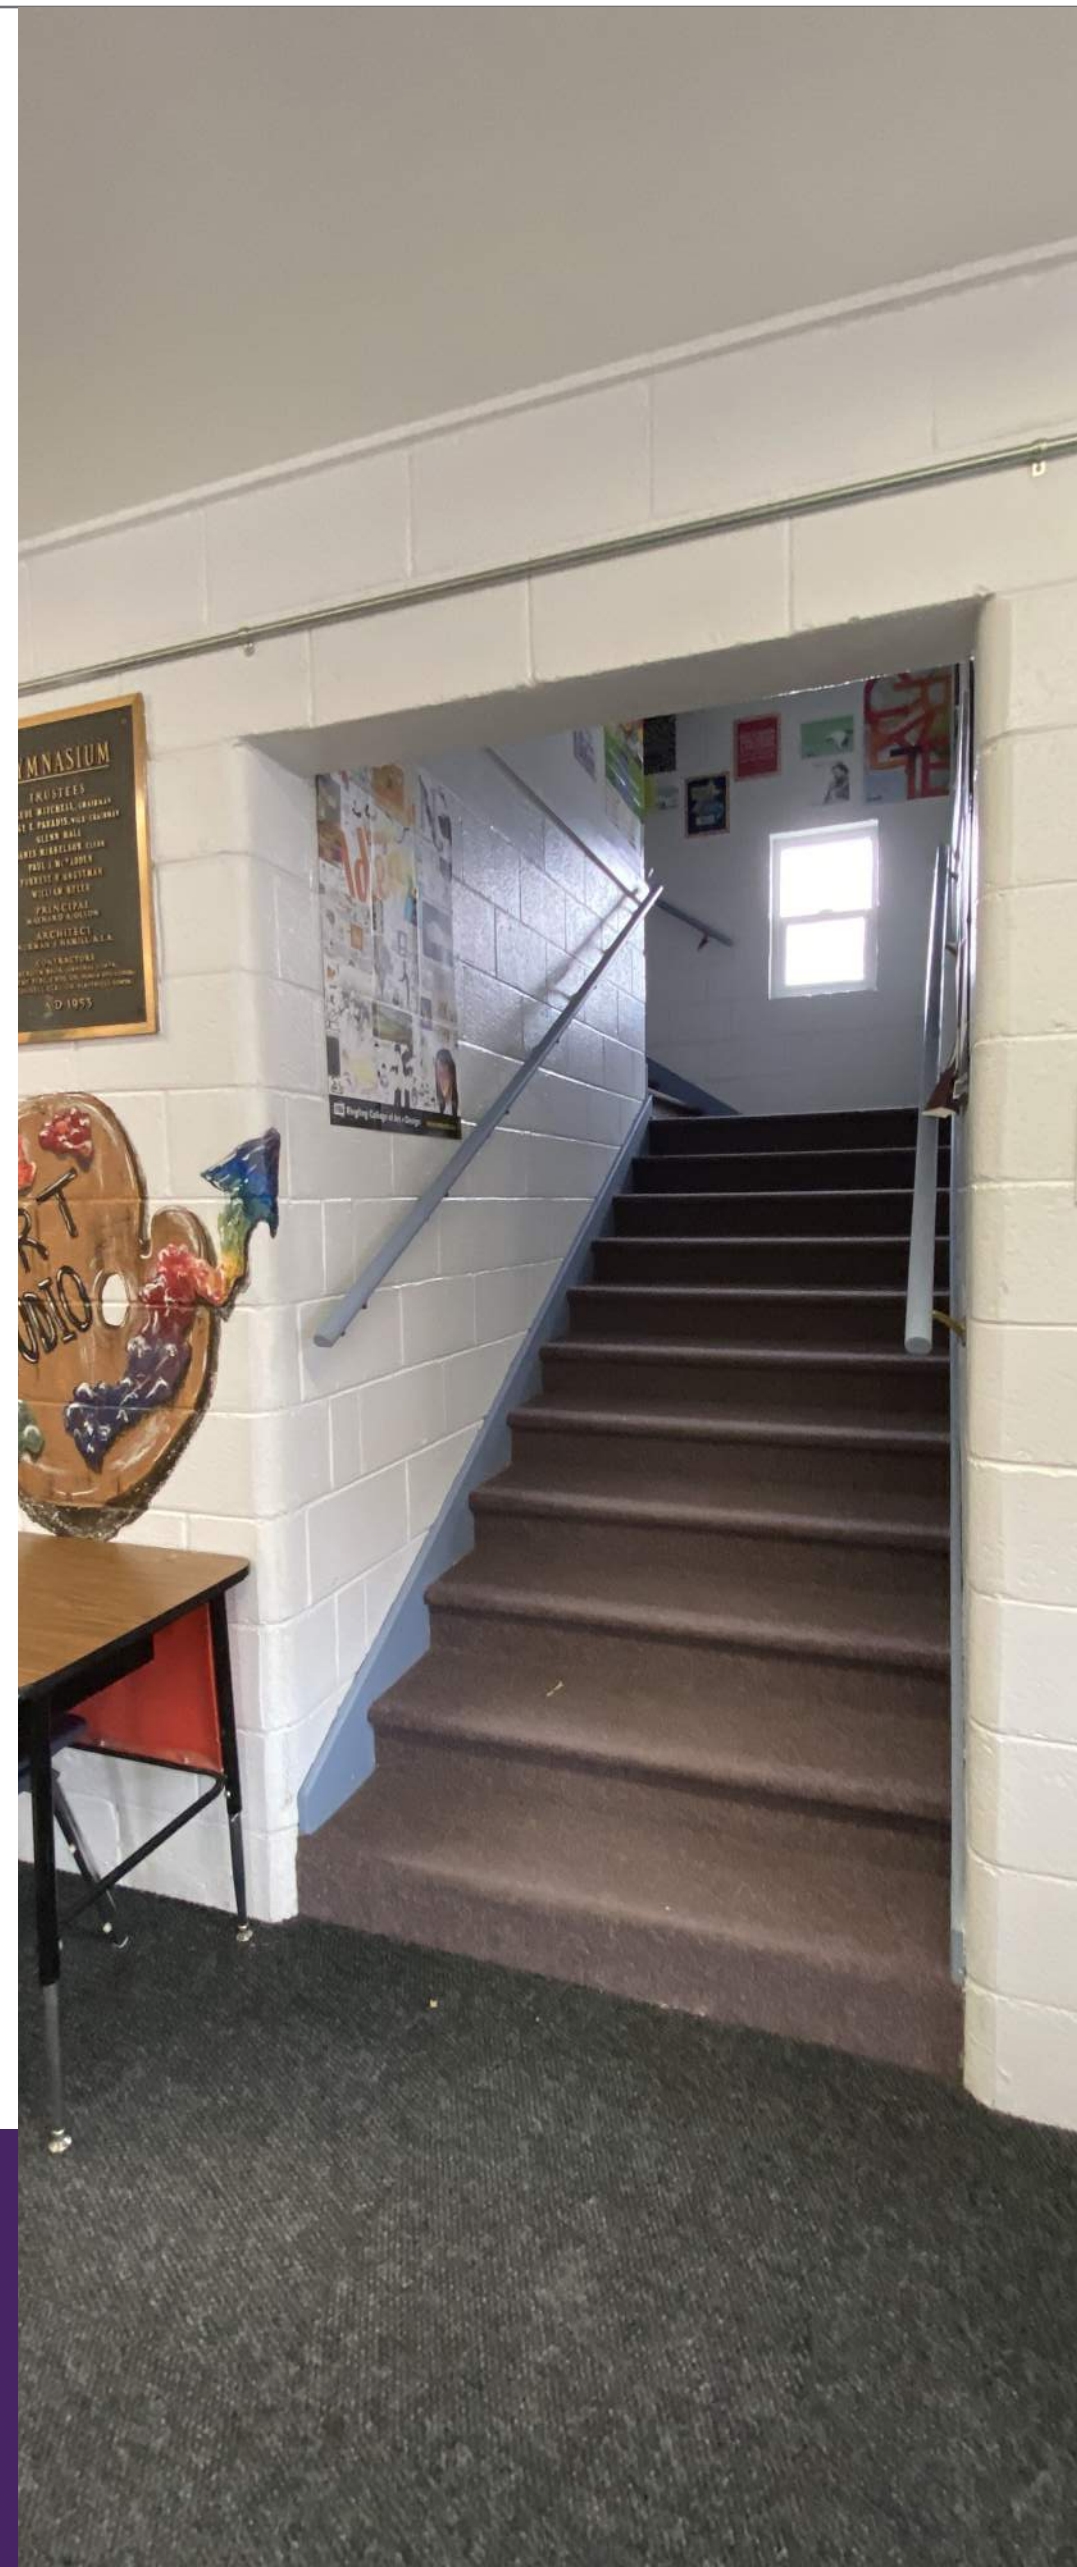
- Not ADA accessible
- Ample lighting
- Acoustical ceiling and recessed lighting is in new/good condition
- Other finishes also good
- Has suspended power outlets, which is likely adequate compared to power outlets in the rest of the building
- Exterior exit stairs aging

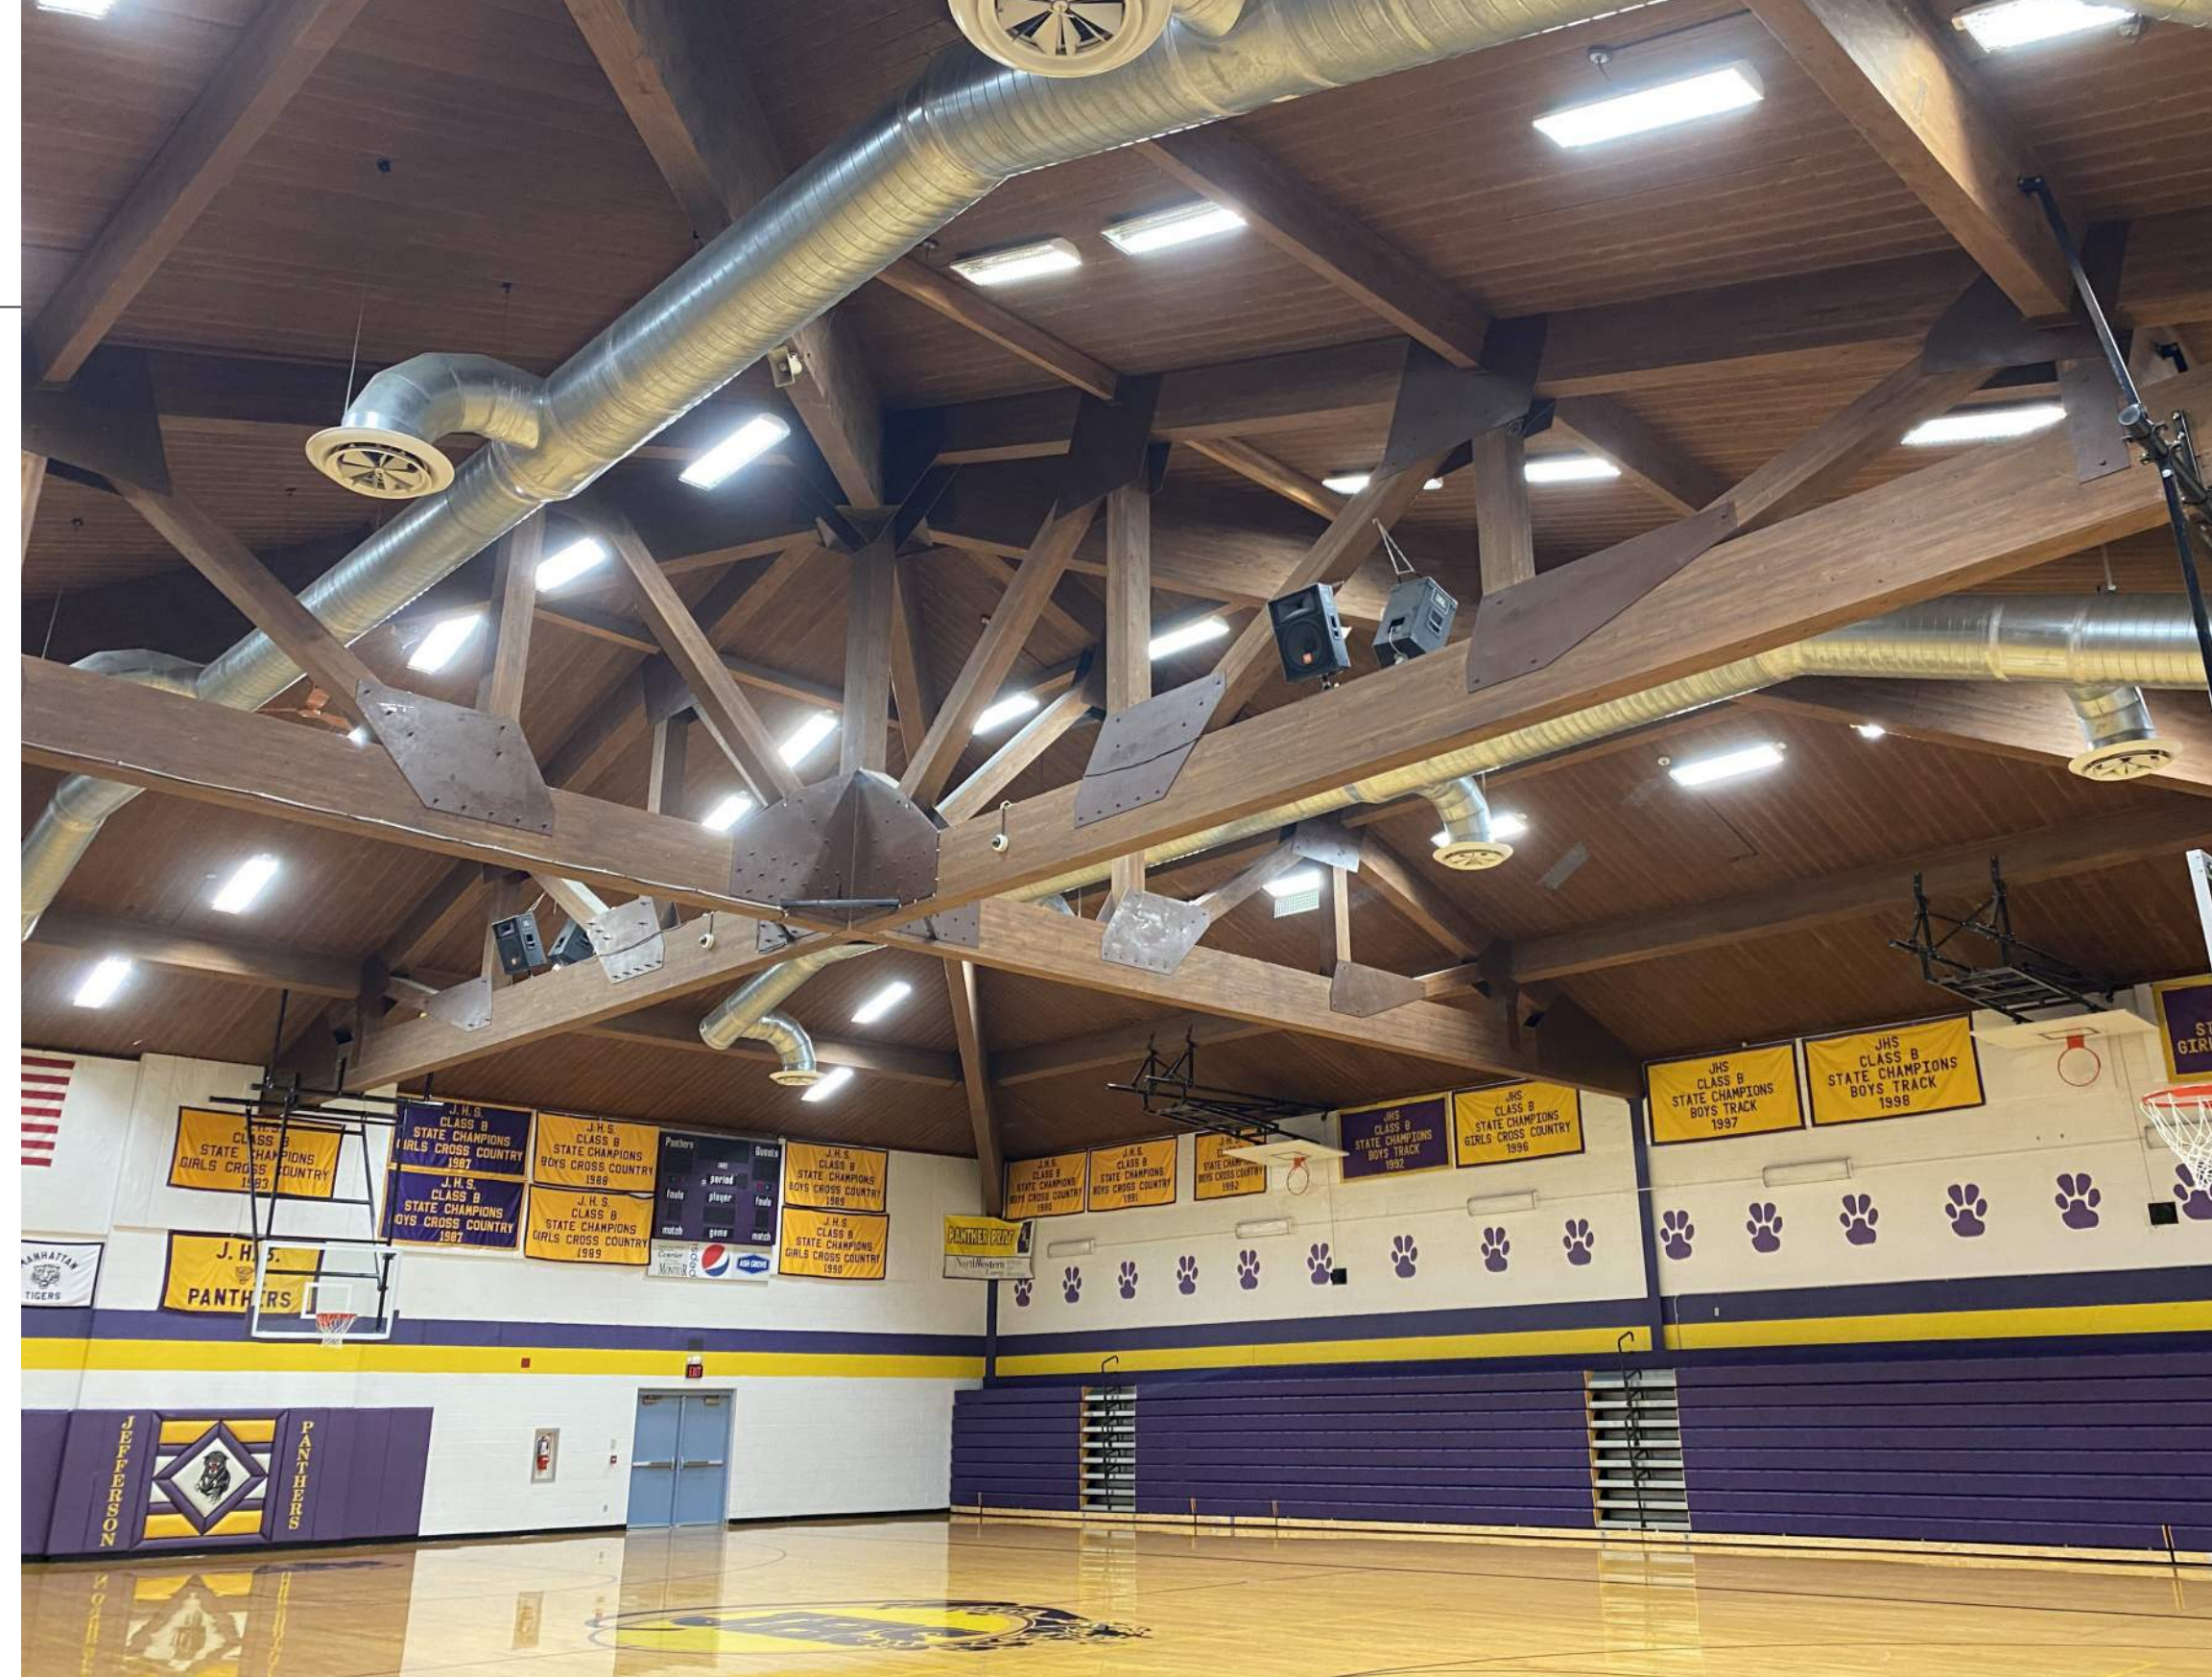
- Accessed via stairs to the mezzanine
- Finishes well maintained, but ceiling tiles showing damage, warping and stains
- Not ADA accessible
- Stair riser height taller than allowed code (measured at 7.5", code is 7")
- Mezzanine not designed as weight or wrestling room—drawings say designed as “Multi-Purpose Room”
- Weight of equipment and heavy plates striking composite slab is likely causing damage faster than intended
- Overall weight room undersized for students and equipment, more equipment and space needed to accommodate current class sizes
- Wrestling space cannot accommodate women’s and men’s wrestling
- Communication between weight and wrestling is only through telephone to the gym (difficult for setting up mats, etc.)

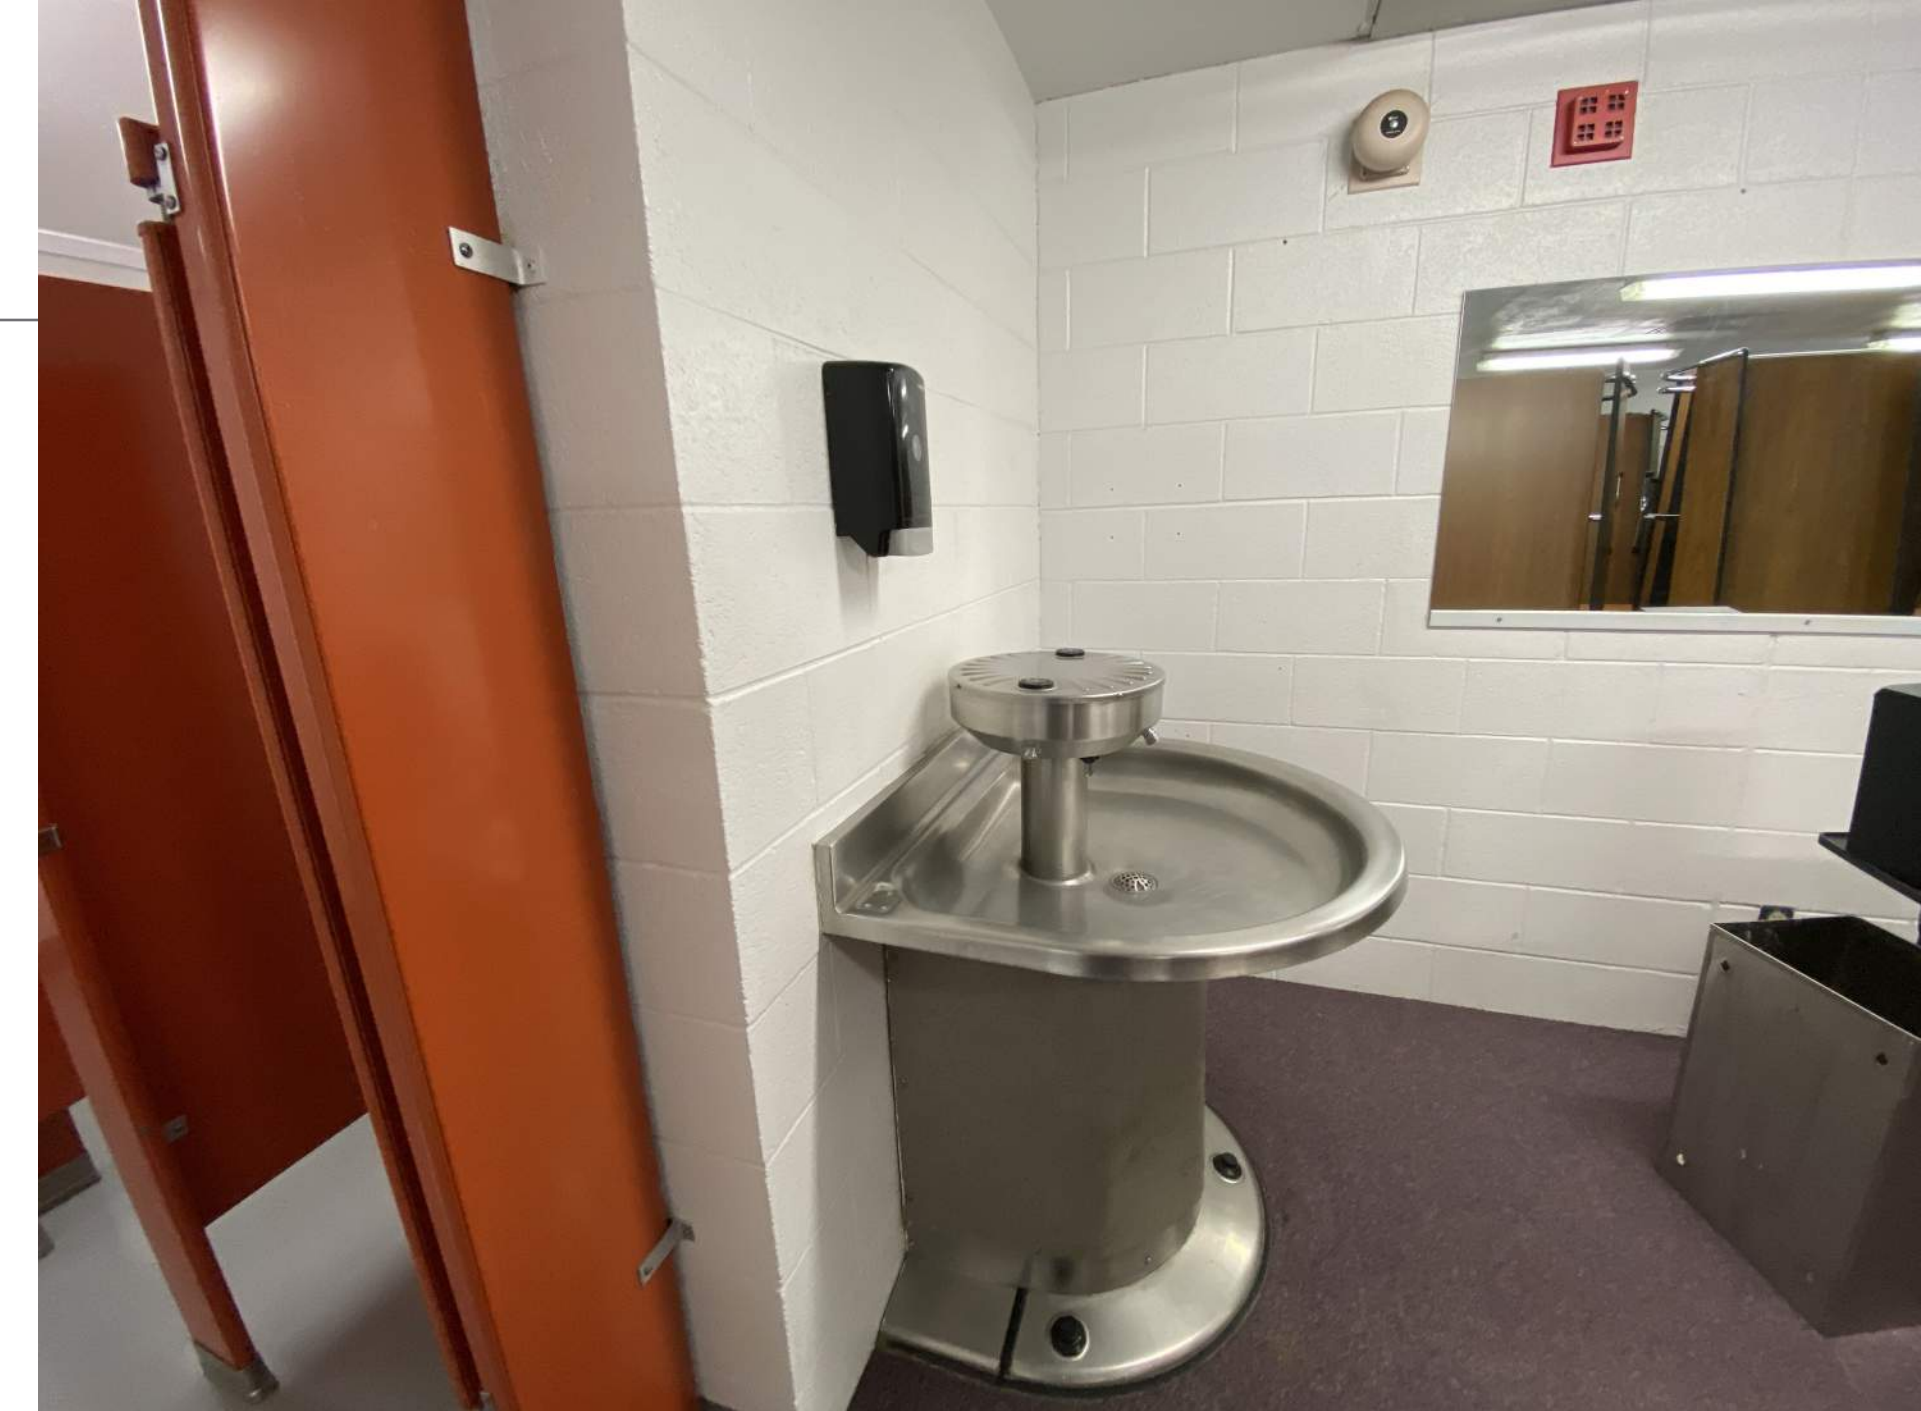
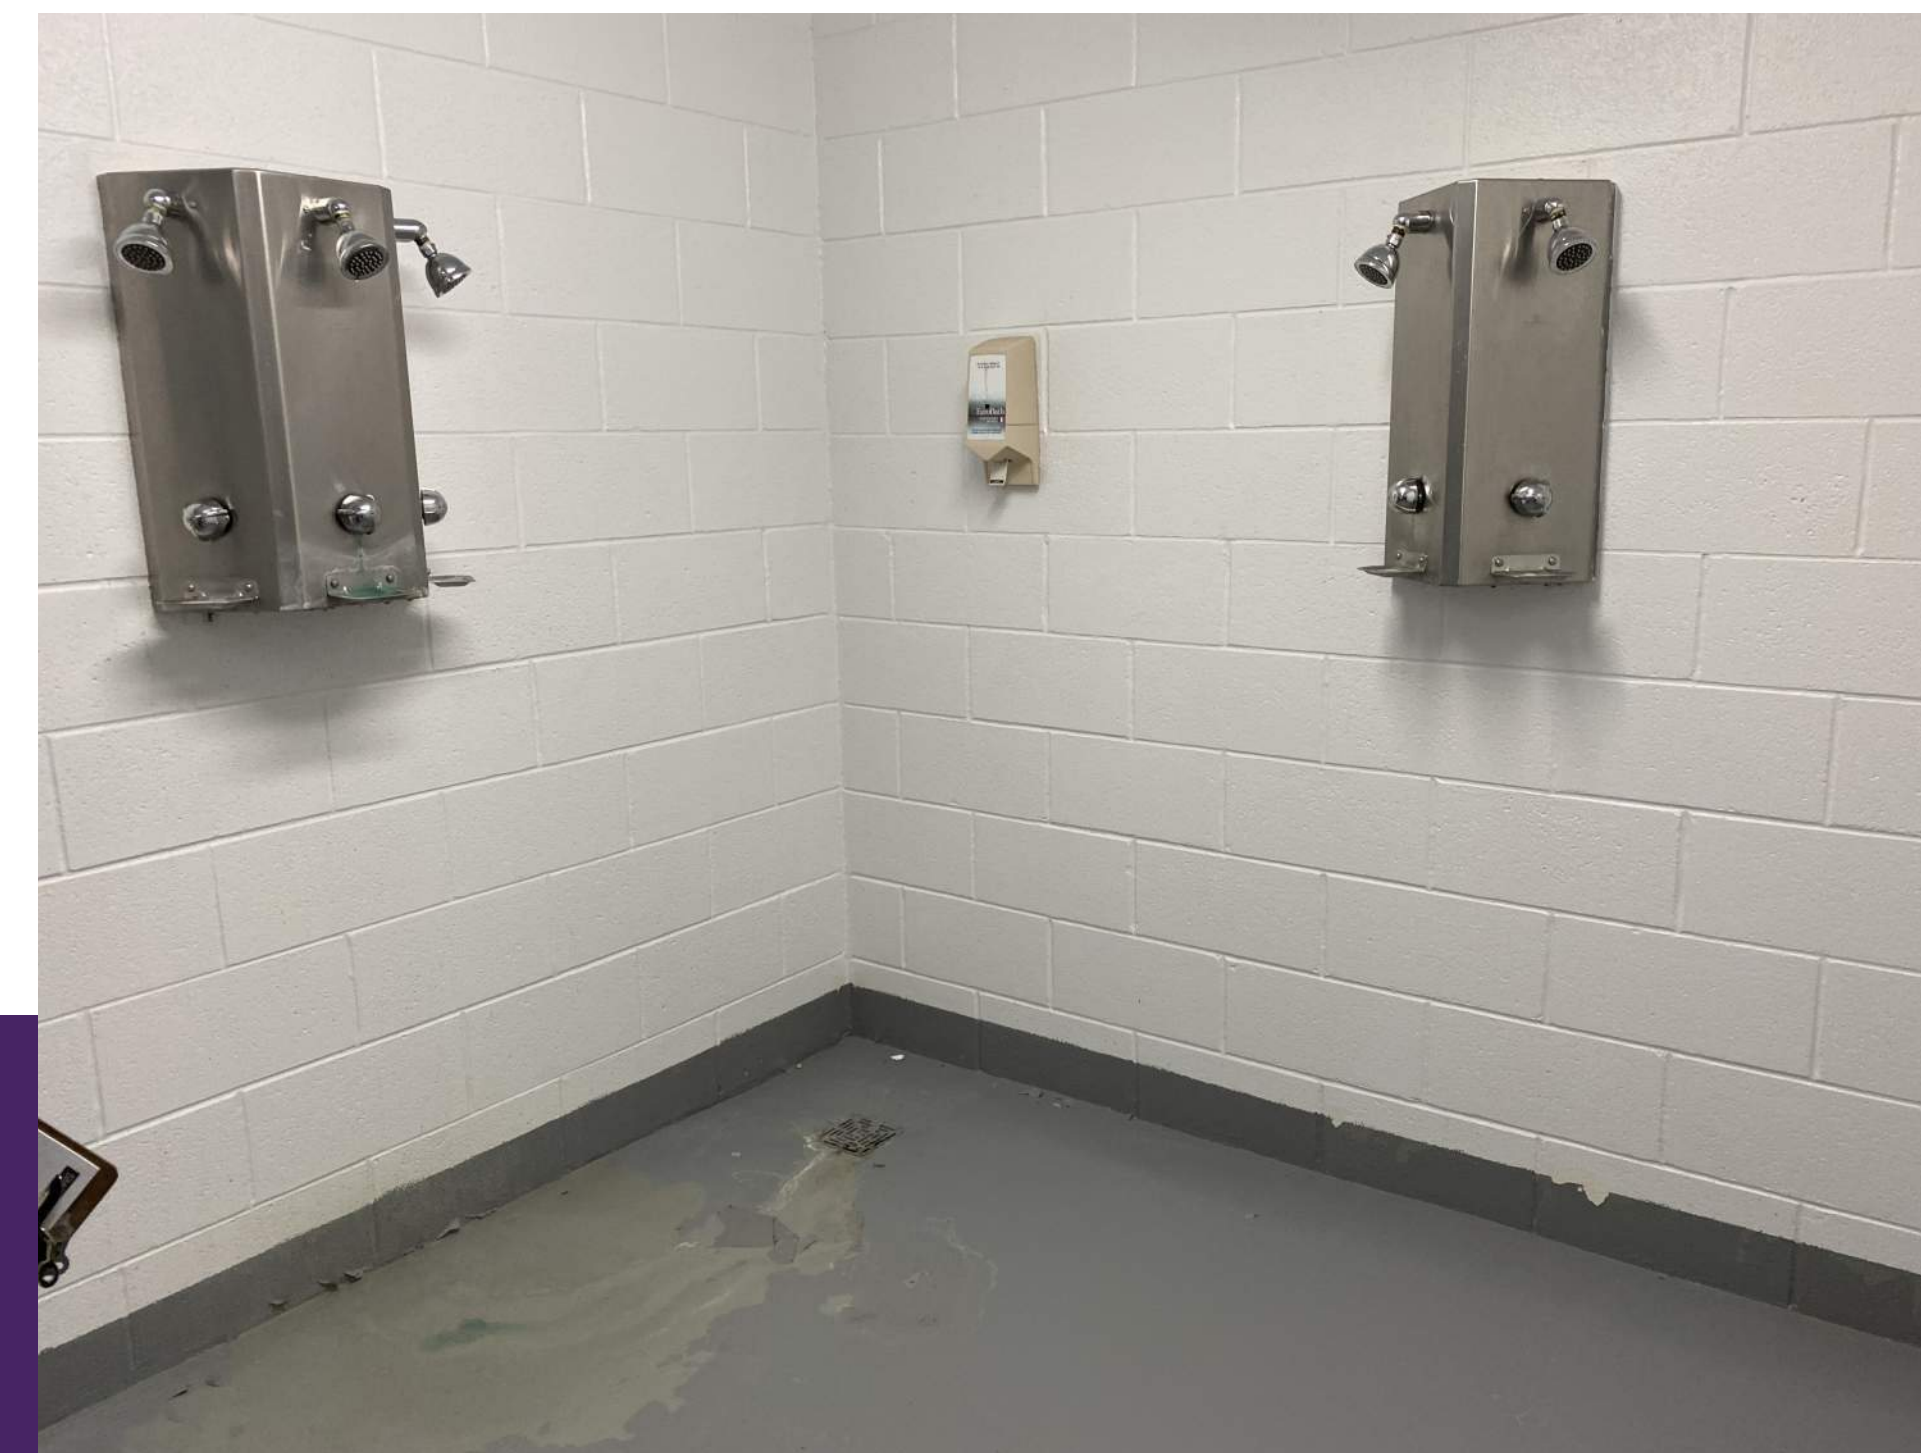
# MAIN LEVEL LOCKER ROOMS

- Used by general students for gym, weight room and wrestling
- One of few places in school with true ADA accessible toilet stalls
- Carpet flooring not ideal and can lead to mold and fungus growth
- “Gang” type showers can be a liability and are generally avoided by students to avoid body shaming and bullying
- Only a few wash basins are usable due to location

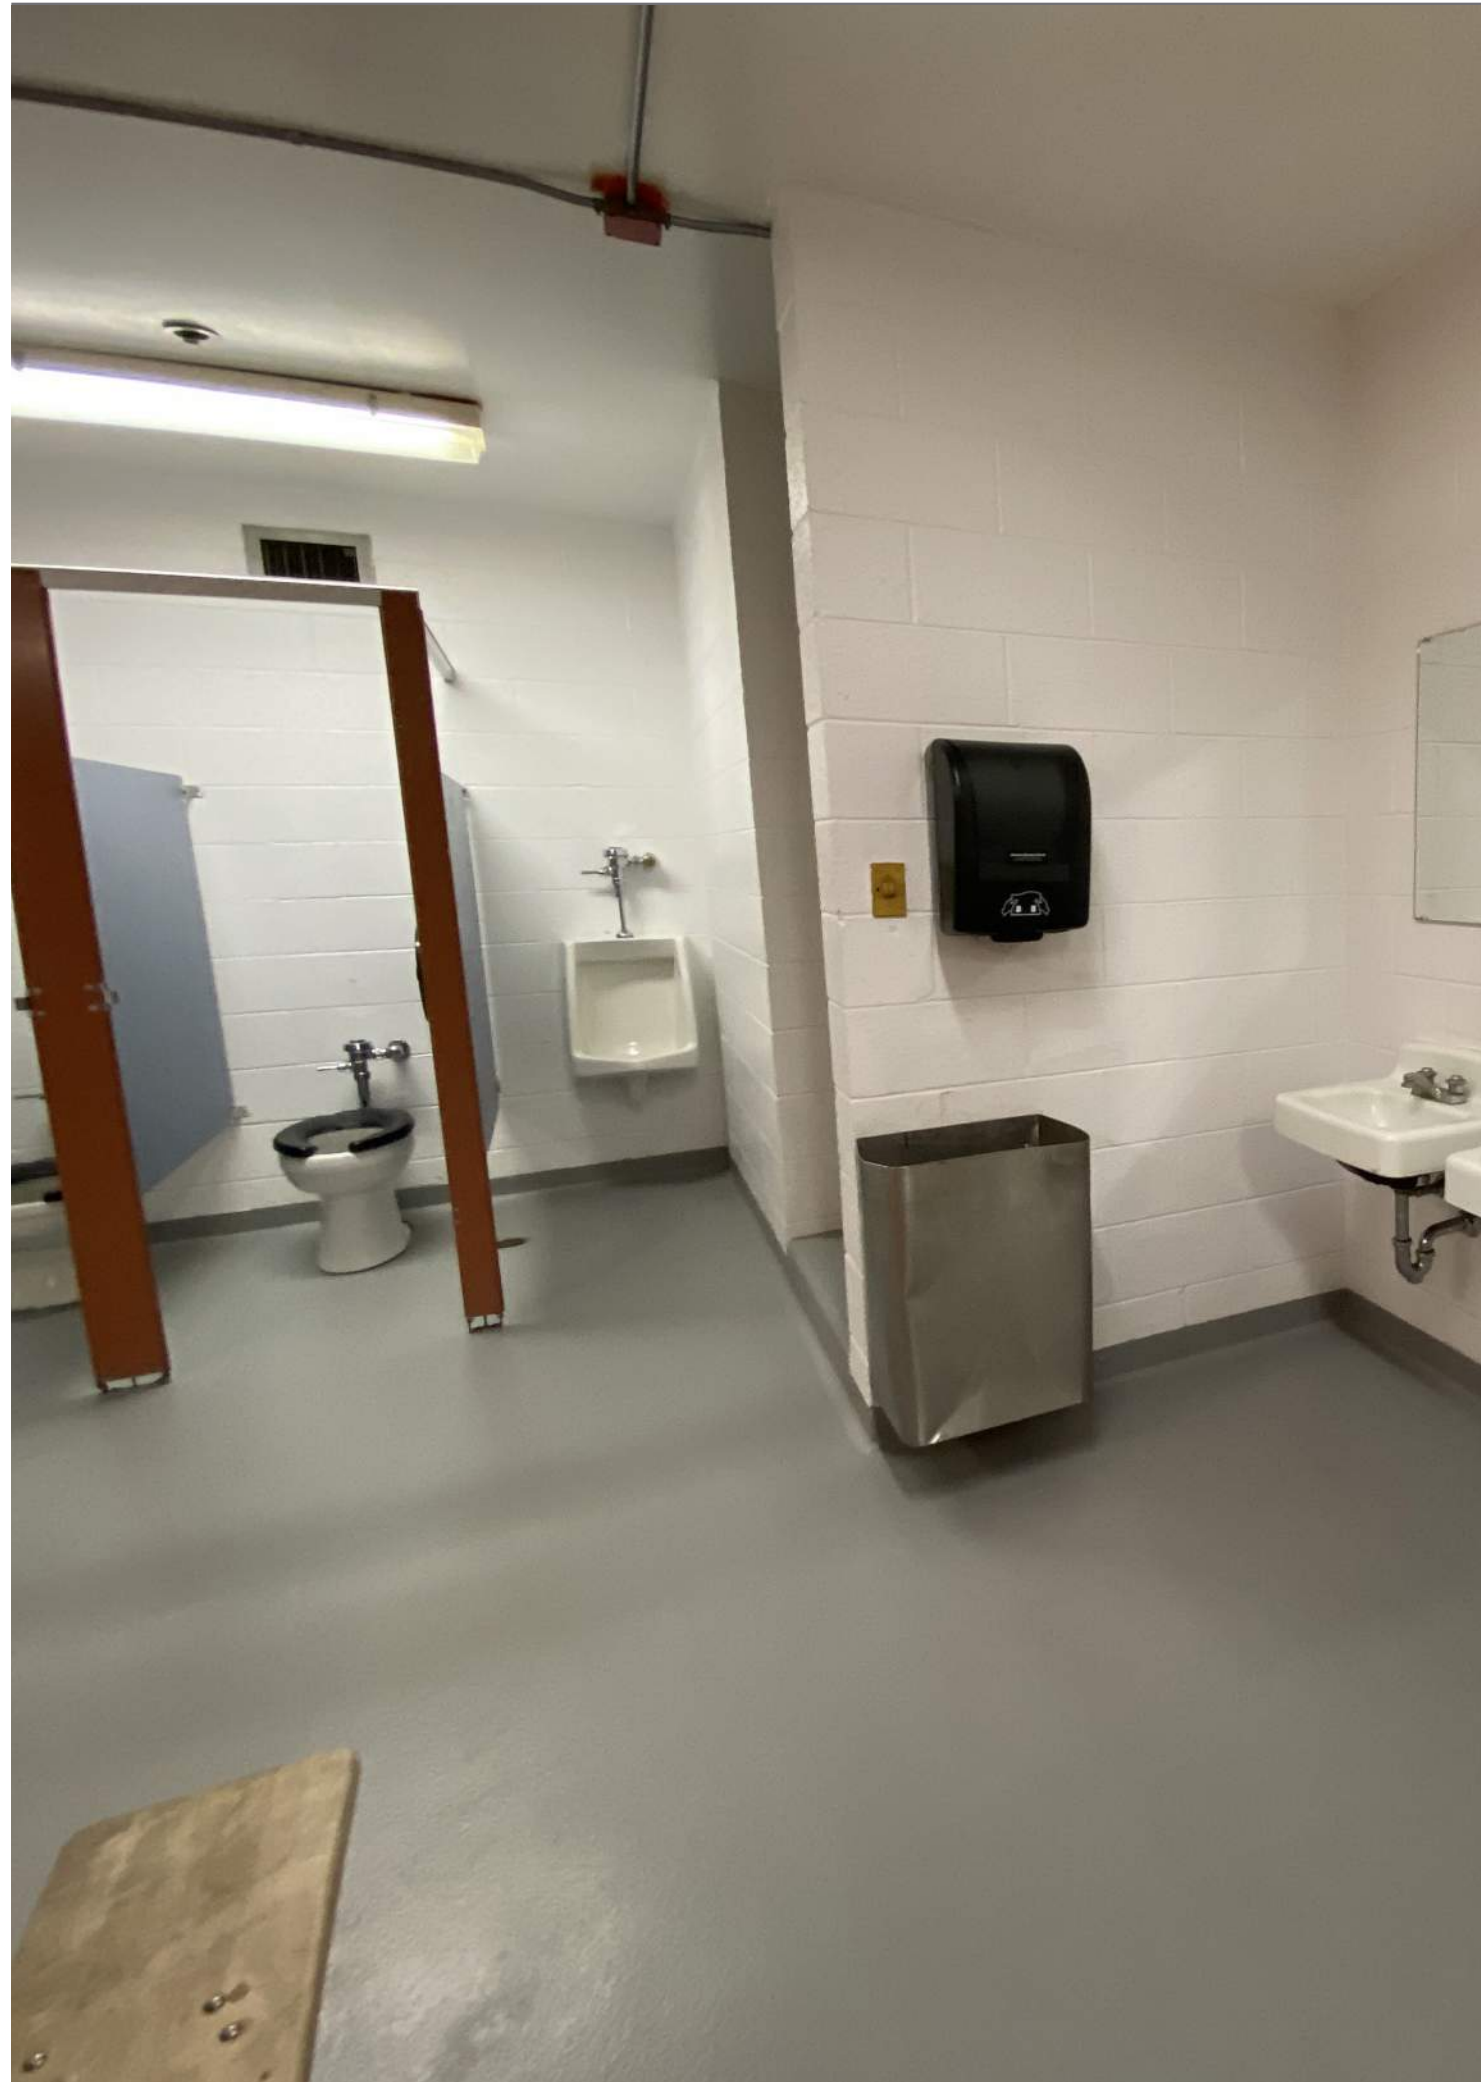
# LOWER LOCKER ROOMS

- Outdated in layout and functionality
- Adjacency problems, poor ventilation and accessibility problems
- Used by athletics such as football, tennis, track
- Finishes overall good
- Distance from rest of school creates supervision issue for staff and faculty
- “Gang” type showers- privacy concerns and bullying probable
- Toilet stalls not ADA accessible
- Men’s stall doors removed
- Other concerns included having enough storage and size of space for accommodating full teams
