# BUILDING CONDITION REPORT

**JEFFERSON HIGH  
SCHOOL DISTRICT #1**  
July 21, 2020

SMA|ARCHITECTS

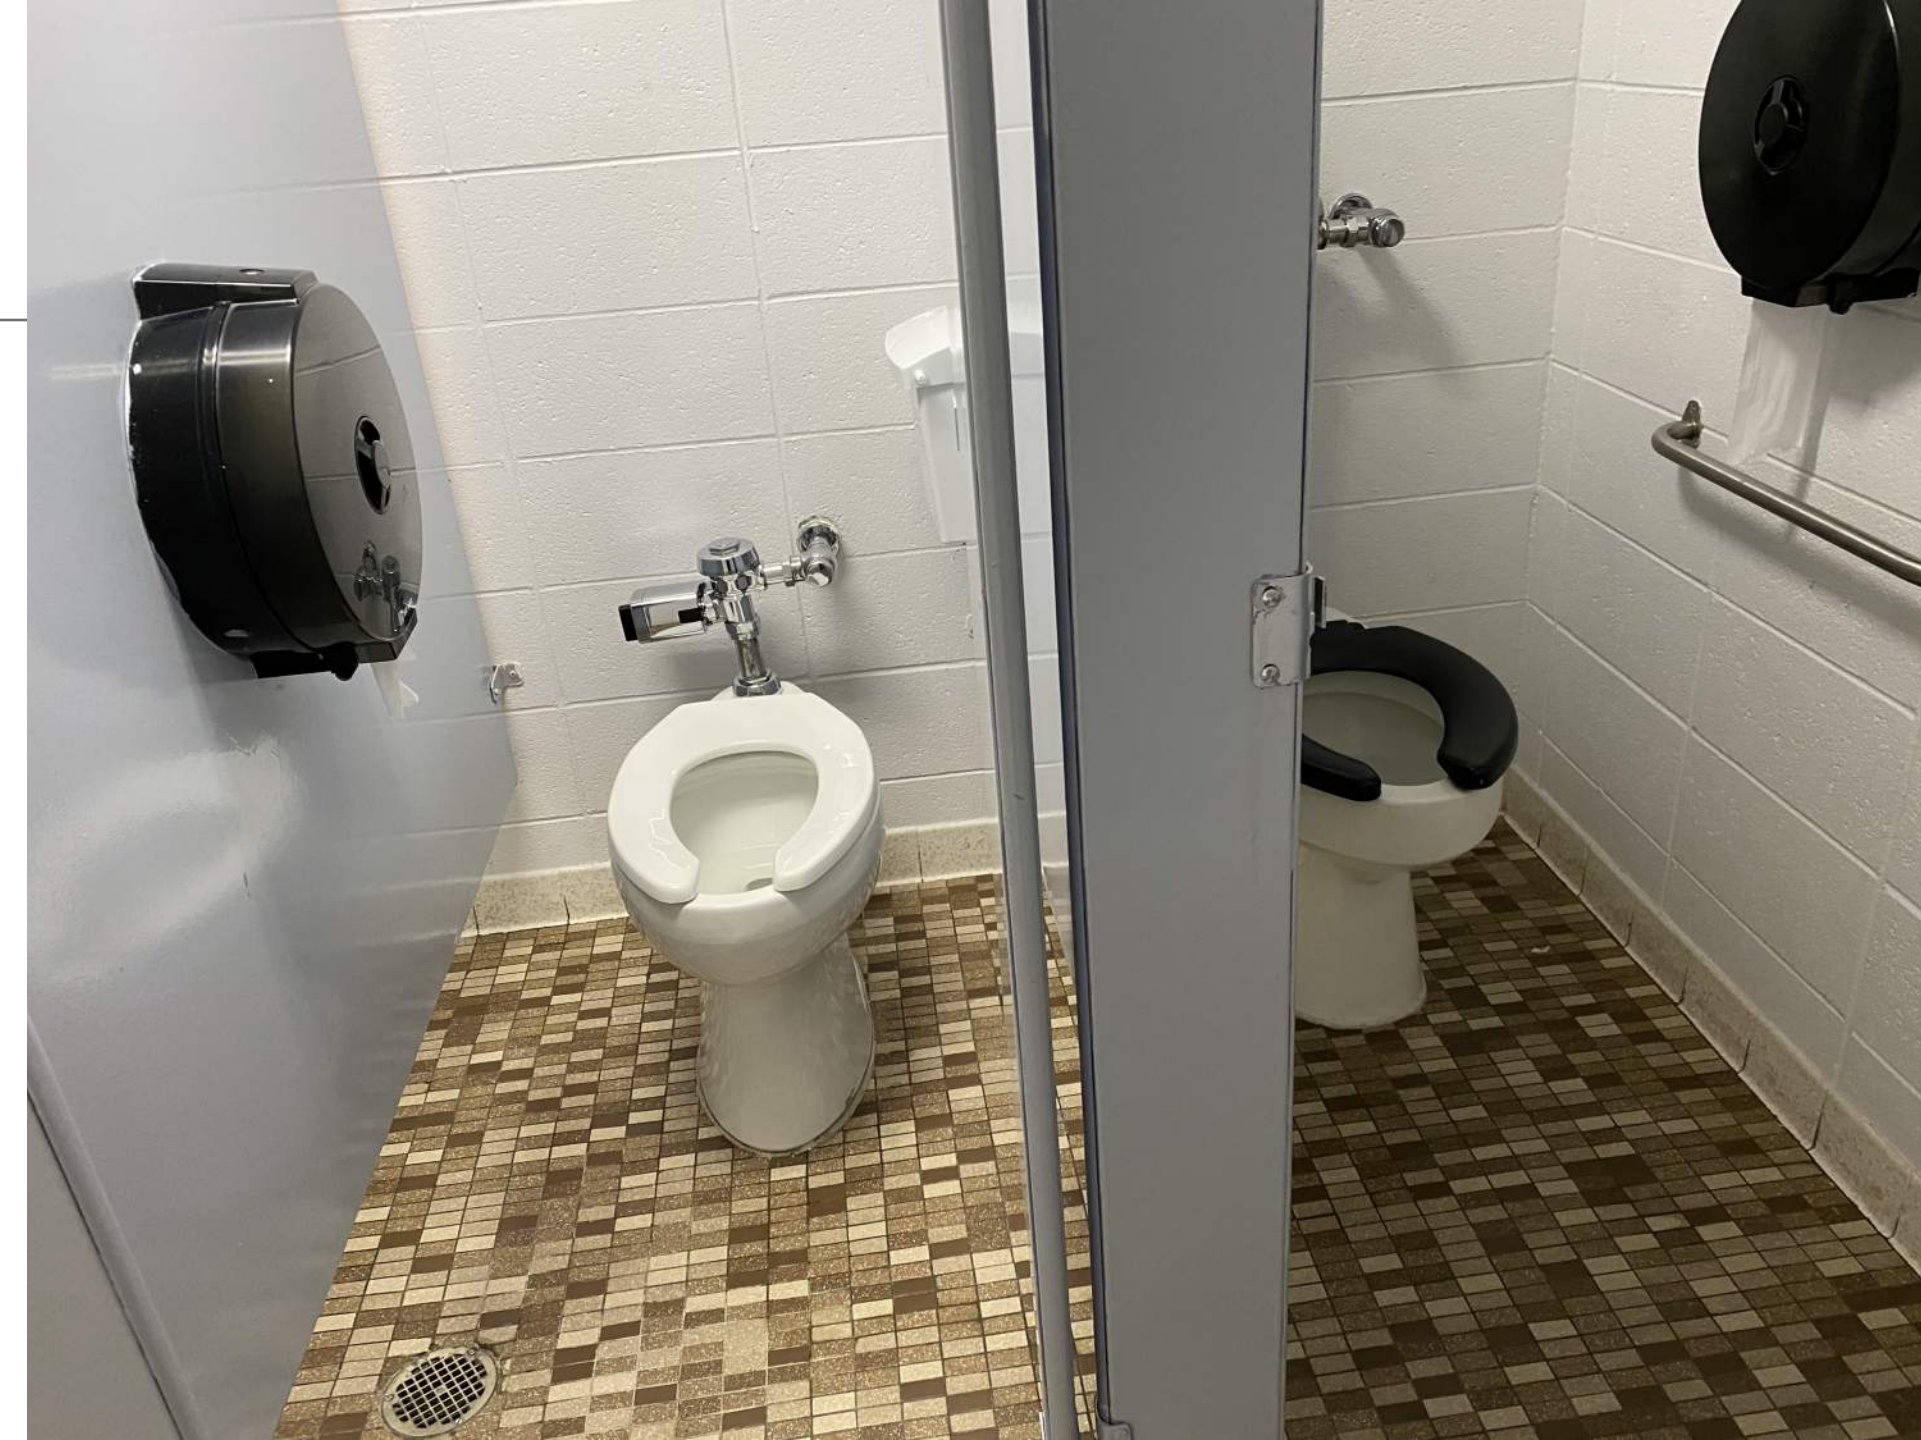
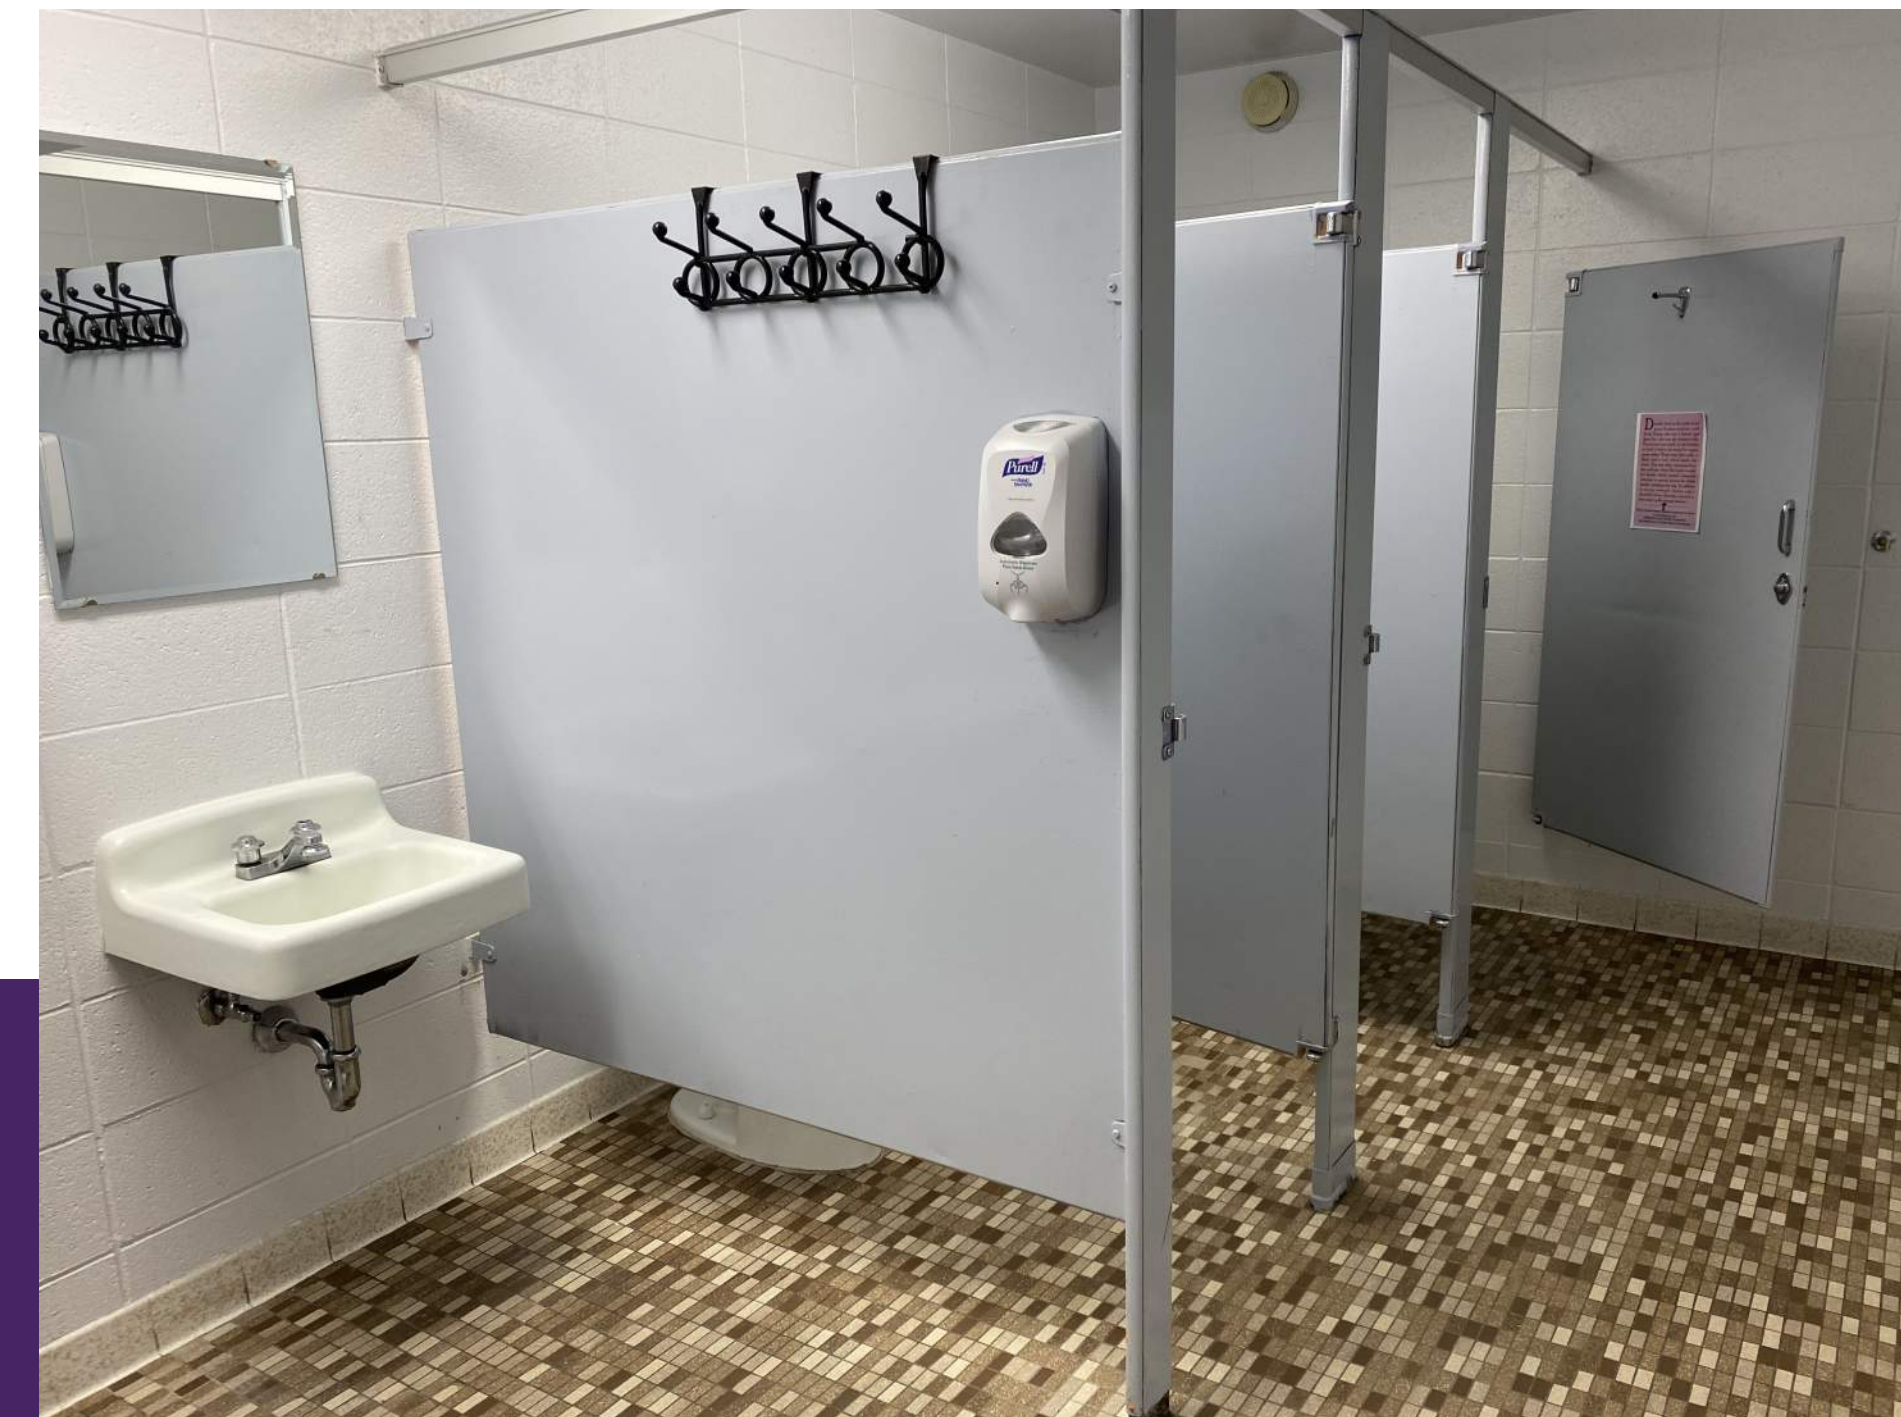
# RESTROOMS

- Most are in adequate condition
- ADA is a common problem
- Inadequate ventilation is a common complaint
- Fixture count appears adequate

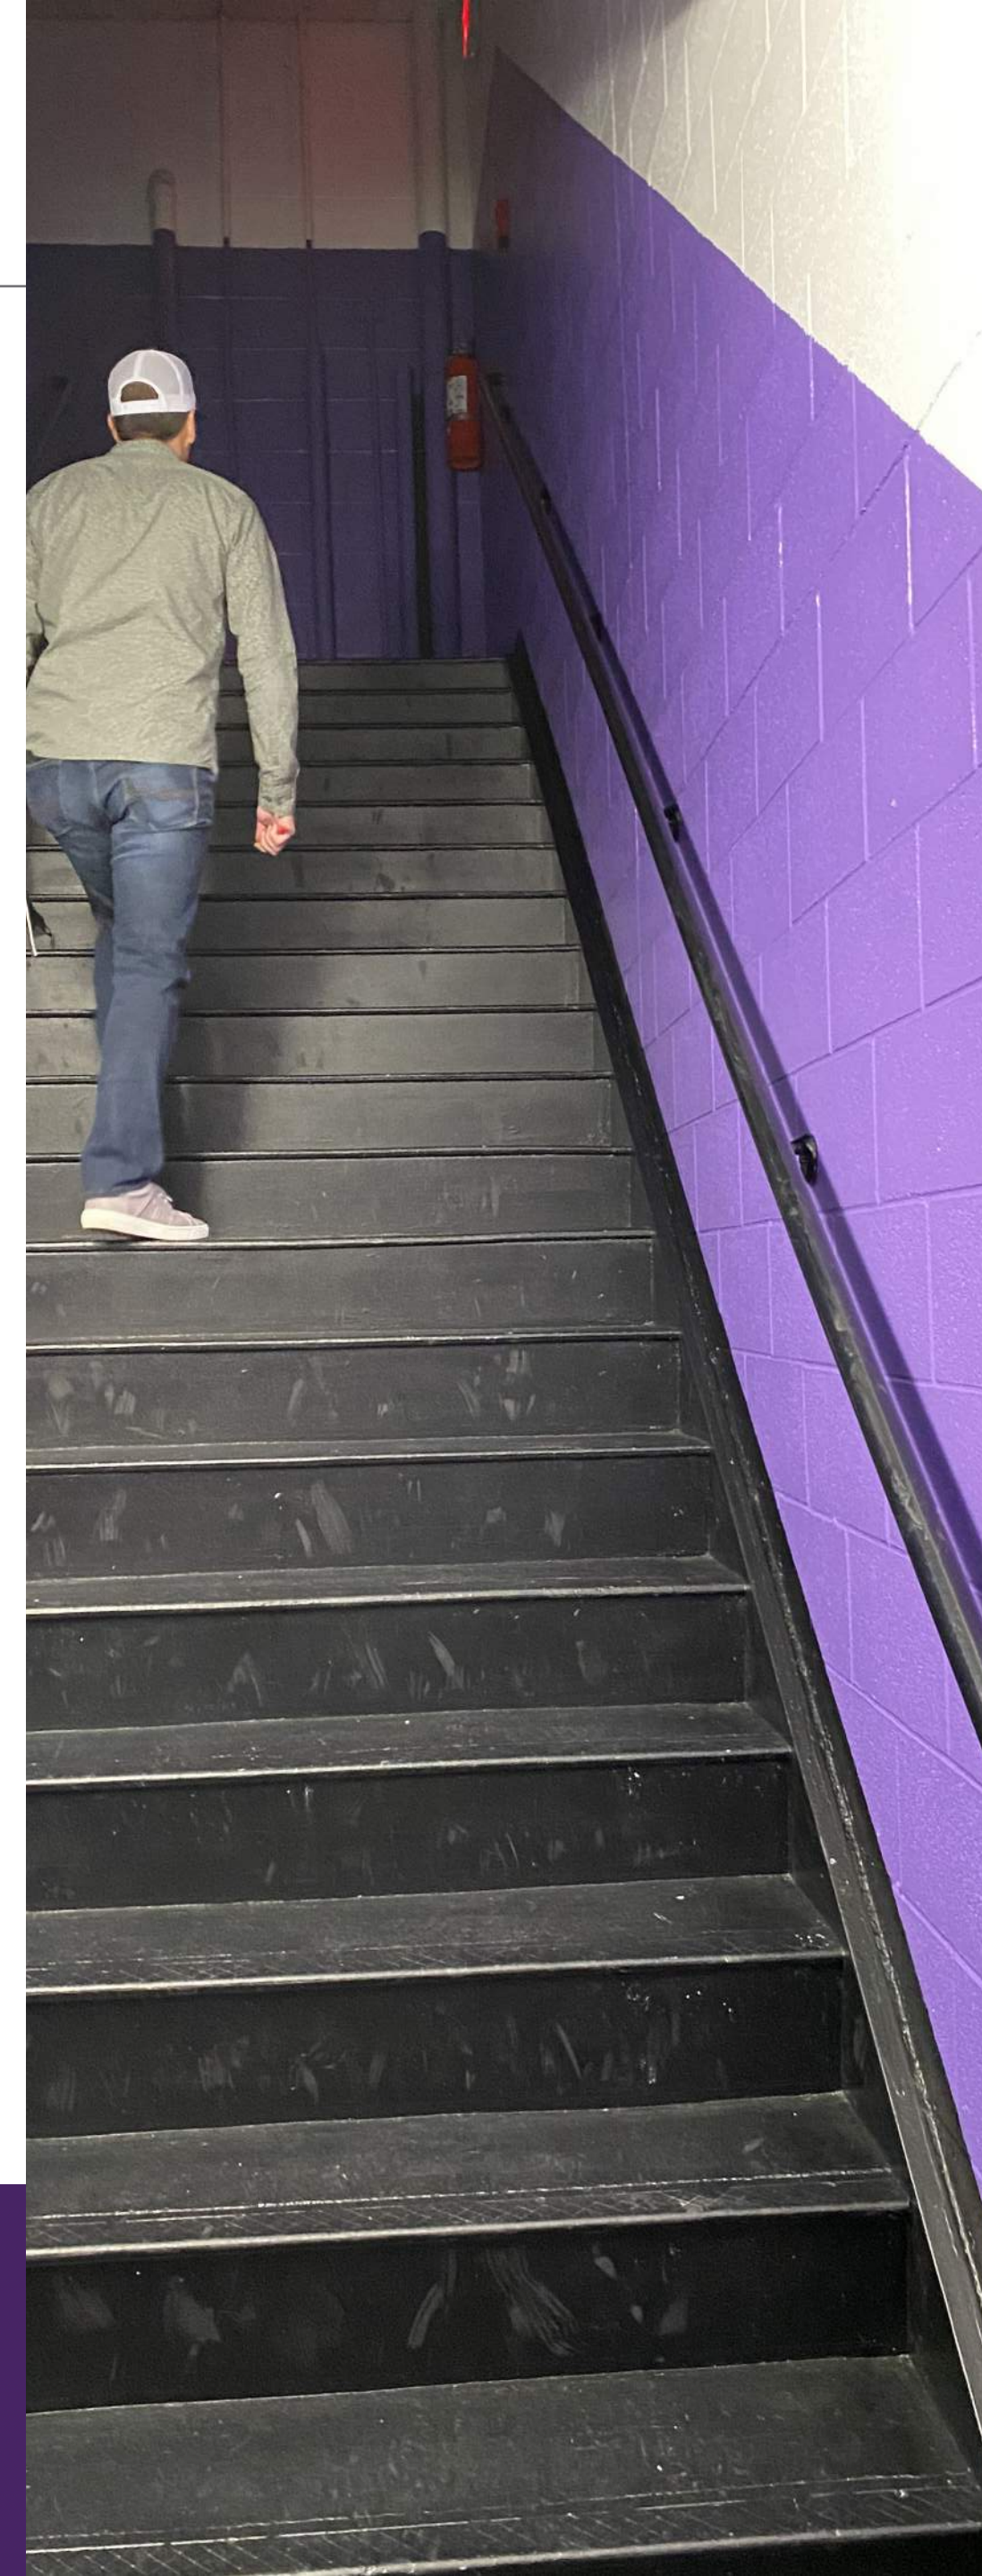
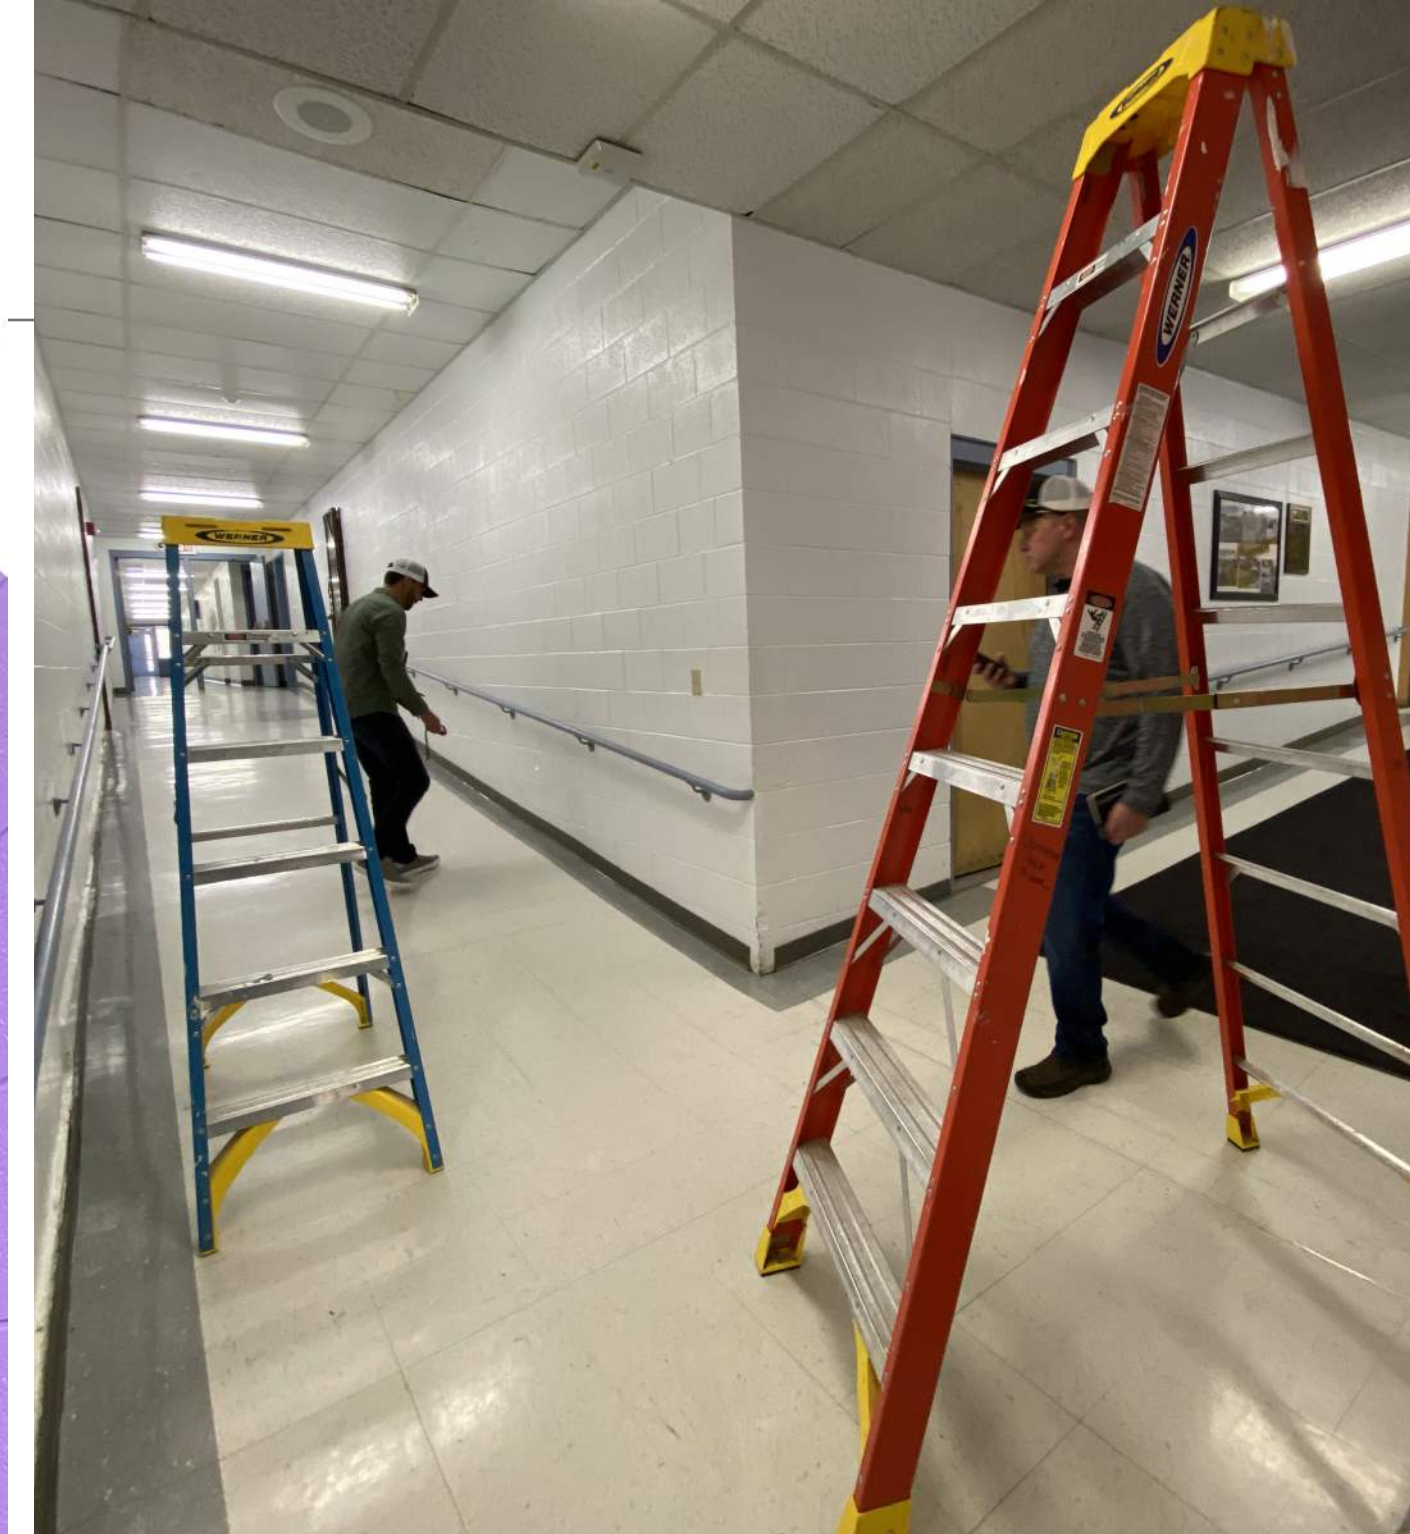
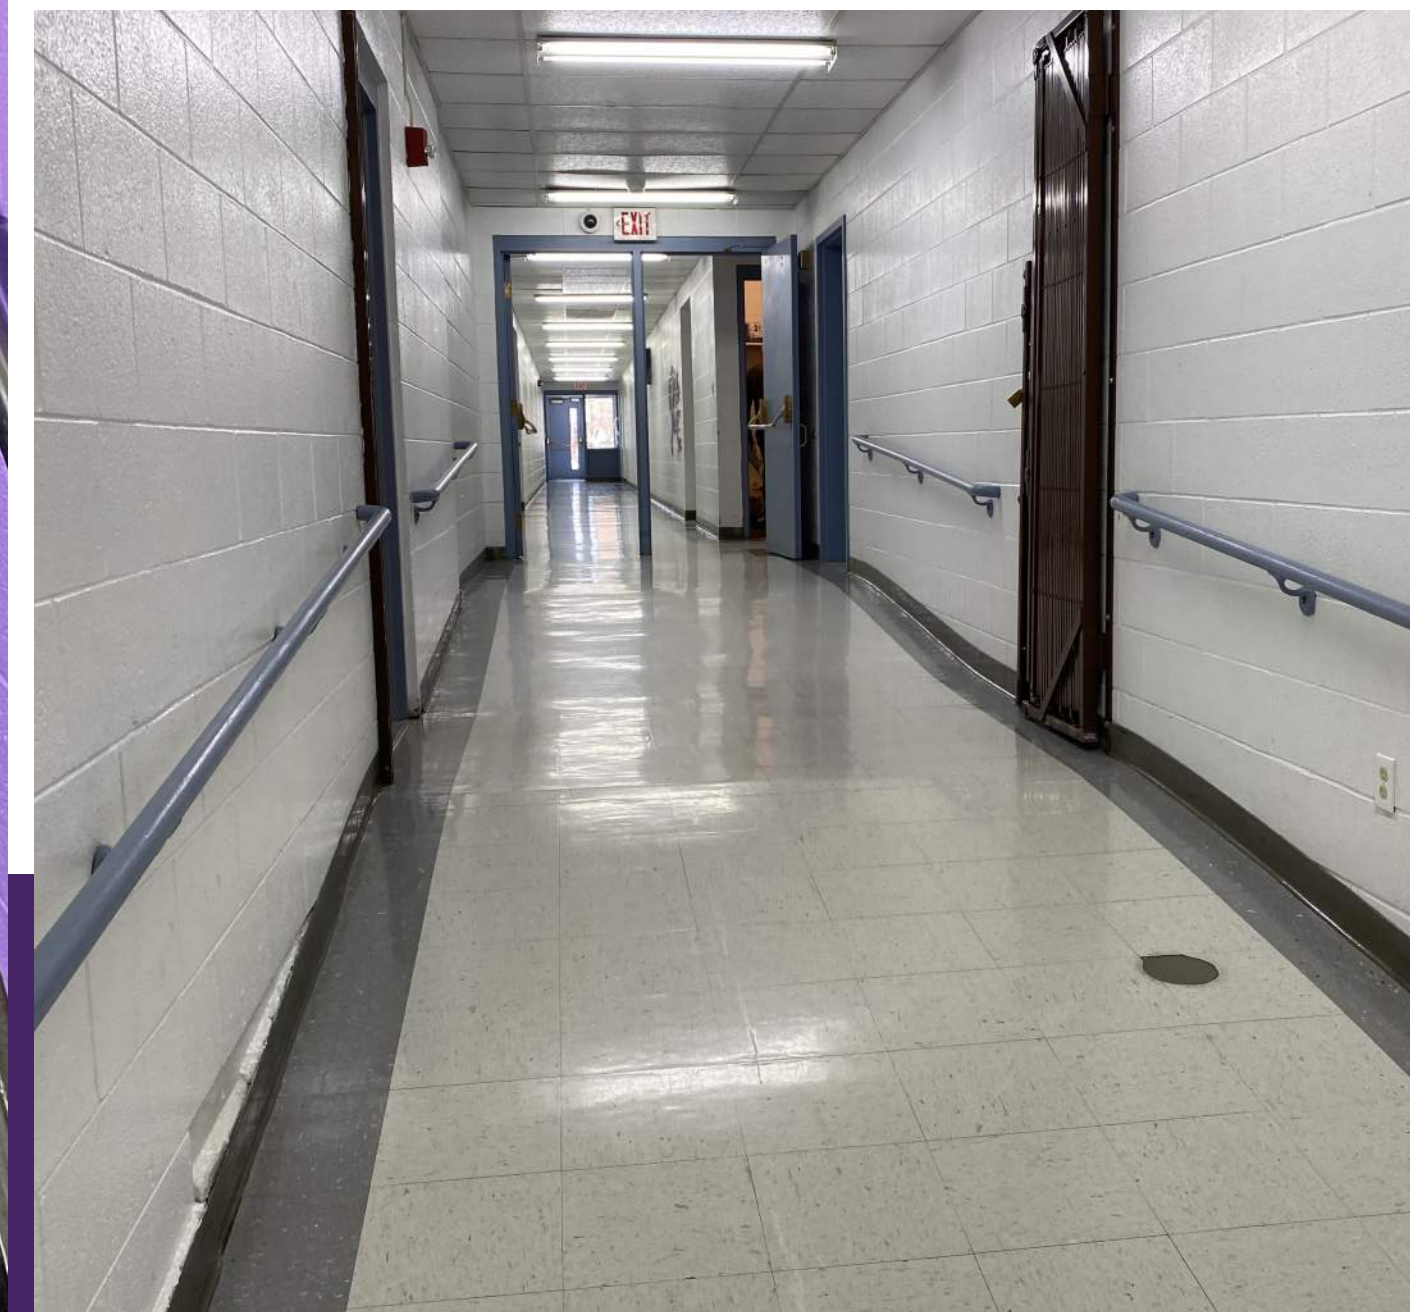
# INTERIOR STAIRWAYS & RAMPS

- Almost all ramps meet or nearly meet codes for slope, landings and railing requirements
- Stairs also meet code, excluding the weight room, and drama storage
