Jefferson High School Building Condition Report

312 S Main Street, Boulder, Montana 59632

July 30, 2020

SMAARCHITECTS

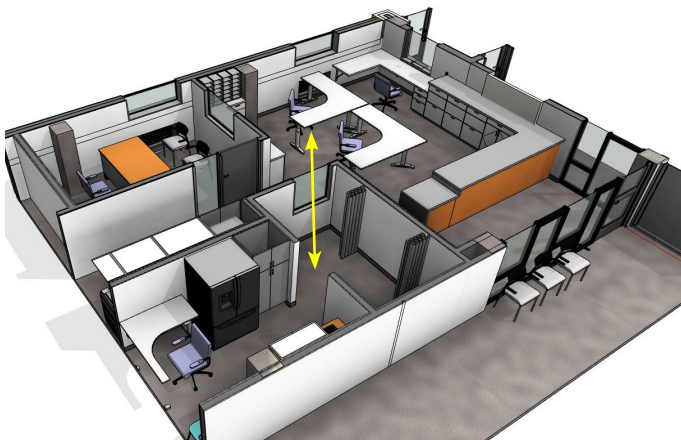
Front desk staff has views into the nurse's room and beds via a window. This gives the staff better monitoring in case of a problem.

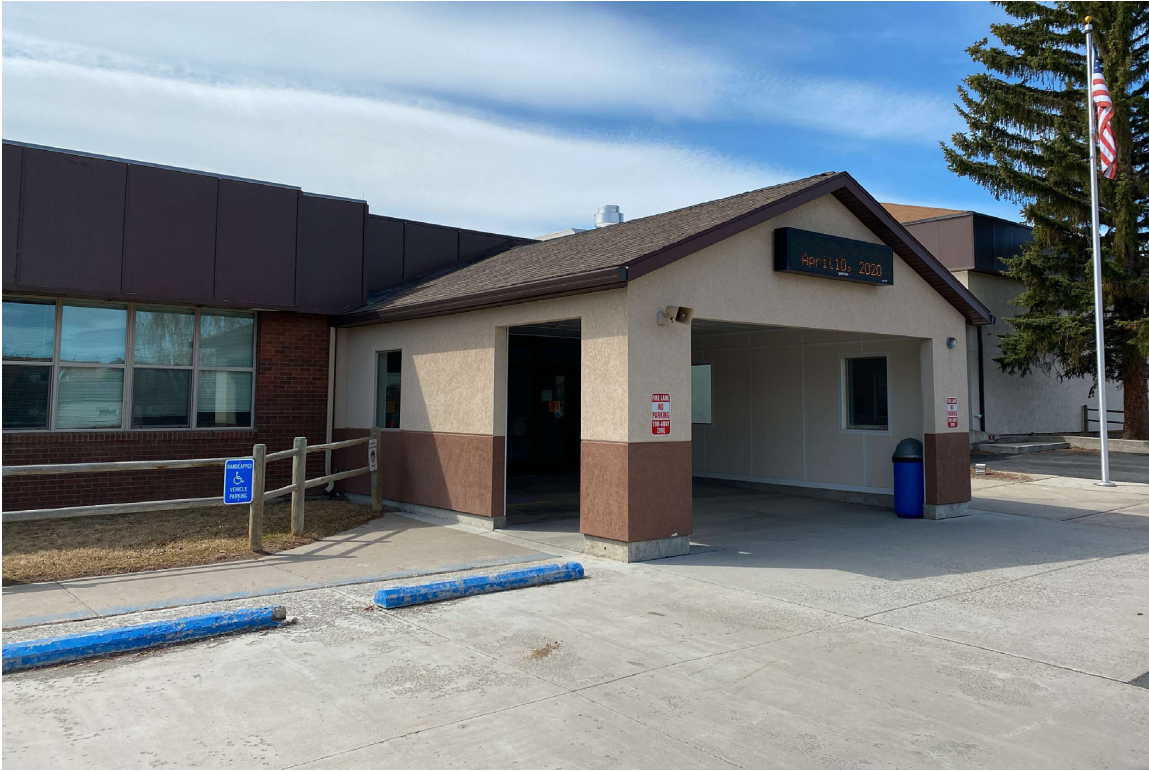
Front entry with overhead canopy and parking, facing East 4th Avenue.

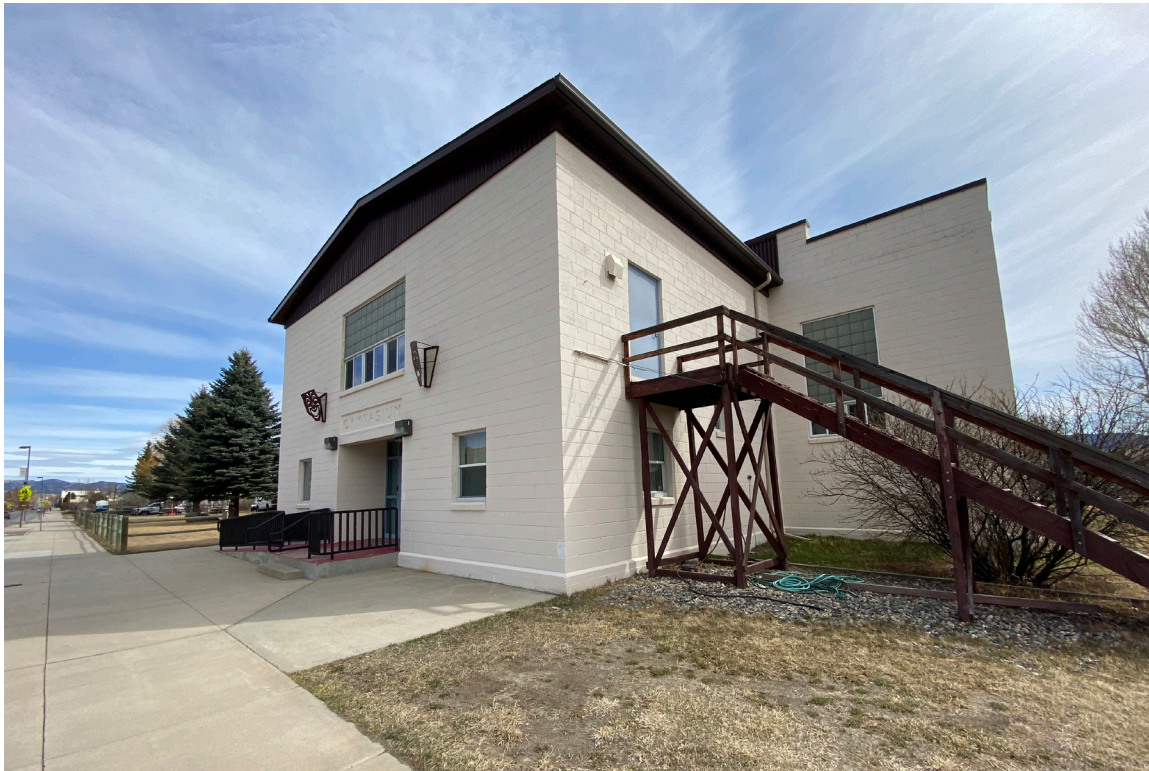
West entrance at existing gym and Art Room, facing Main Street. The entrance is very close to the street edge. Art Room egress stairs are on the right.

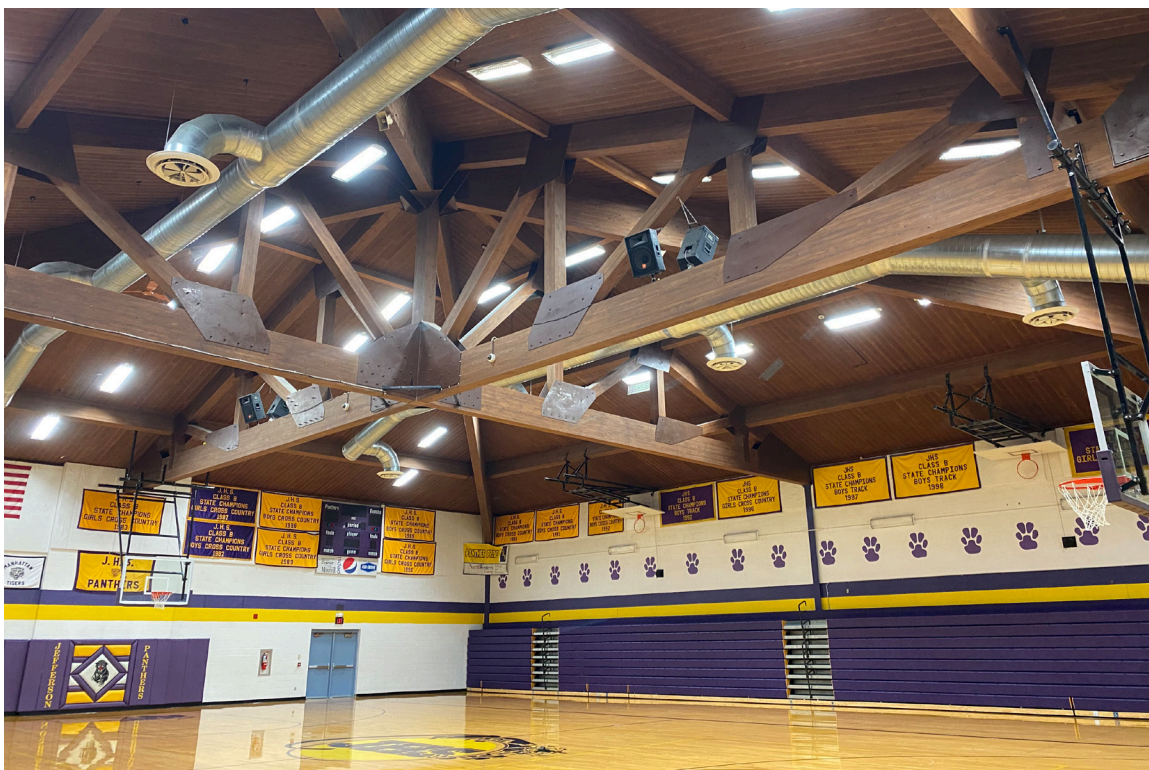
North (New) Gymnasium. Finishes and flooring are new and roof trusses are an attractive touch to this space.

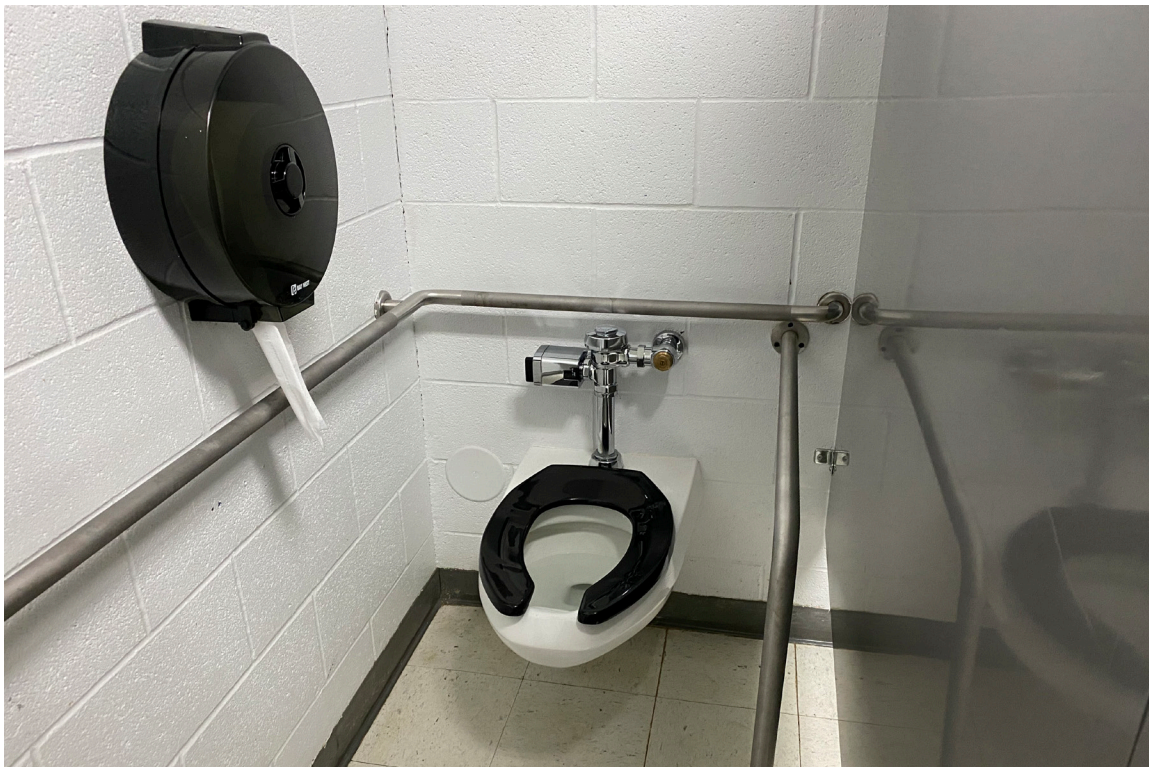
Toilet fixture and stall in restrooms adjacent to Cafeteria seating area. Even though it has several grab bars, this restroom, like most in the school, does not meet current codes for accessibility.

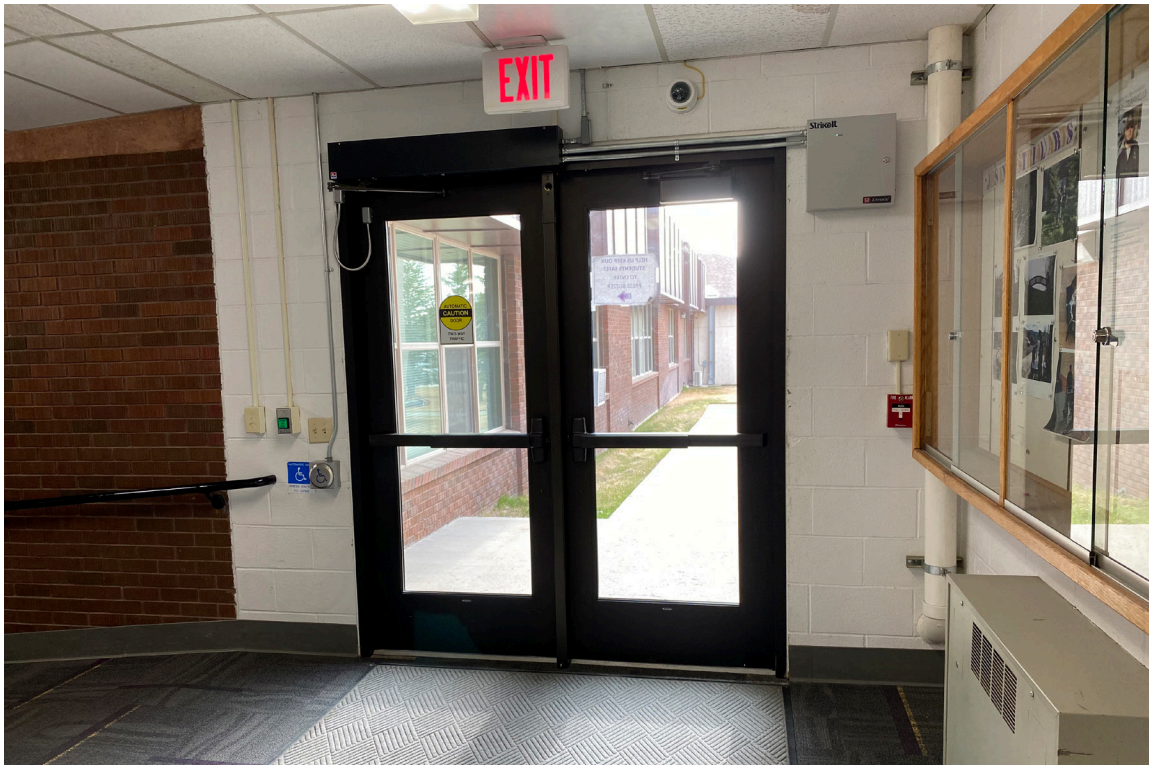
East entry door, looking east towards Area C classrooms and Area D Library. Recent security upgrades have improved access control for students and staff.

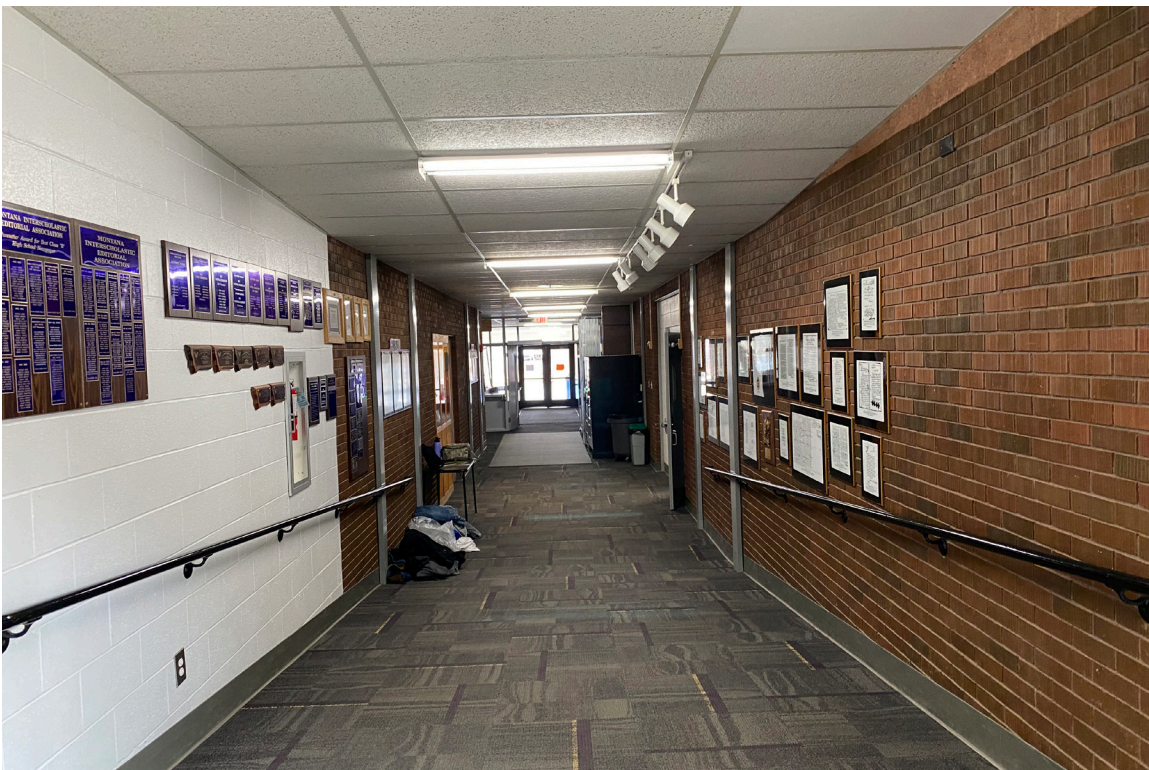
Looking north from the previous entry door location, down the ramp toward the front entry. Staff input was that this area is excessively busy between class periods and becomes a bottleneck. This intersection is the most direct way to access the gym, band room, shops, and weight room from the classroom areas.

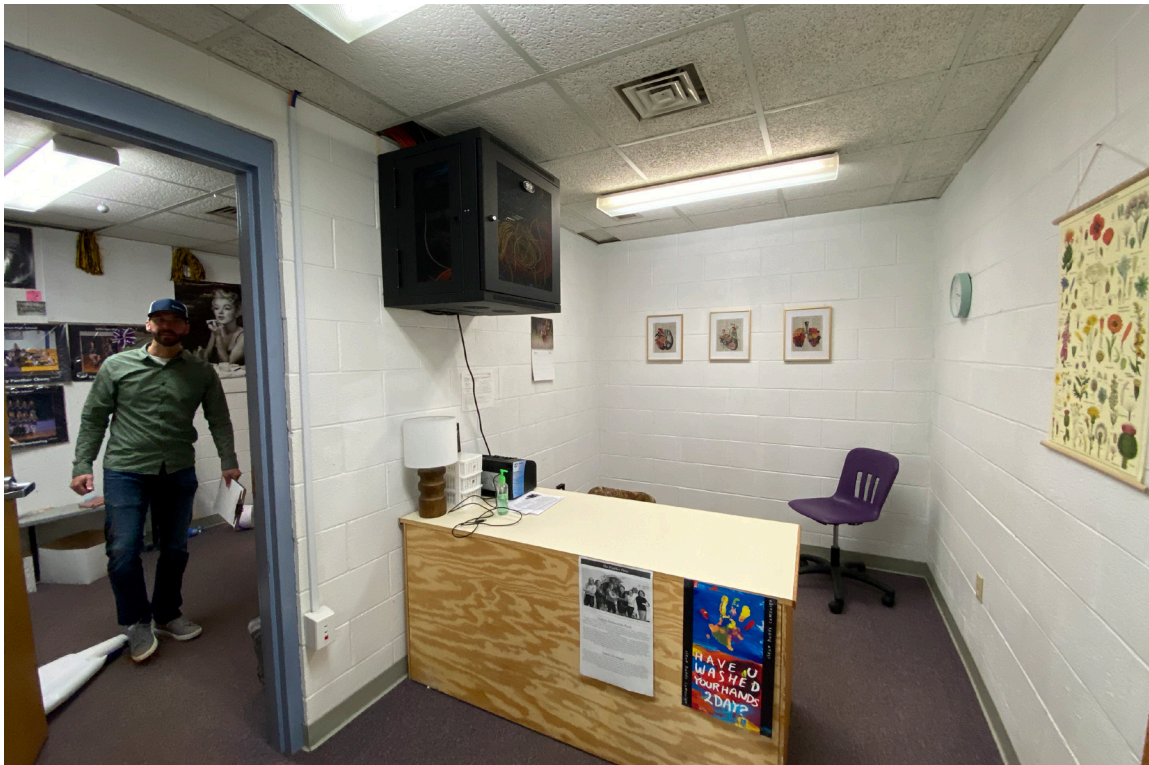
Nurse's Office. The large computer rack hangs above on the wall. Finishes in many of these offices are clean but small and outdated.

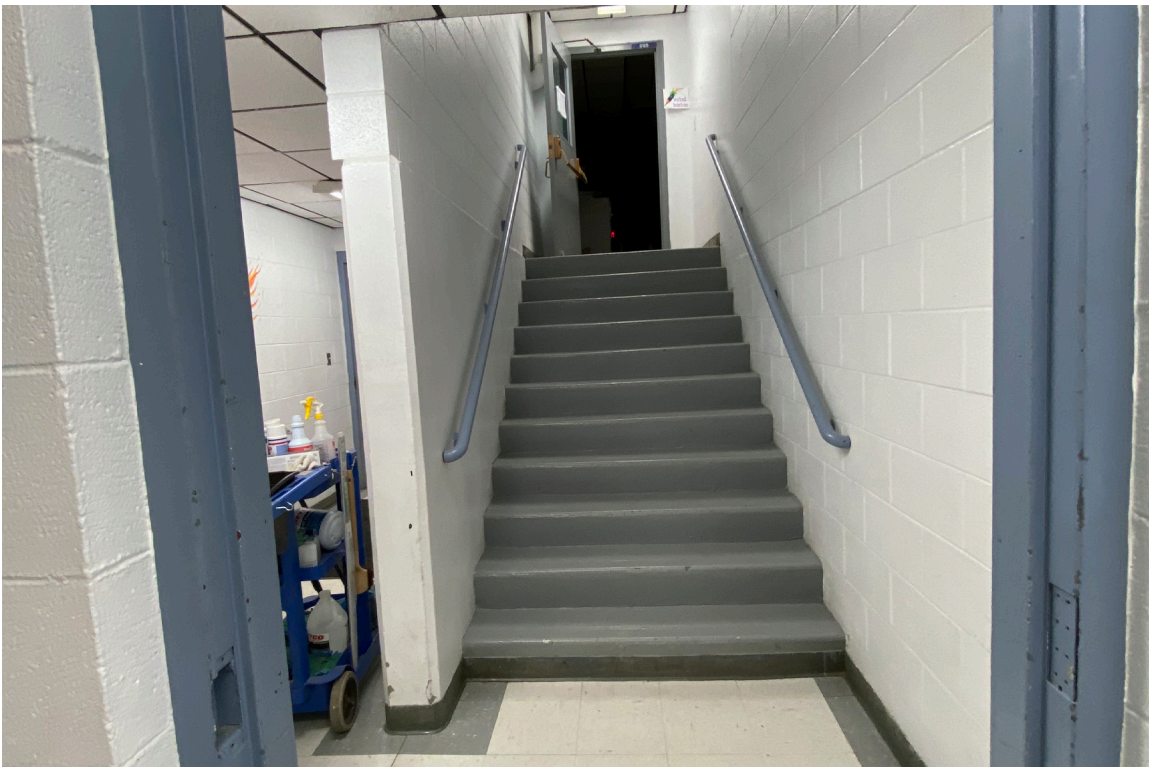
Stairs leading up to the Band Room from the Hallway. There is no accessible route to the Band Room, limiting access to those with mobility issues.

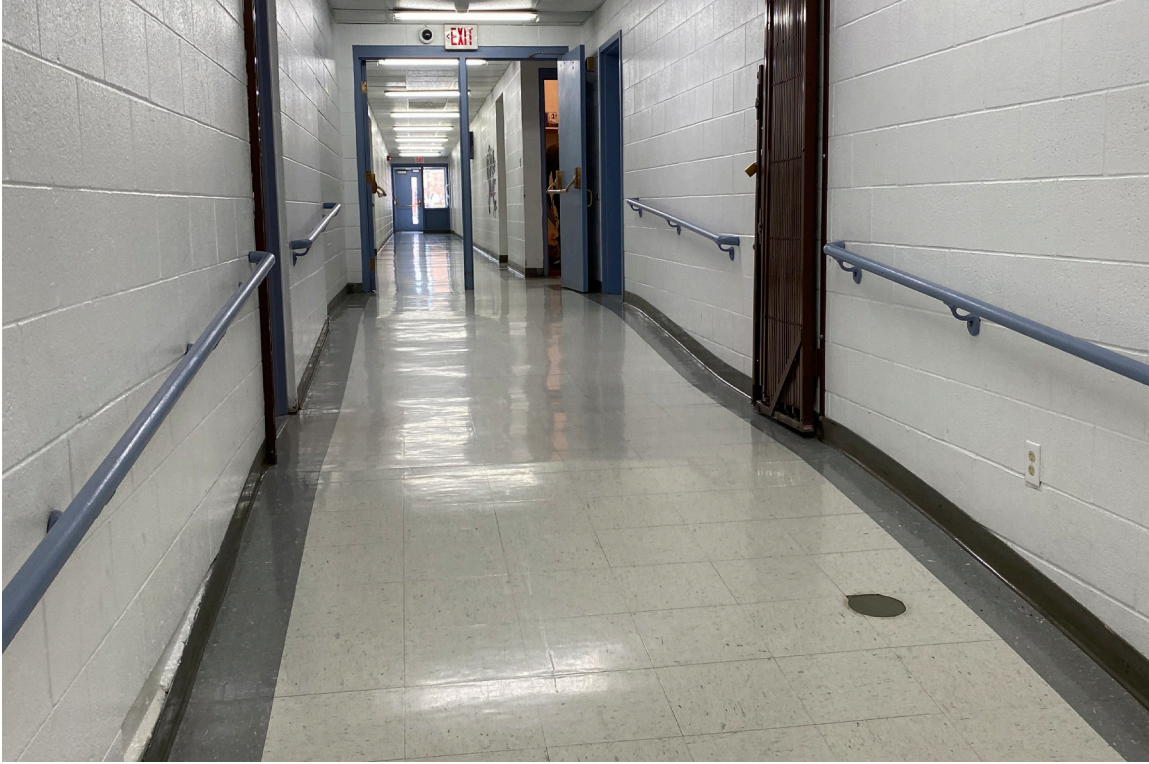
Ramps in main hallway running east-west. Landings, handrails, and slopes all appear to be within current ADA requirements.

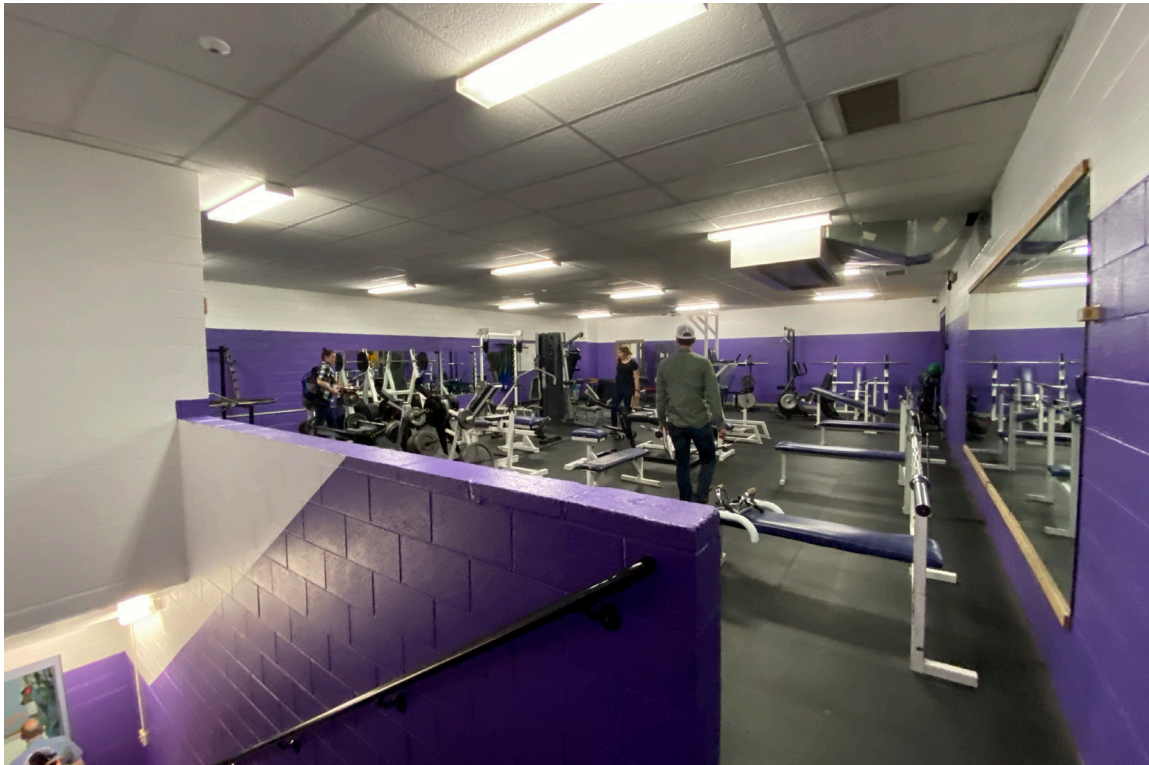
Weight room mezzanine above locker rooms and North gym. Top of stair landing area is too small for current codes.

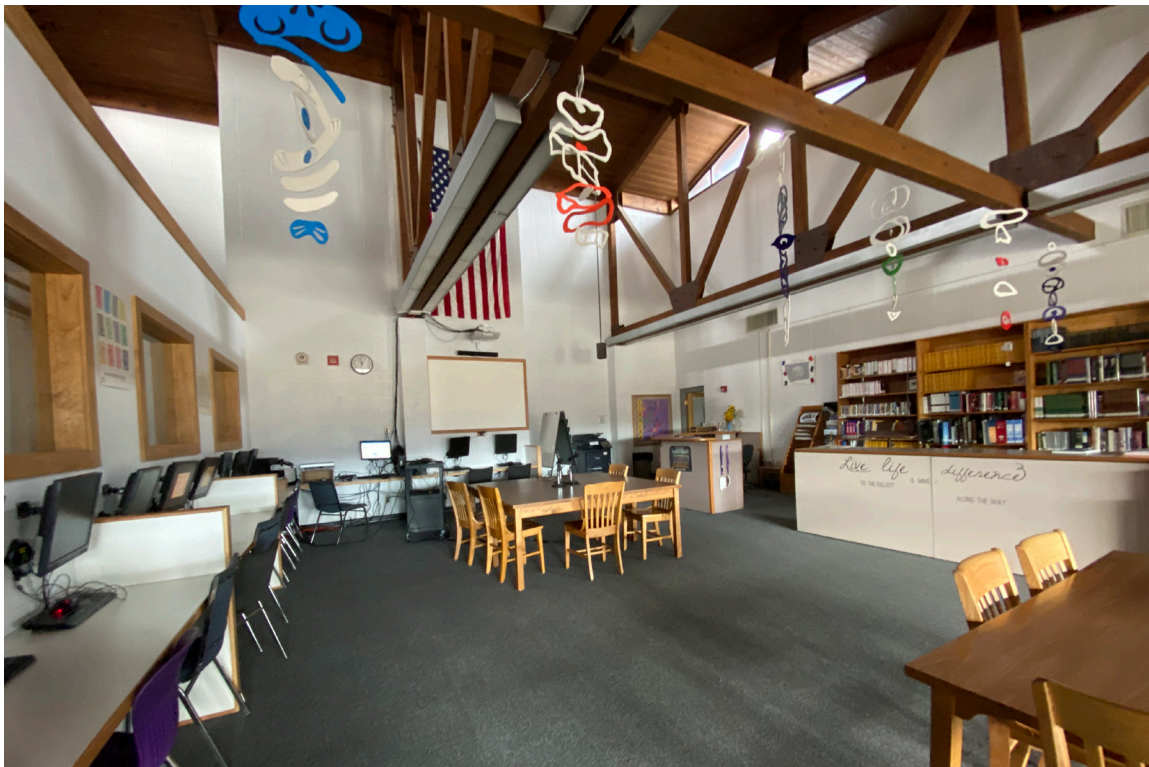
The library space with exposed wood trusses.

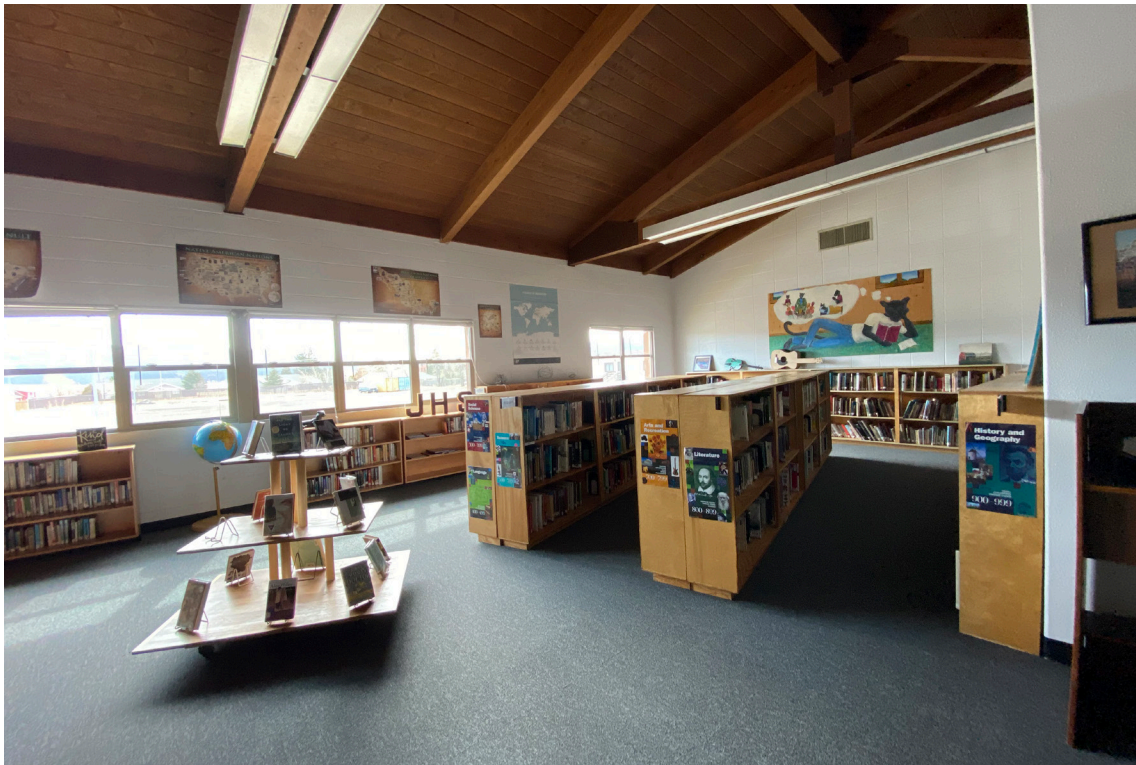
The library windows have to be opened in warm weather to cool the space. During bus loading times, this can make this area noisy.

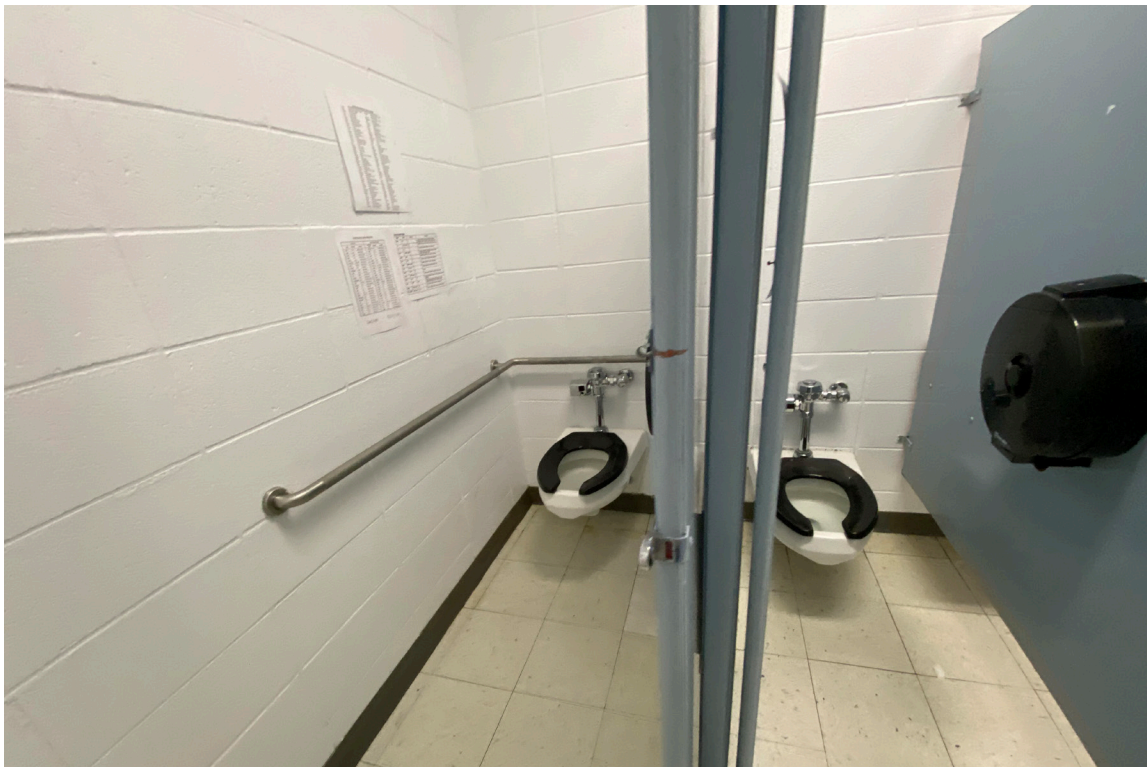
A typical ADA stall in the school. While the grab bars do provide assistance in transferring to the seat, these stalls are not up to current ADA design guidelines.

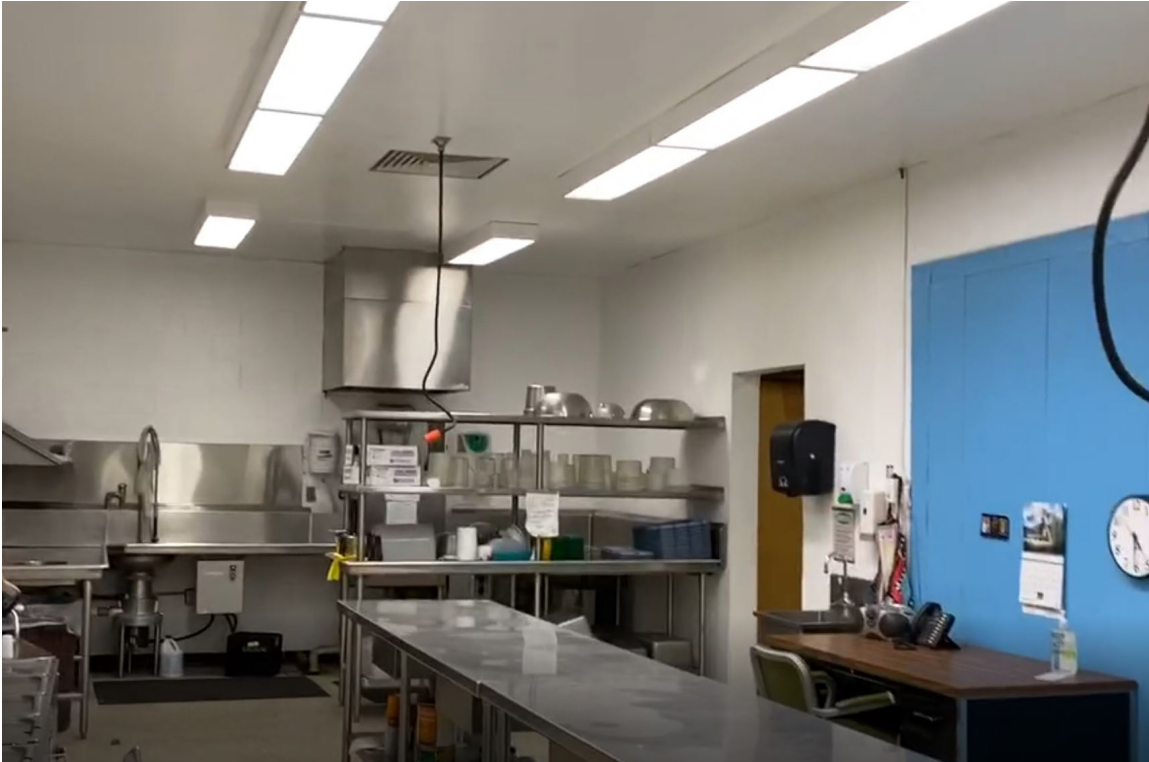
The kitchen dish drop area and prep table. Most of the kitchen equipment appeared to be in good condition.

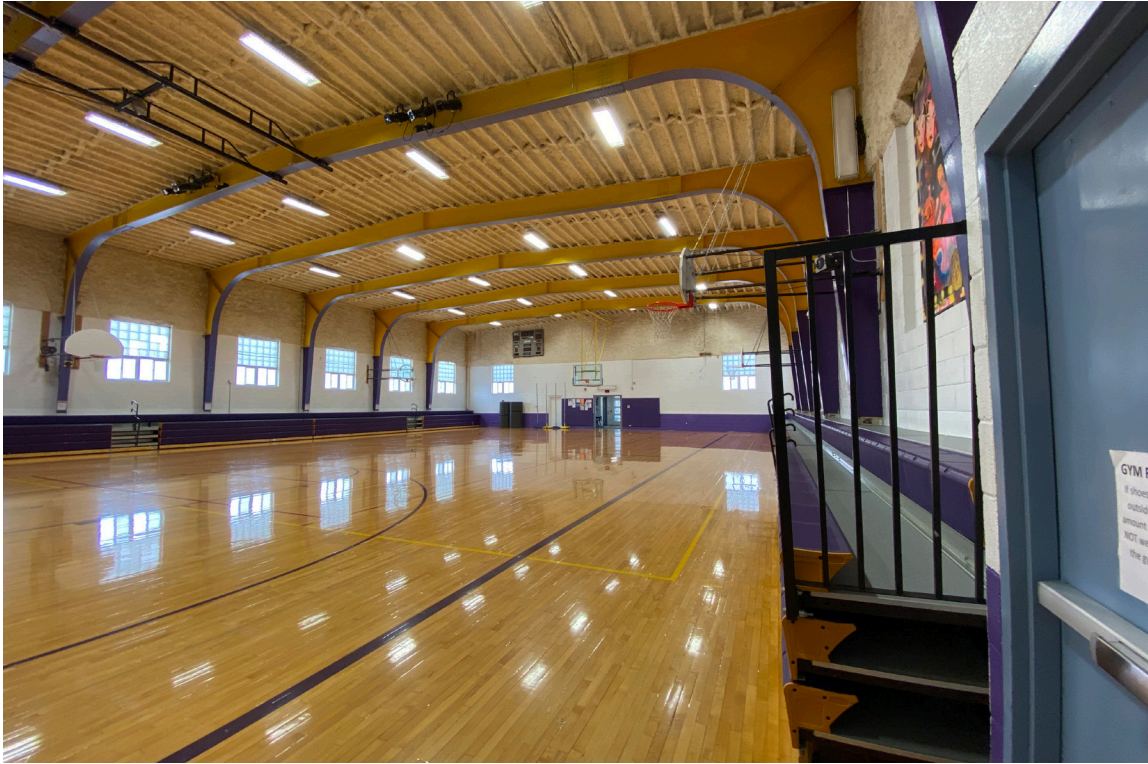
Existing (South) gym. This space is reportedly loud for drama and theater presentations, and is shared with athletics. The spray insulation on the ceiling needs to be verified for flammability and smoke spread, as the design team is not confident it should be left exposed.

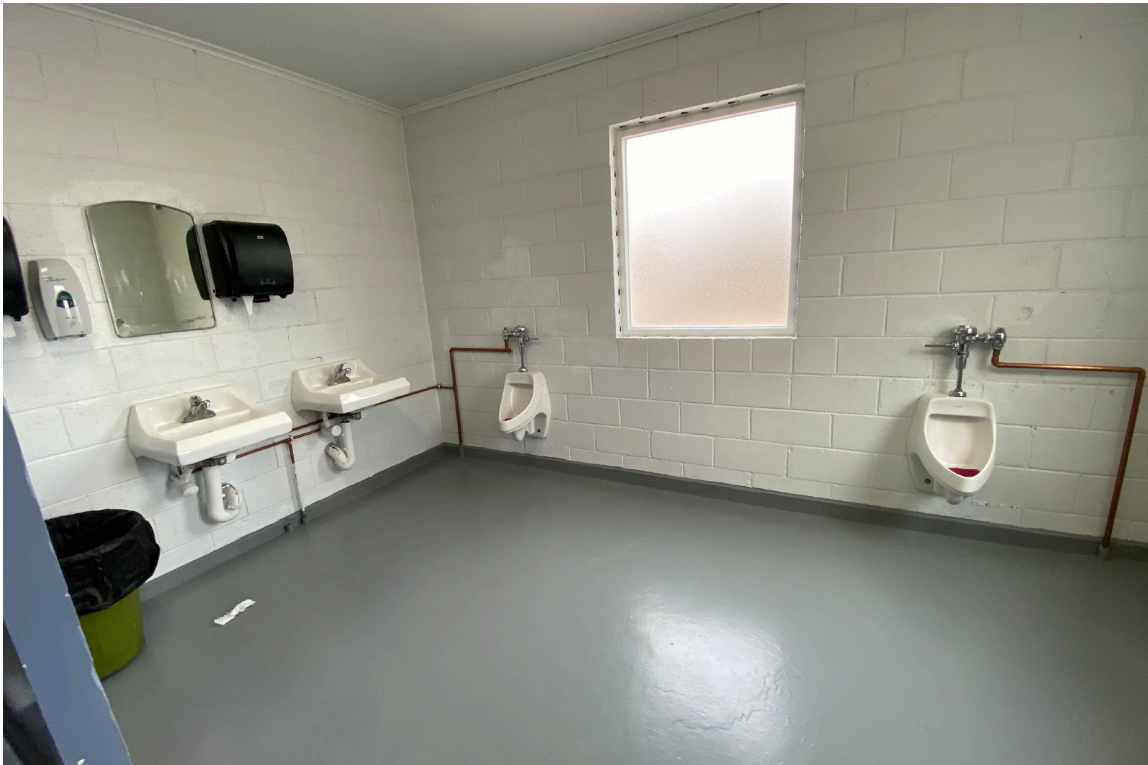
Men's restroom at the west entrance by the Existing Gym. While this room has plenty of turning and clearance space, these restrooms could be better configured to serve more students.

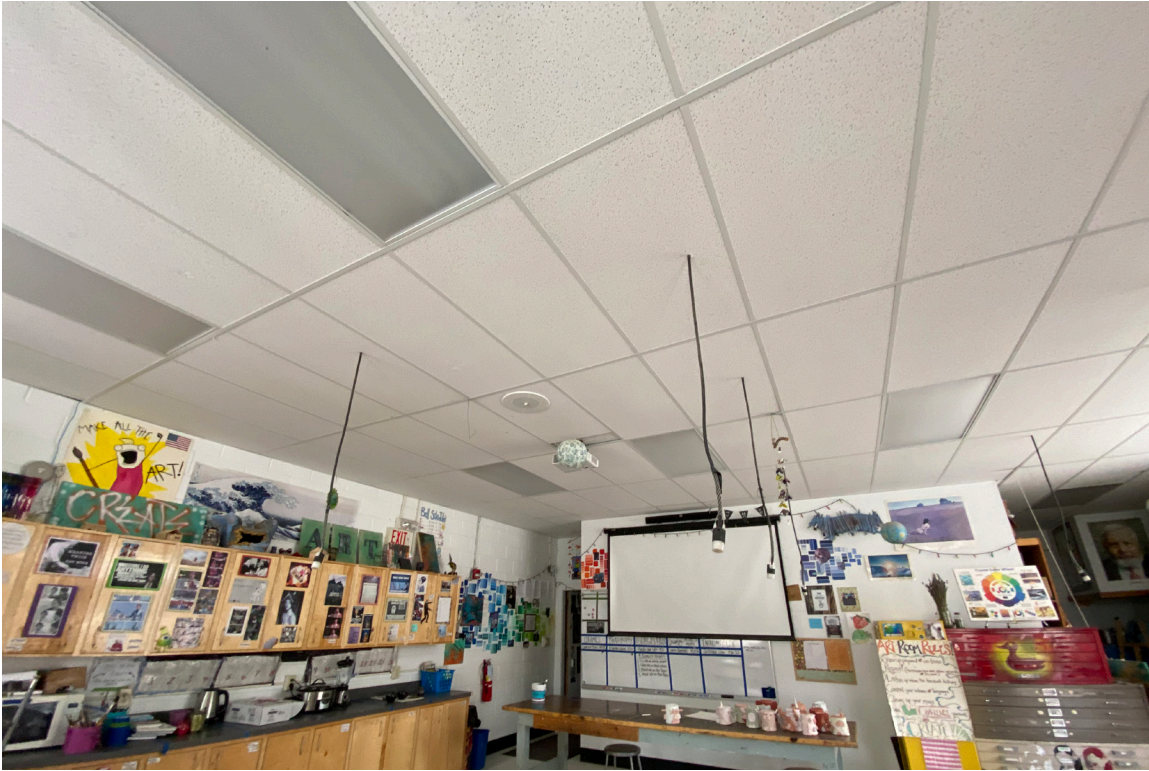
The Art Room, on the second floor. This room is only accessible by stair.

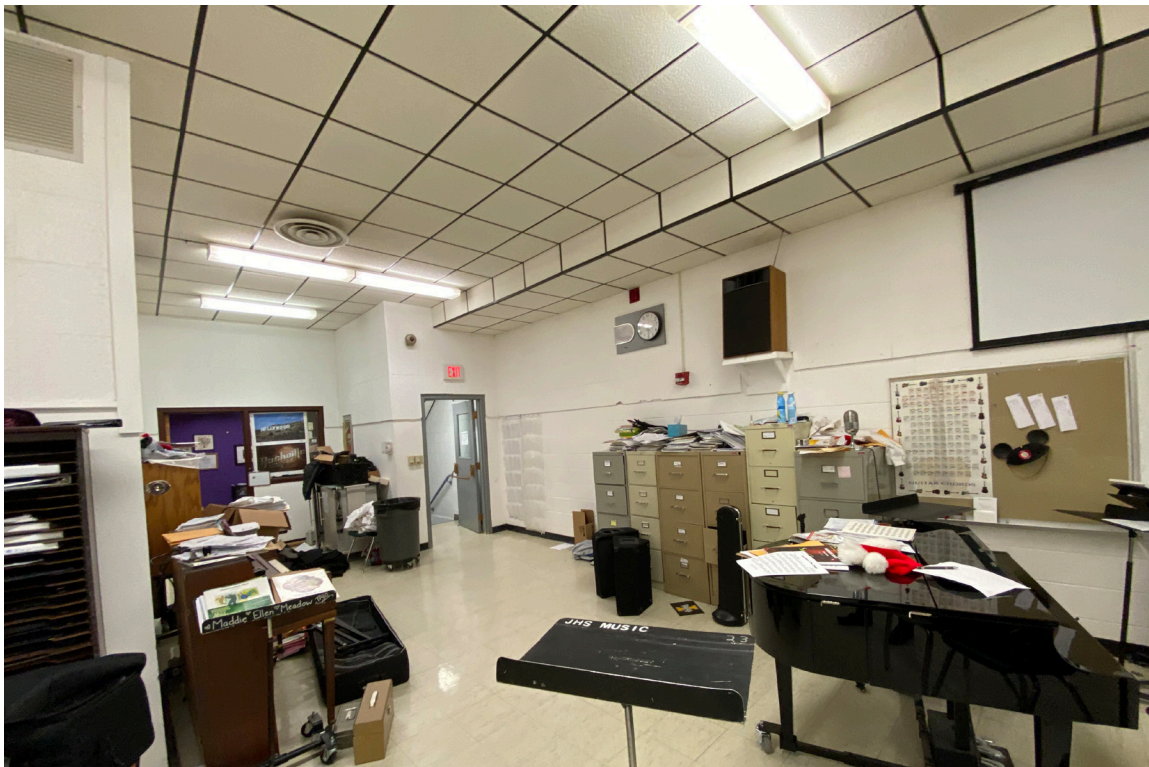
The Music/Band room, also only accessible by stair. This limits access to students and staff with mobility issues.

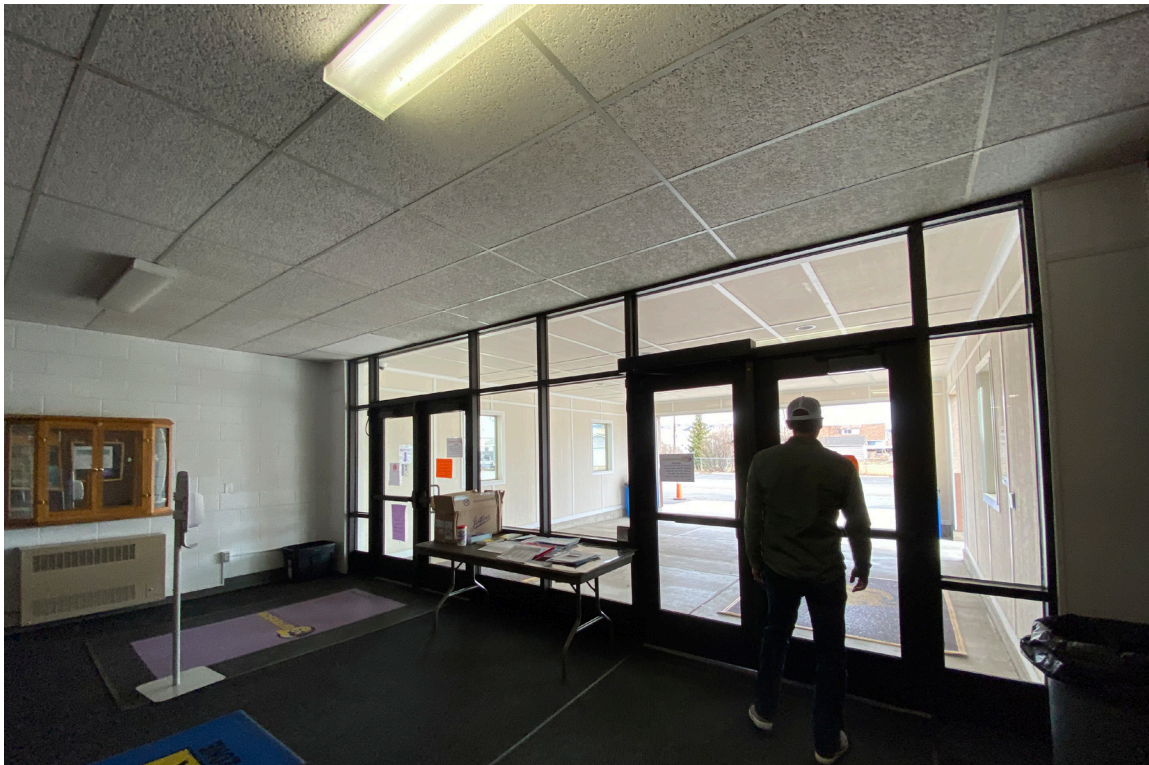
North-facing front entry doors. These have also been upgraded with enhanced security, including a camera and intercom to verify visitor access.

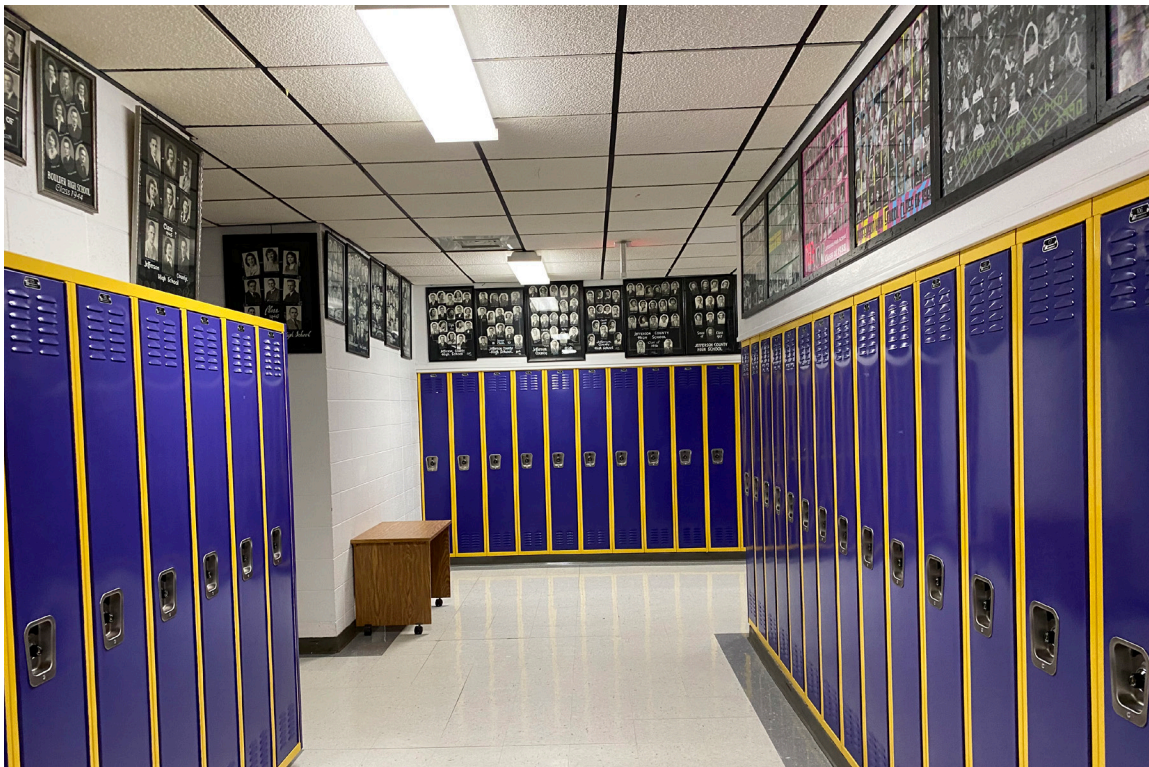
Hallway in Area C, the 1974 addition. Lockers appear clean and new, and hallway widths are acceptable for a school of this size.

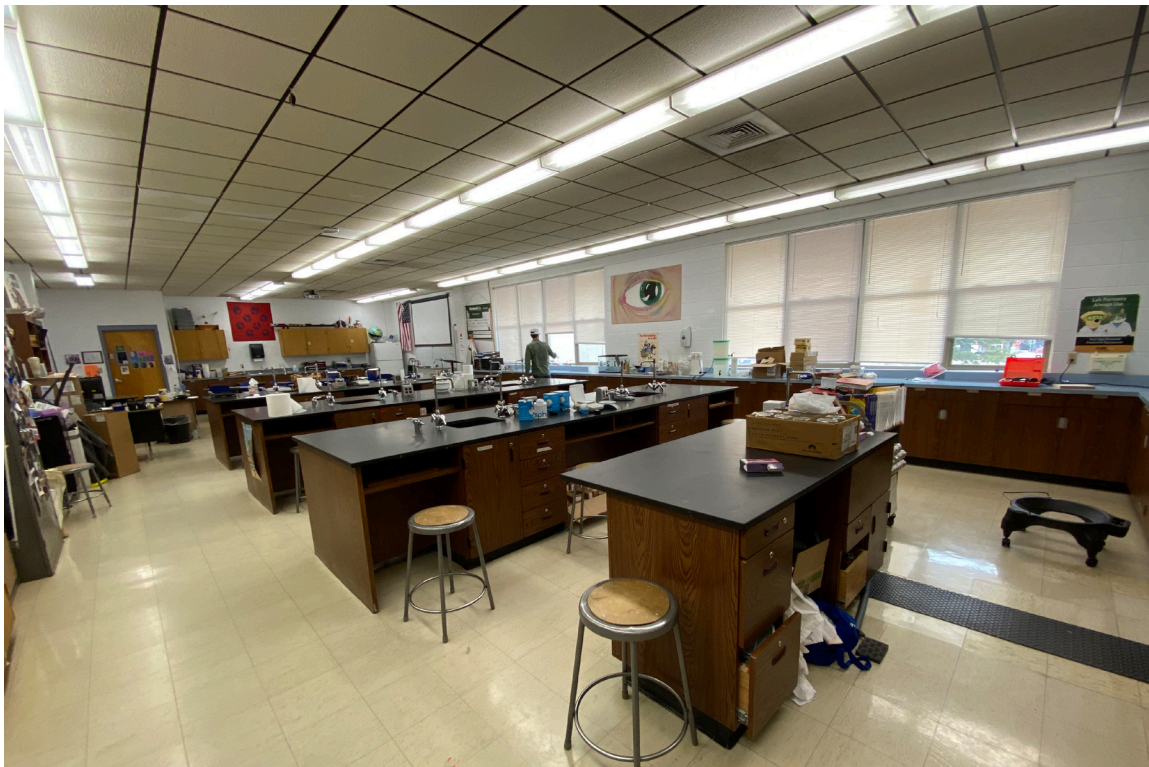
View of the Physical Sciences room. This room is a good size for a science room, based on current design guidelines.

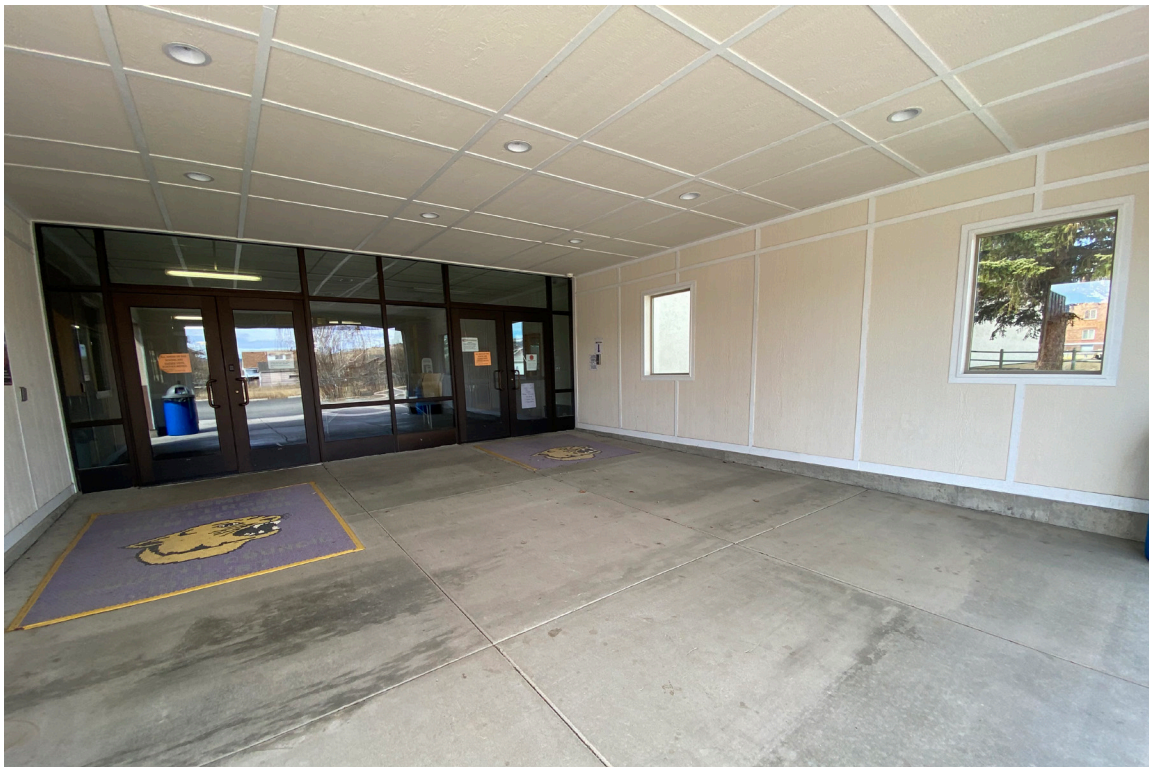
Front entry with overhead canopy and parking, facing East 4th avenue. This large covered entrance provided exceptional weather protection for students entering the building.

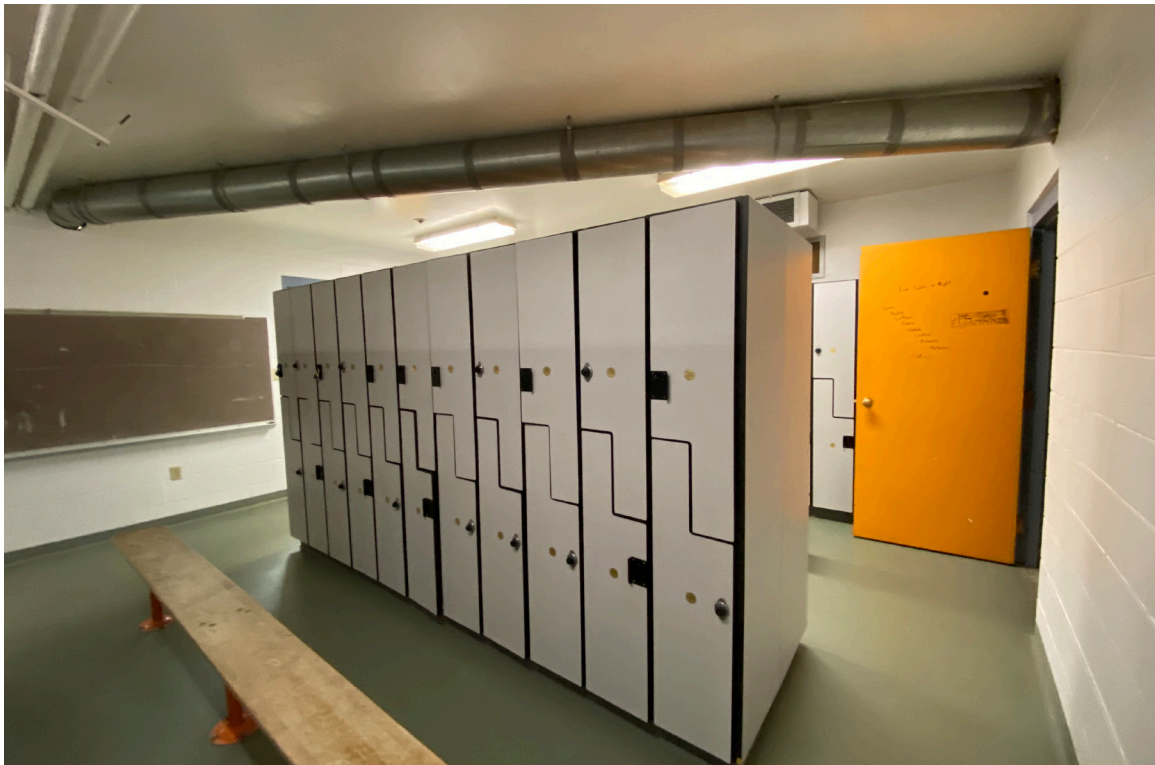
Women's lockers in the lower level of the Existing (South) Gym area. These locker rooms were reported to have issues with accessibility, ventilation, and adjacency to the Men's locker room. These are only accessible by stair.

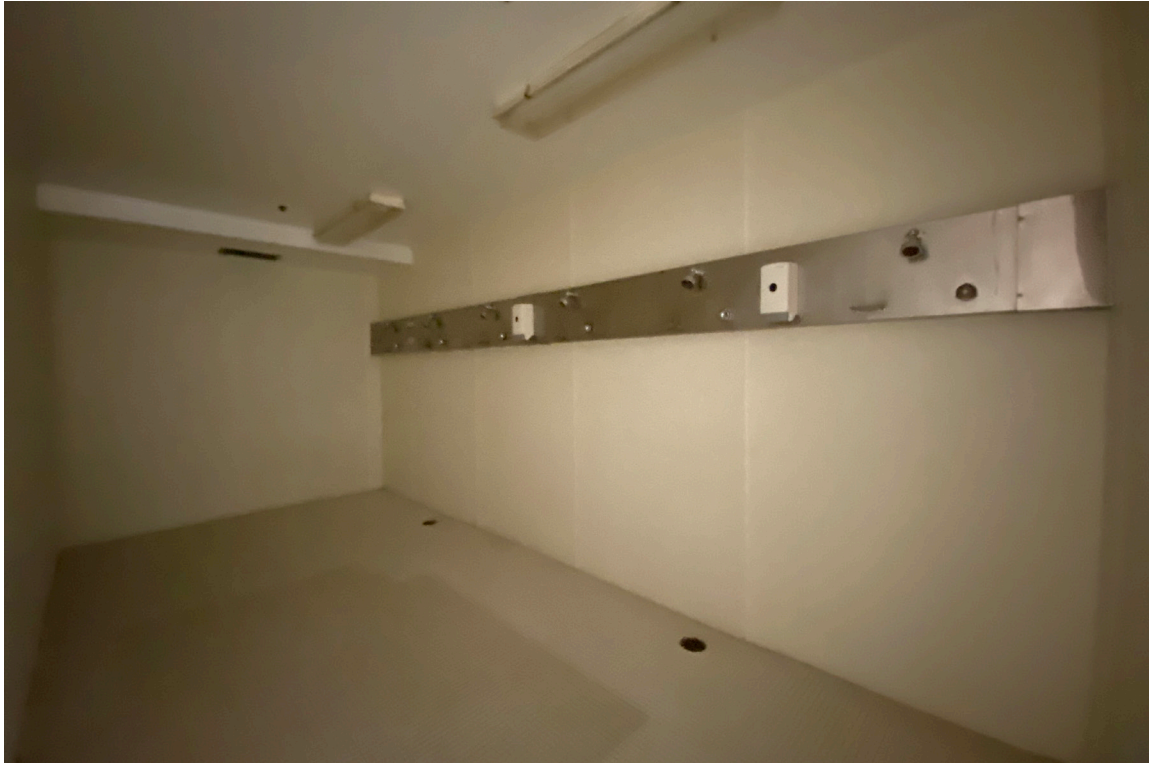
Gang showers in the lower level locker rooms are no longer designed in schools due to bullying and body shaming issues.
