Jefferson High School Building Condition Report

312 S Main Street, Boulder, Montana 59632

July 30, 2020

SMAARCHITECTS

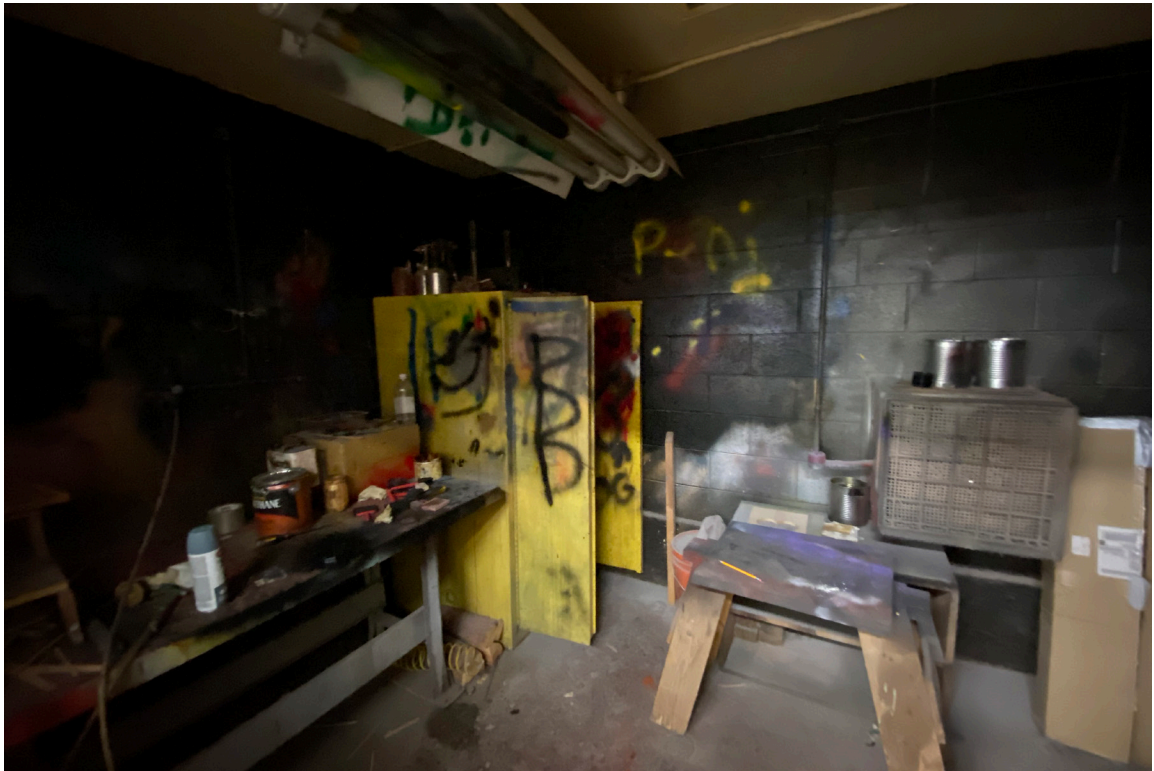
Spray booth in the CTE space. Problems of overspray are reported.

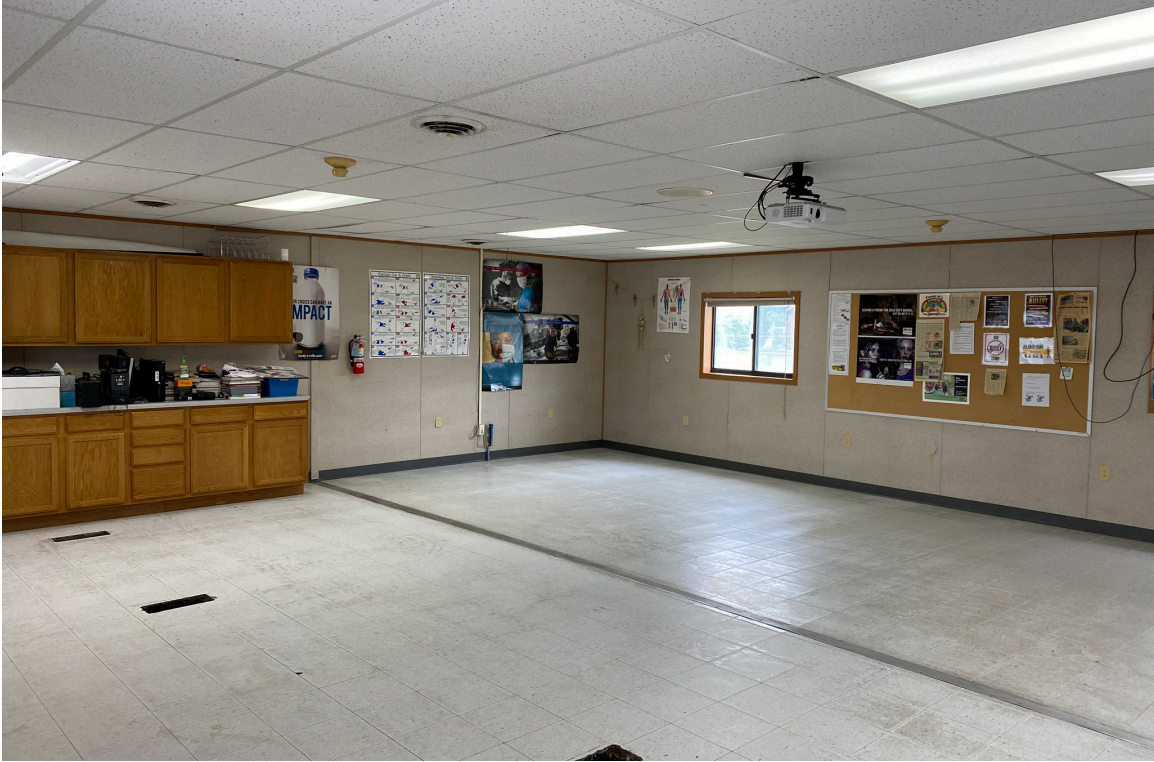
Another modular classroom. Maintenance has been kept up in these rooms and they have floors, ceilings, and casework in good condition. ■

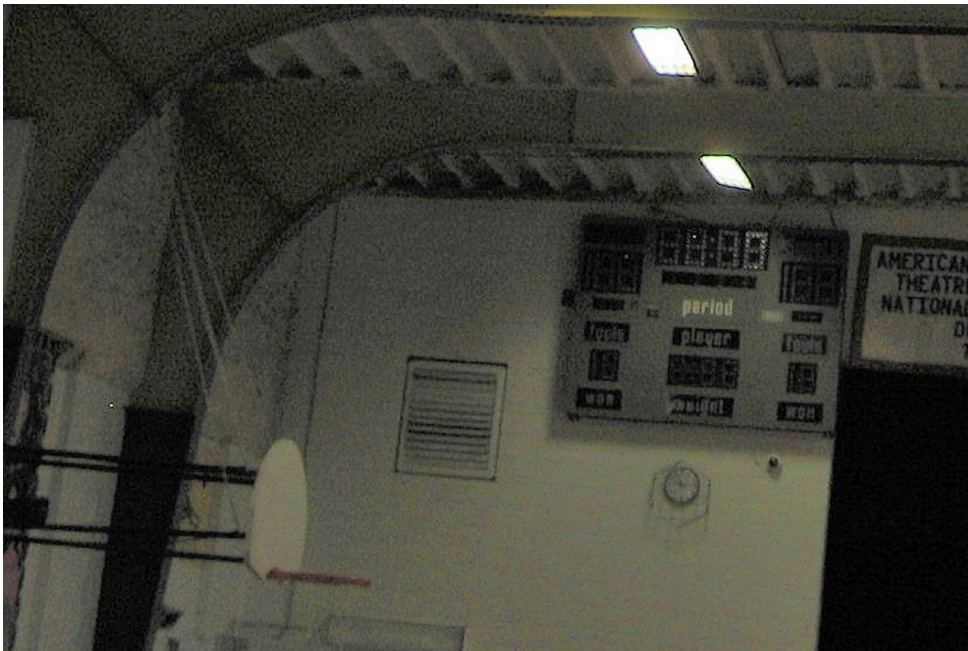
M2: Old Gym Unit Heater

Age and Existing Conditions: The heating units are original to the 1956 gymnasium and are in need of replacement.

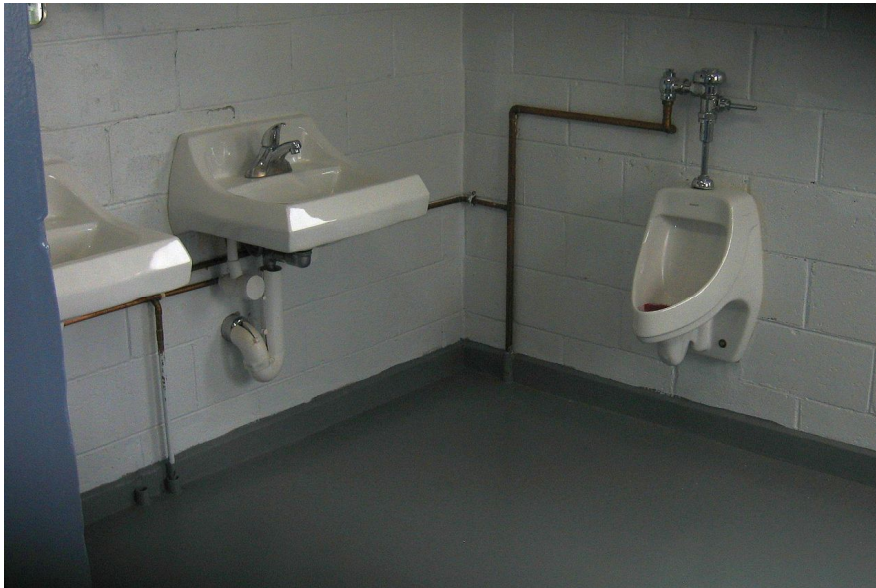
M4: Old Gym Area Urinal

Age and Existing Conditions: I was not able to determine the age of the fixtures, they are an older style, but in decent condition. They are flush valve and appear to be functional.

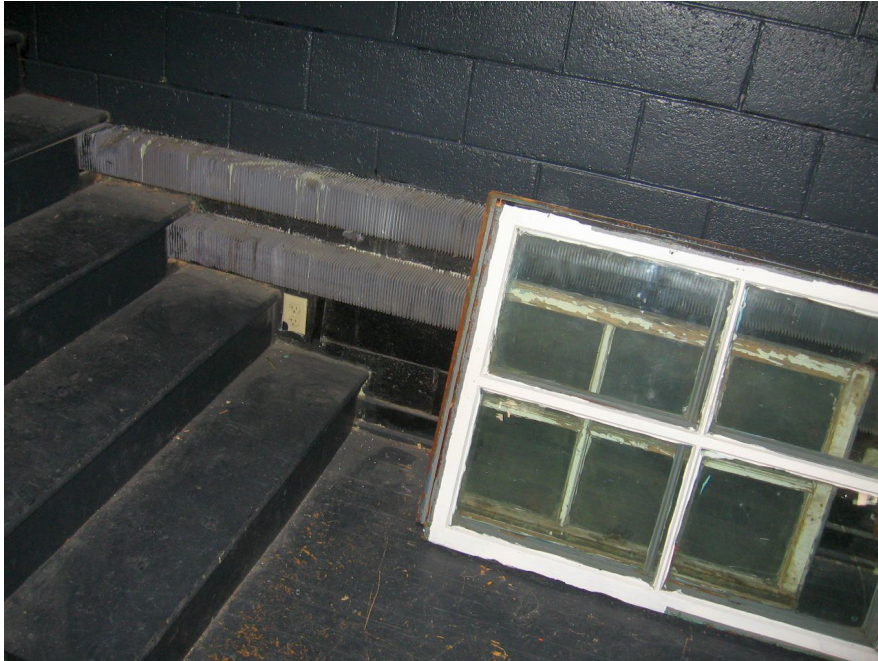
M5: Stage Fintube

Existing Equipment and Systems: This area does not appear to have any HVAC or H&V air provided. It is heated by two pieces of exposed hot water fintube installed on the East wall without a cover. The fintube is dented and damaged and the South unit has had the TC valve replaced. (See M5)

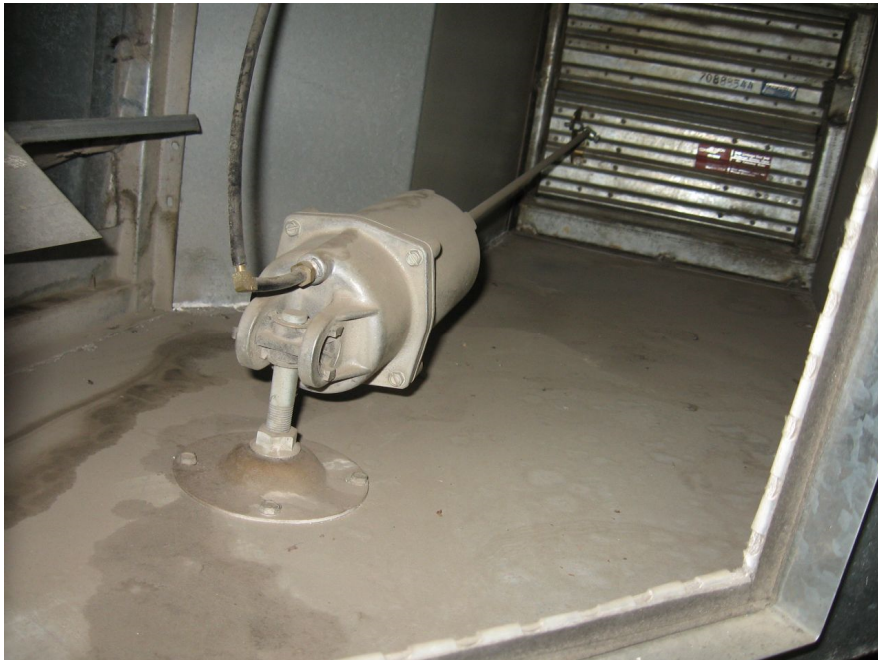
M16: Furnace Outdoor Air Pneumatic Damper

The temperature control system is a combination of older pneumatics and electronic controls and stand alone electric thermostats. Parts availability for the pneumatics is difficult and the controls overall should be upgraded to a DDC system with the heating water control valves replaced.

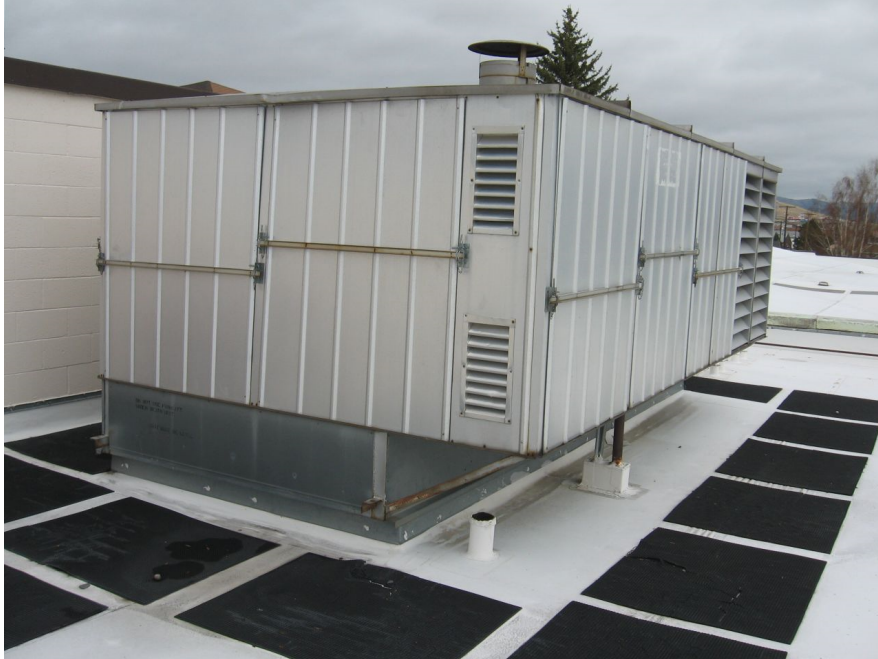
M19: Wood Shop Rooftop Unit

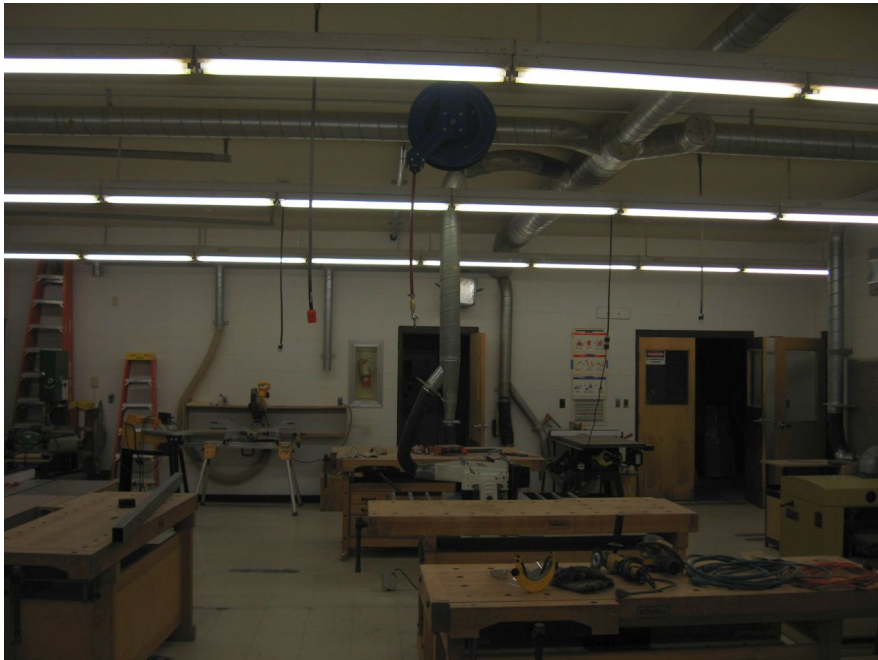
M20: Wood Shop Exhaust

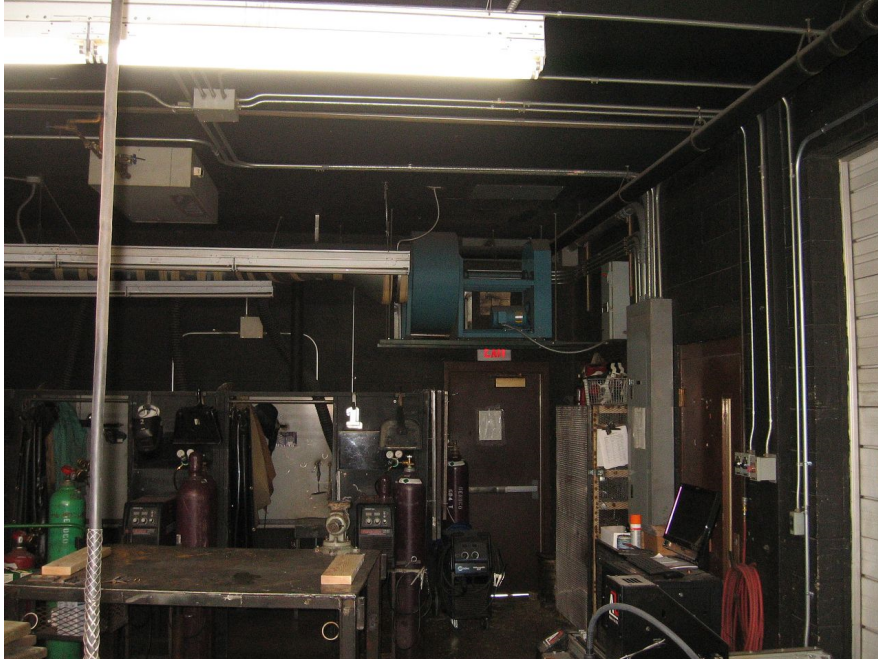
M21: Welding Shop Exhaust Fan

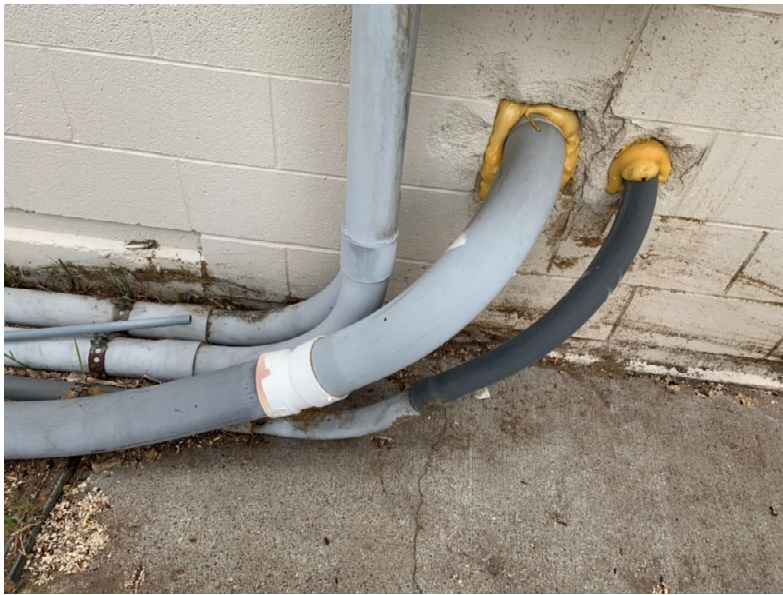
E4: Conduit entrance at dust collector. Shows change in materials at fittings, conduit runs and sealant used.

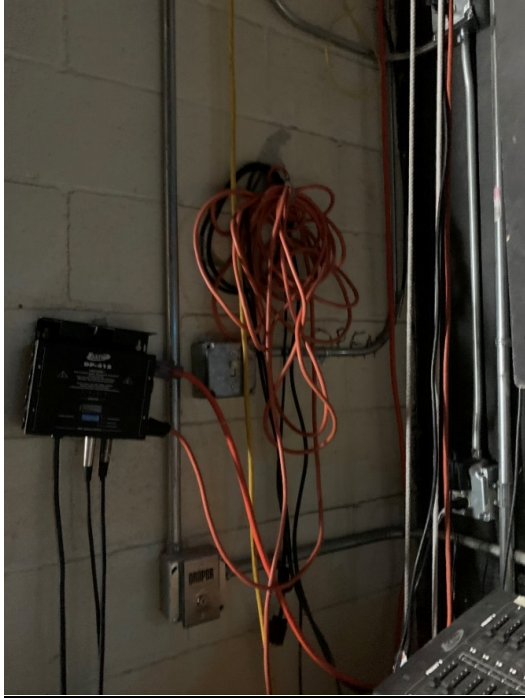
E7: Extension cords at stage area.

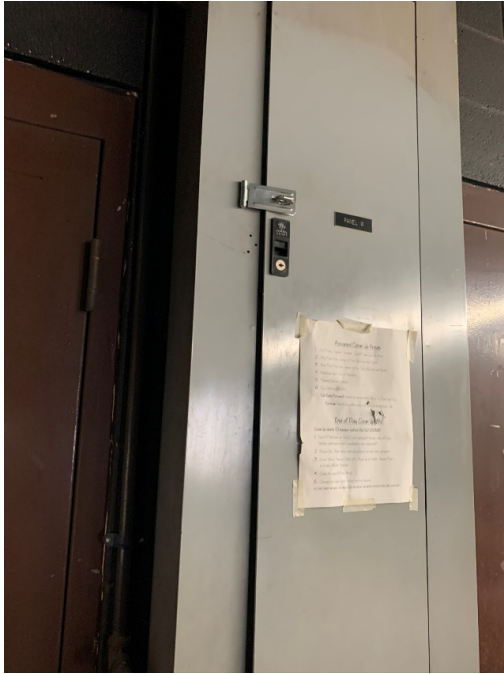
E9: Panel in Metal shop with door latch not properly working.

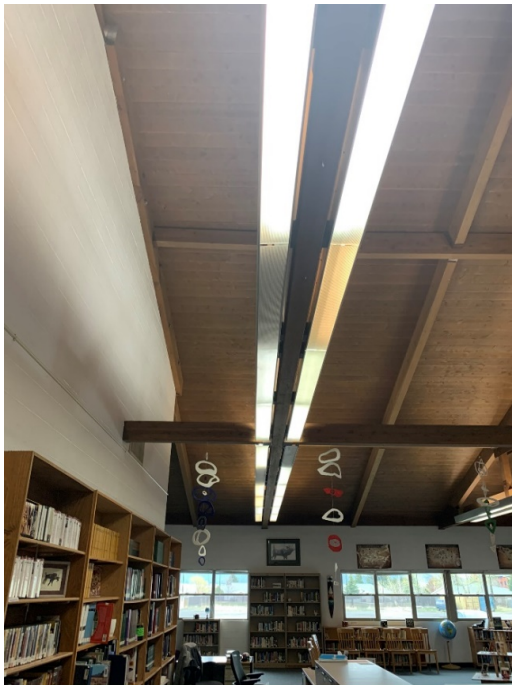
E10: Lighting lens discoloration in the Library

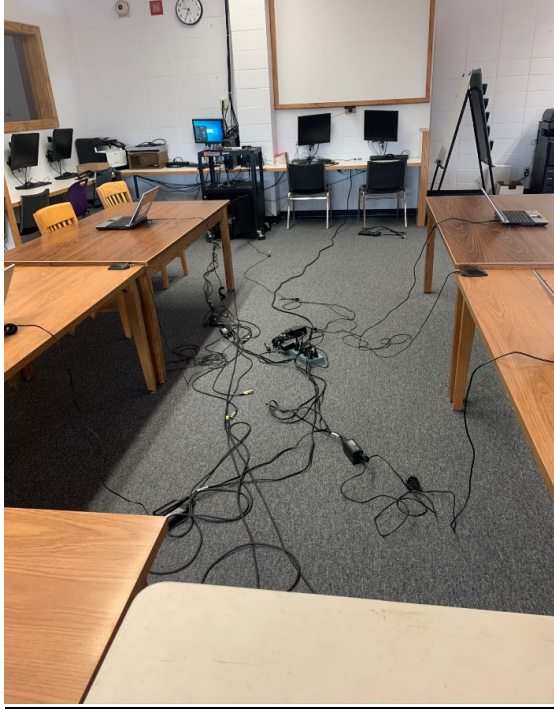
E11: Extension cords and power strips at meeting area in Library

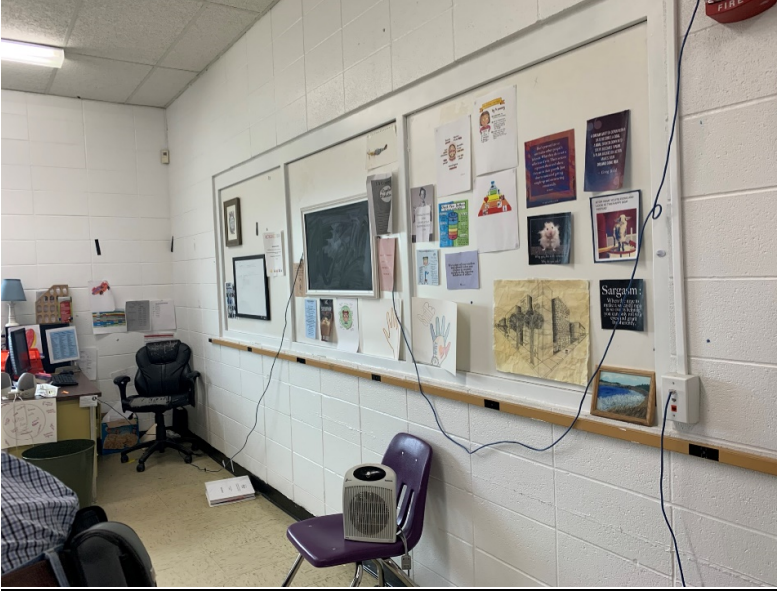
E13: Communication cable draped across teaching wall to desk.

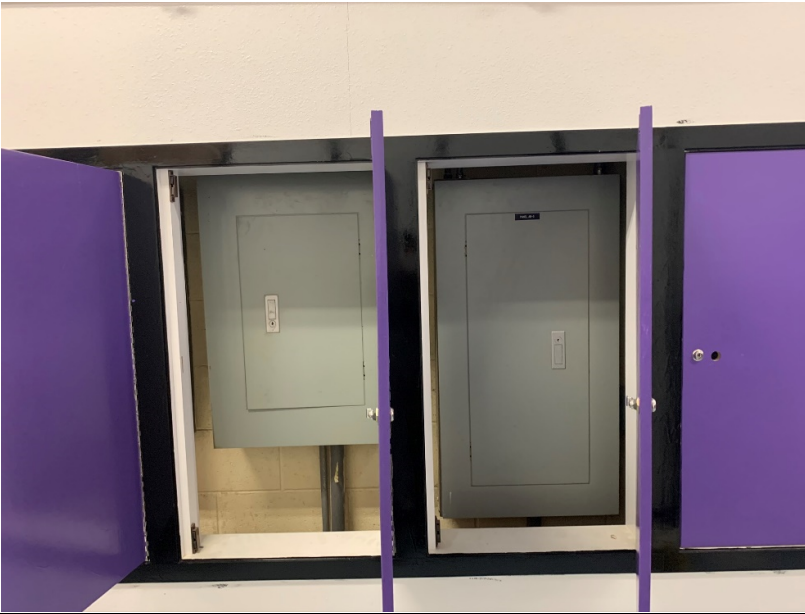
E14: Panels off of Gym lobby enclosed in cabinets. Working space clearances not met.

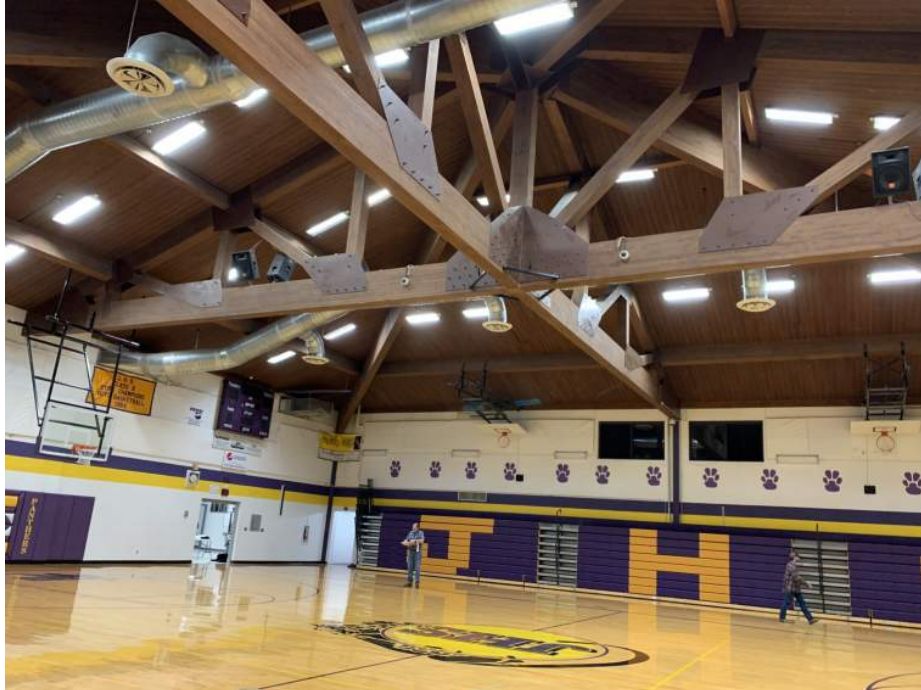
Figure 2. 1985 Gym Roof Trusses

The 1985 Gymnasium structure consists of two large intersecting roof trusses constructed of glued-laminated timbers (glulams). These trusses intersect at the center of the gymnasium along with four glulam hip beams that span from the center to the corners of the gym area (Figure 2). Smaller glulam purlins span between the trusses and glulam hips and support the 3x6 heavy timber decking roof diaphragm.

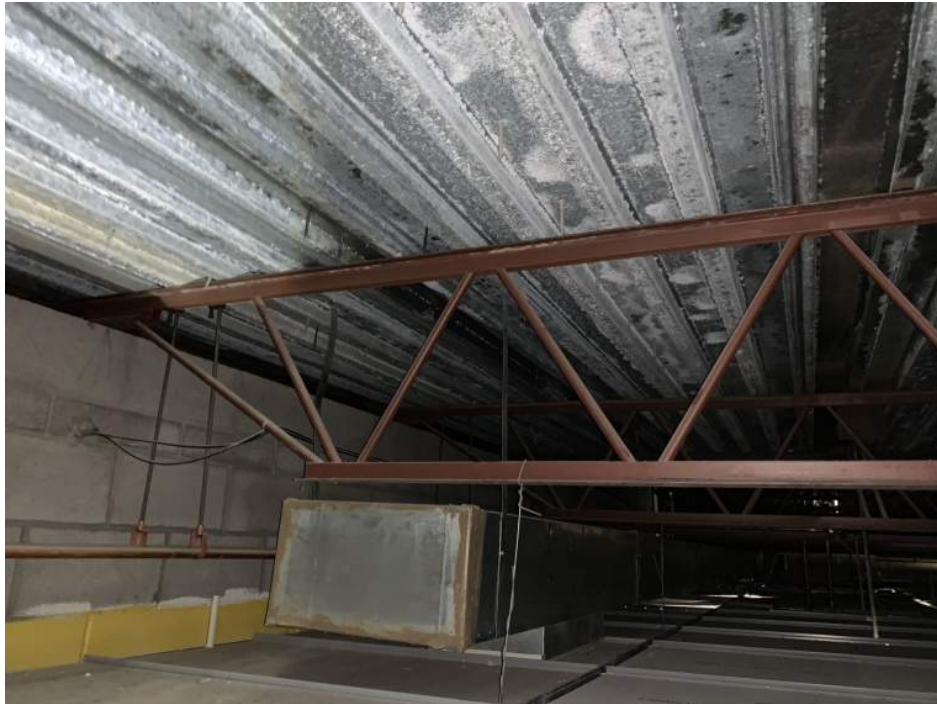
Figure 3. Roof Framing Above Wrestling Room (1985 Addition)

The south wall of the gym is shared with a two-story area consisting of locker rooms on the first floor, and a weight room and wrestling room on the second floor. The roof framing above this area consists of OWSJs spaced at 5-feet on-center supporting a metal roof deck. These joists bear on CMU walls on both ends and appear to be in good condition, as seen in Figure 3. It should be noted that signs of roof leaks could be seen at the interface between the metal decking above the weight room and the wood decking above the gym (Figure 4). At the time of the site visit, none of the structural elements showed signs of water damage.

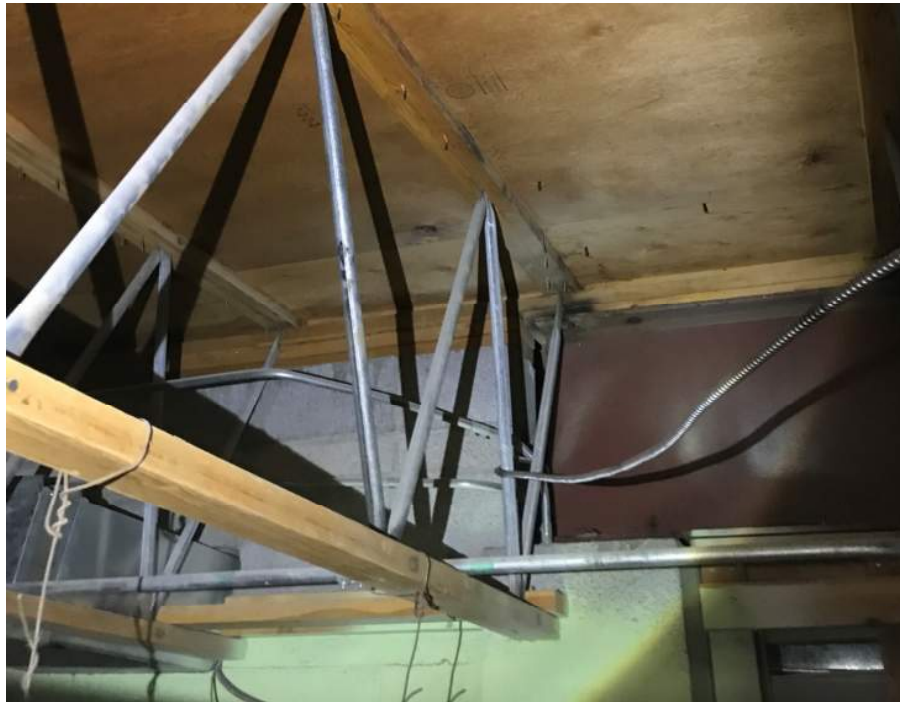
Figure 8. TJL Bearing on Interior CMU Wall (1974 Classroom Addition)

This classroom addition is a single story with CMU bearing walls at the exterior and interior, arranged in stack bond. The roof framing consists of plywood sheathing over TJI joists spaced at 36-inches on-center spanning to the CMU walls, as seen in Figure 8. At the exterior walls, the joists are bottom chord bearing and extend past the wall to form the cantilevered soffit seen from the exterior of the building. The joists and plywood appeared to be in good condition where observed.

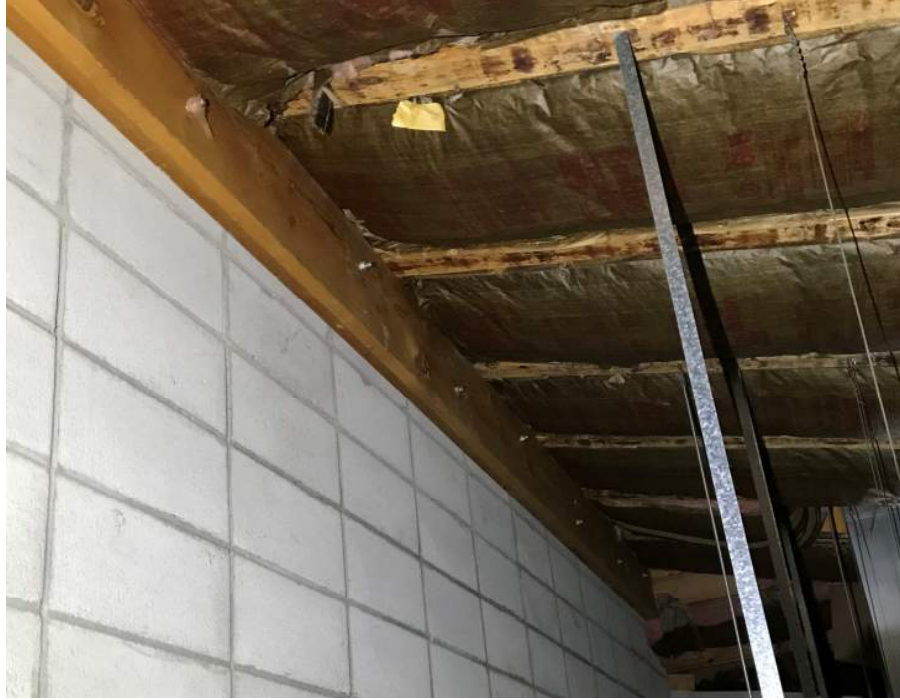
Figure 9. TJI Joist Support at Interior CMU Wall (1985 Classroom Addition)

The 1985 classroom and library addition has running bond reinforced CMU bearing walls with wood roof framing. The exterior walls bear on concrete spread footings at frost depth and the floor in this addition is a 4-inch concrete slab on grade. Over the classrooms, TJI joists are sloped with the roof pitch and supported on glulam beams and CMU bearing walls (Figure 9). The roof diaphragm is a 5/8" plywood sheathing supported by the roof joists in these areas. Where observed, these elements were in good condition.

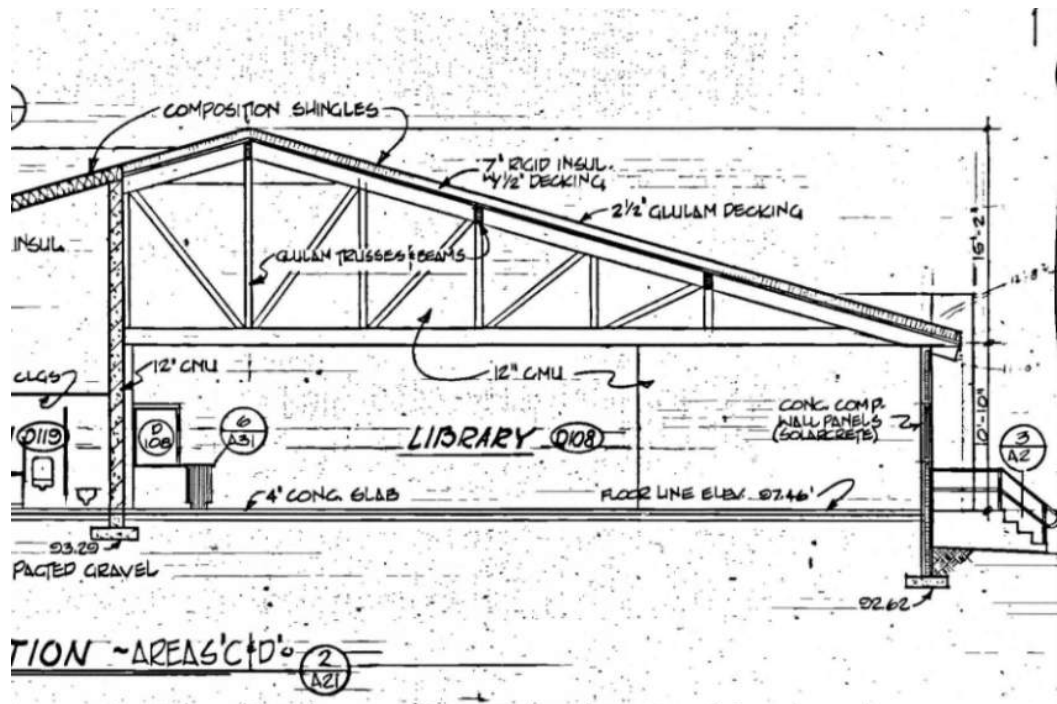
Figure 10. Section of Library Truss from 1985 Addition Drawings

Over the library, the roof framing consists of 3x6 decking over glulam joists and purlins. These are supported by 3 large trusses that span between CMU bearing walls, as seen in Figure 10. At the exterior, some of the tails of the trusses and joists are showing signs of weathering (Figure 11). This weathering is not yet extreme but, if left untreated, could continue to deteriorate the structural members and eventually compromise the structural integrity.

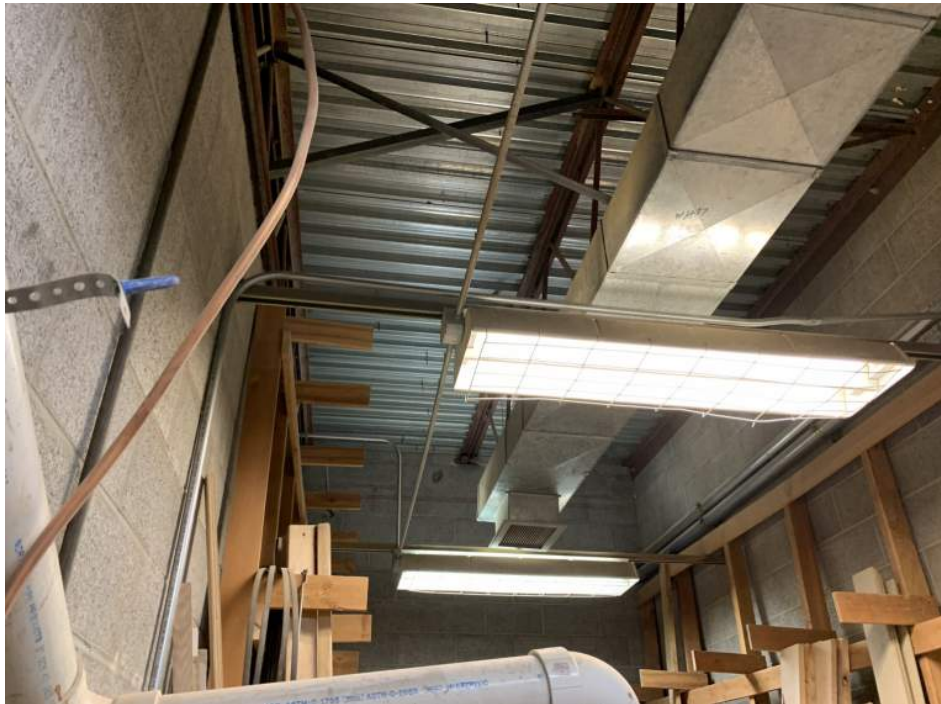
Figure 12. Roof Framing Above Wood Shop (1974 Addition)

The roof framing above the music room and the wood shop is OWSJs supporting metal deck. The joists bear of CMU walls stacked in running bond (Figure 12). The wood shop floor is a concrete slab on grade. The music room is above a basement locker room that connects to the 1956 gymnasium locker room. The walls are CMU laid in running bond and assumed to bear on spread footings. The floor of the locker room is a concrete slab on grade. In this area, the floor framing for the music room could not be observed from below.

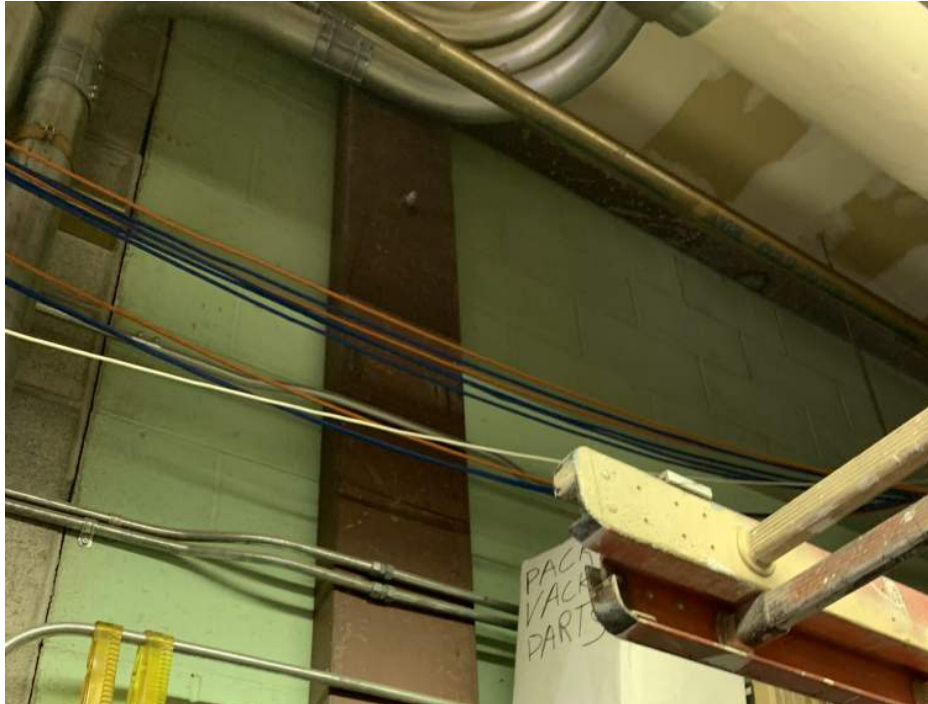
Figure 13. Channel Ledger and Column at Interface Between Mechanical Room and Wood Shop

The weld shop and mechanical room were added to this area in 1985. The construction matches the 1974 addition, with OWSJ supporting a metal roof deck. The exterior walls are reinforced CMU in running bond and bear on spread footings at frost depth with a 4-inch concrete slab on grade for the floor. At the interface between the 1974 and 1985 additions, the OWSJ from the newer addition bear on a channel ledger attached to the wall of the 1974 addition and supported by channel columns also bolted to the wall. One channel column and the bottom of the channel ledger are visible in Figure 13.

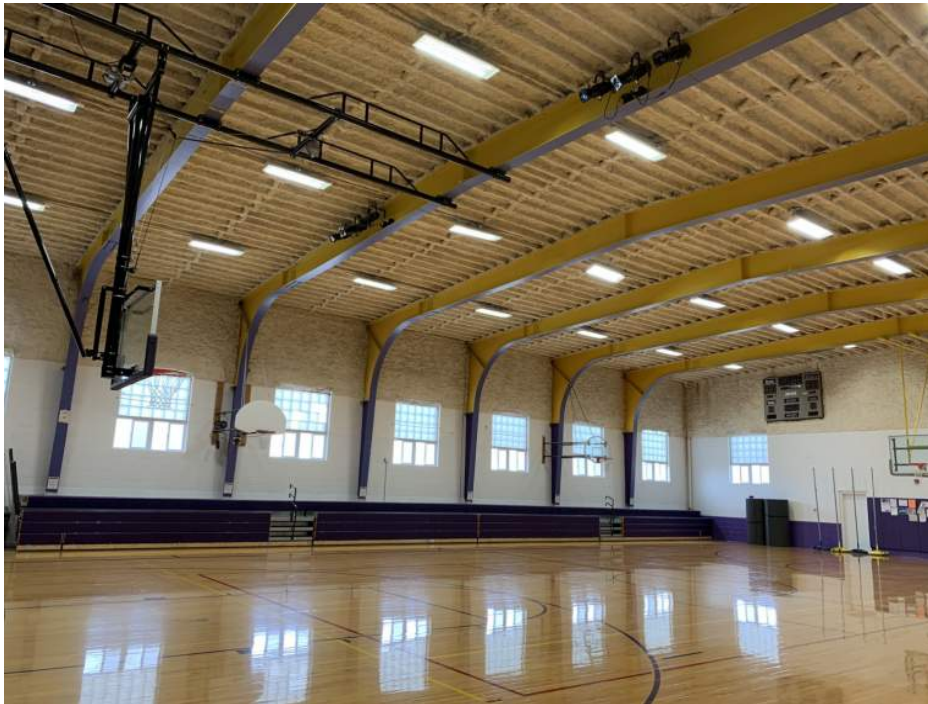
Figure 14. 1956 Gymnasium Overall Structure

The gym has large steel frames spaced at approximately 15-feet on-center that support the roof structure above, seen in Figure 14. The roof structure is covered in a coating assumed to help with acoustic damping. Based on the diagonal blocking visible between the roof joists, we assume that these are wood members spaced at approximately 24-inches on-center. While not visible, we assume that the roof diaphragm consists of diagonal 1x planking based on framing in other areas of the gym. The gym floor, as well as the entrance area, is a slab on grade.
